SAFETY ALERT

AUSTRALIAN STEEL INSTITUTE
SAFETY GROUP

| Number: | Sample SA0003 |
| Subject: | Lifting Arrangement Failure and Importance of PPE |

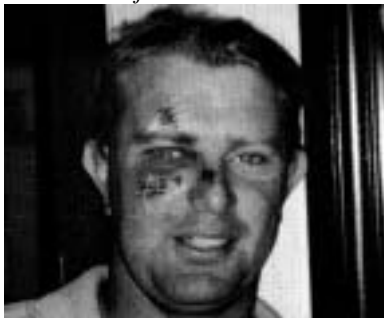
Incident: (Brief facts only, do not include company name or location, insert picture if available)
Whilst installing the bogey arrangement for the wheels on a mobile machine, the worker was leaning over the assembly trying to align a shim between the bogey and the frame when the lifting bolt pulled through the threaded steel frame. The bolt came into contact with the employee's face, his eye only being saved by the wearing of his safety glasses (see photos below)

Injured worker

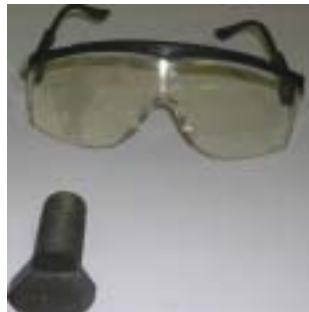
Damaged Safety Glasses and Bolt

- Review the capability of all equipment from suppliers
- Requirement for PPE
- Recognition of 'stored energy' as a potential hazard

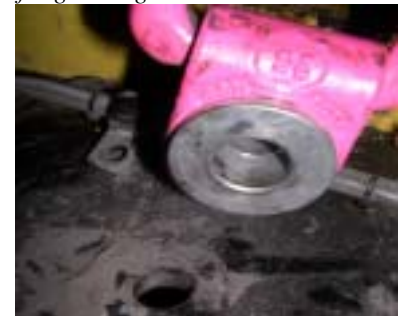
Lifting arrangement and threaded hole

- Design review of bogey lifting arrangement with original equipment manufacturer
- Review of all similar lifting arrangements on the site with potential hazards
- Ensure hazard of 'stored energy' is reviewed in all JSAs
- Utilisation of hand winch arrangement for better control and alignment
