SAFETY ALERT

AUSTRALIAN STEEL INSTITUTE
SAFETY GROUP

Number: SA0011
Subject: Coil Stack Integrity Failure
Date: November 2005

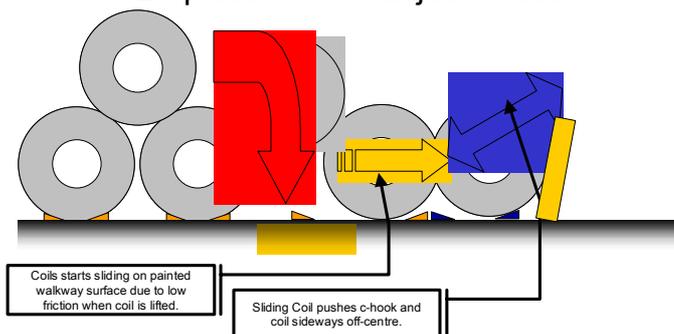
- Warehouse Operator was lifting coil using a c-hook attachment on a crane, when the adjacent coil starting sliding across the floor due to the weight force of a coil on top of it. The coil fell to ground thus breaking the strapping and clock-springing the outer wraps.(Refer diagrams & photos)

3. Displacement of adjacent coil

- All Coils to be removed from painted areas
- All operators and supervisors to be aware of dangers of placing coils on new areas of warehouse, without conducting a risk assessment first.
- Operators to be put through a training package on coefficient friction requirements for coil stacking.

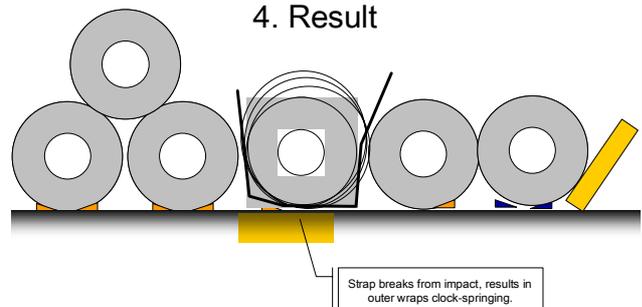
4. Result
