SAFETY ALERT

AUSTRALIAN STEEL INSTITUTE
SAFETY GROUP

Number:	SA0012
Subject:	Failure of lifting apparatus while moving coil
Date:	December 2005

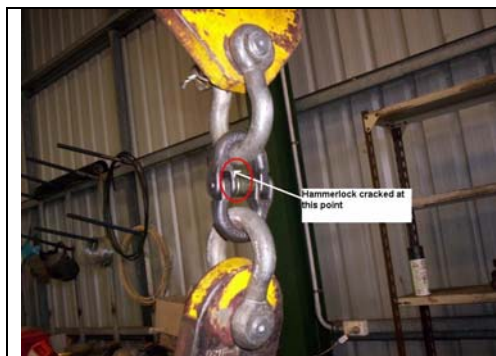
- A near miss event with the failure of the coil loading/unloading lifting apparatus. The event occurred when one of the hammerlock joiners securing one of the lifting links broke while unloading the coil from the Decoiler mandrel. Enough of the coil was still on the Decoiler to catch itself between the Decoiler and lifting apparatus. This lifting equipment had just had its 3 monthly test (09.11.05) with load test and was tagged as safe to work. The problem was identified as a crack in the linkage of the hammerlock, which was undetected by the visual or load test inspection of the service technician. The red circle in the below left photo was the location of the crack.

- Encourage staff to report abnormal incidents concerning equipment even though no damage may be apparent.
- Run education programs for operators on use and care of lifting equipment
