# SAFETY ALERT

AUSTRALIAN STEEL INSTITUTE  
SAFETY GROUP

<b>Number:</b>	SA0013
<b>Subject:</b>	<b>Pedestrian hit by forklift</b>
<b>Date :</b>	May 2006

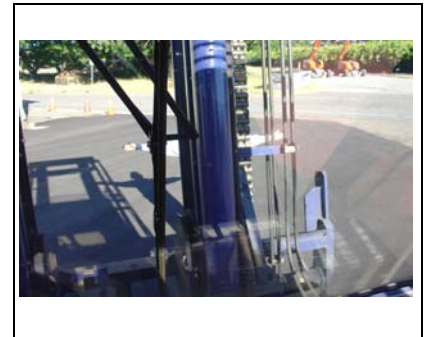
- Whilst crossing the main roadway inside the Finishing area, a pedestrian failed to see or hear a forklift approaching from his left. The pedestrian proceeded onto the walkway crossing (an area where forklifts have right of way).
- At the same time, a forklift was entering the Finishing area from the outside storage area.
- The forklift driver failed to see the pedestrian entering the crossing. Both continued until the forklift's right tyre struck the pedestrian's leg, knocking him off his feet and falling on the tyre until the forklift came to a stop 2-3 meters past the crossing.
- The pedestrian was treated for minor injuries.

- Low speed (estimated 8km/hr) reduced the severity of the incident.
- Forklifts have blind spots from the masts that reduce visibility (refer photograph).
- Forklift crossings need front of mind awareness – other activities in the area can impact on attention to the task of all parties.

- Review designated crossings through forklift areas for effectiveness, specifically gates and signage.
- Improve visibility for person and forklift. Review effectiveness of clothing (benefits of reflective strips), review forklifts (lights, contrasting mast and horns) and discuss forklift blind spots with all people on site.
- Revisit site plans for addressing Forklift procedures, specifically 8km/hr speed and separation/access in high traffic work areas. Useful information on Forklift safety can be found at [www.workcover.vic.gov.au](http://www.workcover.vic.gov.au).
