# SAFETY ALERT

AUSTRALIAN STEEL INSTITUTE  
SAFETY GROUP

<b>Number:</b>	SA0020
<b>Subject:</b>	<b>Forklift strikes utility pole</b>
<b>Date:</b>	November 2006

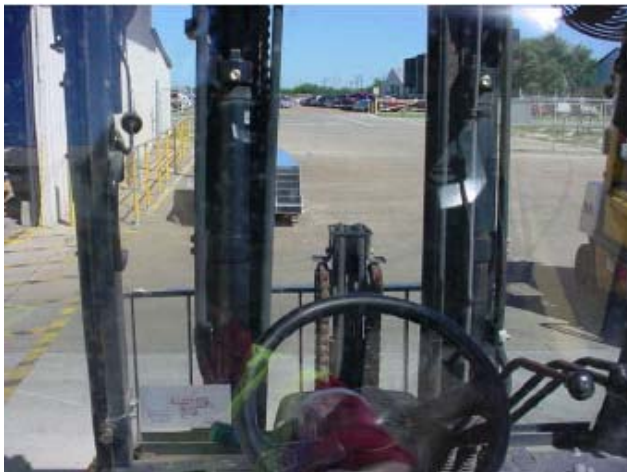
Employee had moved metal and was returning the forklift to the designated parking area. On his way to the parking zone contact was made with the bedrail of the forklift and the utility pole. The force of the contact did not stop the travel of the forklift. The employee slowed to a stop and evaluated the condition of the forklift and the utility pole before returning the forklift to its designated spot.

View from the cockpit of the forklift

- Adjust the direction of travel to park the forklift.
- Make the pole more visible using hi-viz stripes.
- Install safety railing or guarding around utility pole.

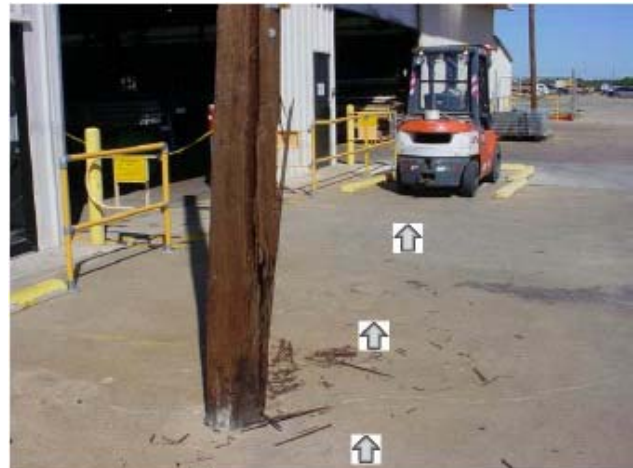
Diagram of the travel of the forklift
