SAFETY ALERT

AUSTRALIAN STEEL INSTITUTE
SAFETY GROUP

Number:	SA0021
Subject:	Overhead crane cable failure
Date:	December 2006

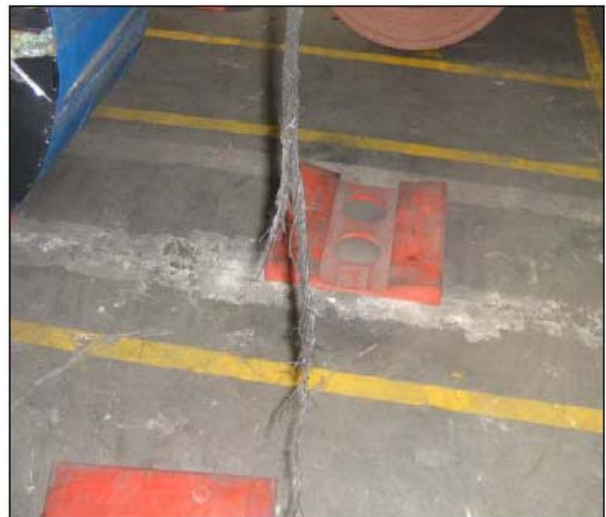
A Gantry Crane lifting cable gave way while lifting a 3.5-ton sheet metal coil dropping it from a height of 2 metres. The crane was rated at 6 ton and is a class 3. The crane had been undergoing daily routine inspection by the supervisor and had regular routine service inspections as per the service booklet. Both failed to detect the fraying of the cable in the early stages.

- Maintenance and inspection frequencies to be made in accordance with Australian Standard (2550.3 section 7 (*Maintenance Inspection and Repair*)).
- If issues are raised by an inspector, make sure to follow-up on it immediately.

- Ensure inspections/reports clearly indicate the state and condition of the components.
- Ensure all crane start up checks are completed at the beginning of each shift.
- Make sure that the safe distance of clearance from items being lifted to operators is at least 2m.
