SAFETY ALERT

AUSTRALIAN STEEL INSTITUTE
SAFETY GROUP

Number:	SA0024
Subject:	Toppling of steel bar
Date	March 2007

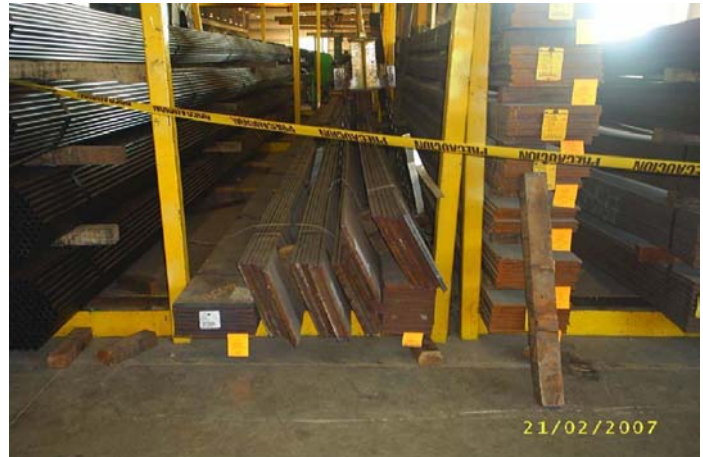
- Employee was moving steel bar material bundles (seven bundle stack) with overhead crane.
- When he lifted the top two bundles he noticed that the suspended load was unbalanced. He tried to rebalance the load by repositioning the suspended load on the original stack.
- As a result, the four bundles underneath toppled in his direction. The top bundle fell on his left foot.
- Employee was wearing steel-toed safety shoes with metatarsal protection but the incident resulted in amputation of phalanges and metatarsus on left foot (about 2/3 of foot).

- Material must be stored in designated areas (not in a tube storage rack as in this instance).
- Management is responsible for enforcing work procedures.
- Lack of hazard recognition.

- Remove bar material from tube storage rack and ensure material is stored in designated areas.
- Ensure appropriate and standardized dunnage is available.
- Improve training and procedures for stacking and storing bar material.
- Reinforce hazard recognition to employees.
