SAFETY ALERT

Number: SA0027

Subject: Over filling of forklift gas bottle

Date May 2007

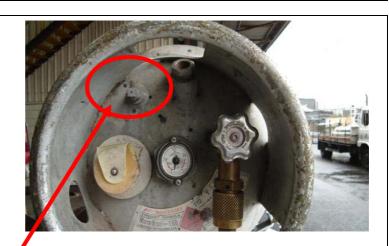
Release valve

Forklift operator was refilling gas bottle on forklift when gas started to rush out of the conection between the gas bottle entry valve and supply gas tank refilling hose, which resulted in operator being hit in face and arms with gas.

Upon Investigation it was found that the release valve on the bottle, which releases small burst of gas to indicate to the operator that bottle is full, was either faulty or had not been opened prior to refilling, causing operator to overfill bottle.

- Have all standard (relief valve) gas bottles changed to <u>afl</u> (auto fill limiter) gas bottles to reduce human error factor when refilling.
- Ensure that all forklift operators are trained in the correct refilling procedures.
