SAFETY ALERT

AUSTRALIAN STEEL INSTITUTE
SAFETY GROUP

Number:	SA0034
Subject:	Crush injury to hand in Pan Brake
Date:	August 2008

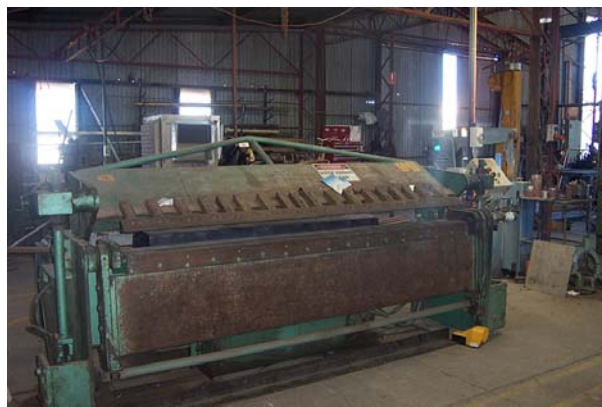
- Significant crush injury sustained to an assistant's hand during dual operation of a Pan Brake (sheet metal folder).
- During dual operation of the Pan Brake the operator activated the lever to begin clamp operation.
- At the same time, unbeknownst to the clamp operator, the sheet metal slipped and the assistant put their hand under the clamp (automatic reflex) to readjust the sheet and consequently got their hand crushed under the clamp.

- Reliance on procedures/training is not always sufficient to prevent an accident.
- The plant was older and existing guarding was not sufficient to prevent an accident.

- Review all plant machinery to ensure adequate plant guarding and/or investigate alternate safeguards where physical guards are not possible (such as light curtains, incremental/intermittent clamping, foot pedals for dual operations etc).
- Review procedures for dual operation tasks and ensure employees are specifically trained (and training documented) for all tasks requiring more than one person.
- Ensure adequate supports/bracing and/or clamps are in place to prevent material slipping for all tasks requiring manual assistance/intervention.
