SAFETY ALERT

AUSTRALIAN STEEL INSTITUTE
SAFETY GROUP

Number:	SA0035
Subject:	Non Compliance To Load Restraint Guidelines
Date:	March 2009

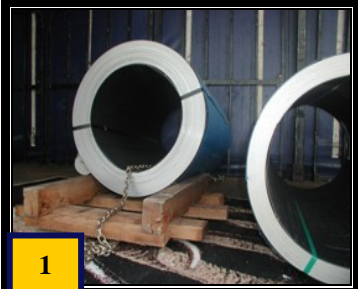
- A coil was loaded onto an upturned pallet (see Photo 1). At the delivery location it was found the coil had shifted sideways and come to rest against the trailer side gates.
- A second coil was loaded directly onto carpet (see Photo 2). Note both coils were chained with a single chain through the bore of each coil.

In both cases the restraint methods used were not in accordance with published load restraint guidelines.

- Consignors and Carriers of steel must be able to demonstrate compliance to performance based load restraint standards and product packaging integrity.
- Loaders and truck drivers need to be trained in their roles and responsibilities under the 'Chain of Responsibility' legislation, including load restraint and packaging standards.

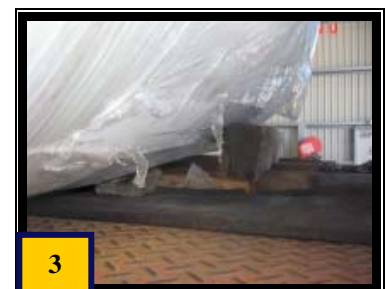
Incident 2: (Photo 3)

- A horizontal coil was loaded onto an upturned pallet used for vertical coils. The pallet failed in transit resulting in the restraining chain coming loose and the coil moving to the other side of the trailer.
