SAFETY ALERT

AUSTRALIAN STEEL INSTITUTE
SAFETY GROUP

Number:	SA0041
Subject:	Coil Loading Incident – Partial foot amputation
Date:	February 2014

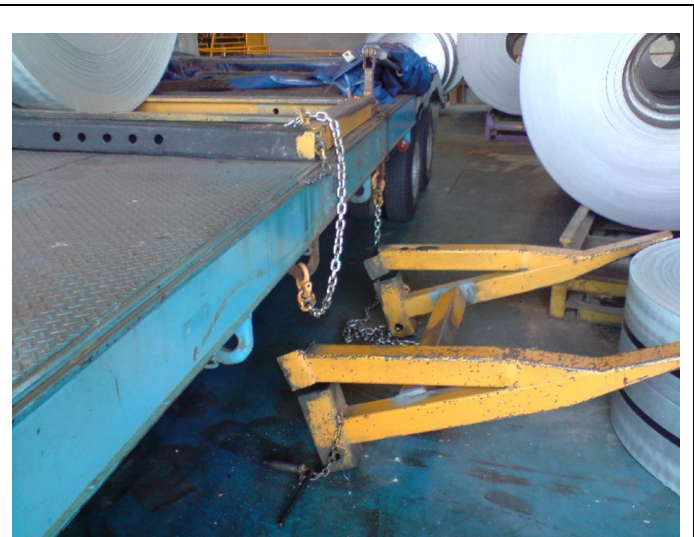
On December 7th, 2009 a labour hire operator was loading steel coils onto a vehicle when the suspended coil caught on another coil already loaded on the vehicle. The coil lifting device became disengaged from the steel coil which then fell from the side of the vehicle.

The operator was standing next to the vehicle when the coil fell. He was unable to retreat and the falling coil struck the operator's foot resulting in a significant injury requiring medical amputation of part of his foot.

- Ensure all employees are trained in loading/unloading exclusions zone requirements
- Ensure risk assessments are conducted for all work processes
- Ensure that all procedures are developed with consideration to findings from risk assessments and are documented
- Develop competency assessments for all high risk tasks
- Develop robust training and assessment processes and ensure that all new employees and labour hire are trained on all relevant procedures and assessed as being competent prior to being allowed to work unsupervised
- Review operation/pedestrian separation areas
- Where possible, use visual exclusion zones in loading/unloading areas
- Develop competency assessments for all Standard Operating Procedures
