SAFETY ALERT

AUSTRALIAN STEEL INSTITUTE
SAFETY GROUP

Number:	SA0037
Subject:	Steel Storage and Dunnage Procedures
Date:	June 2010

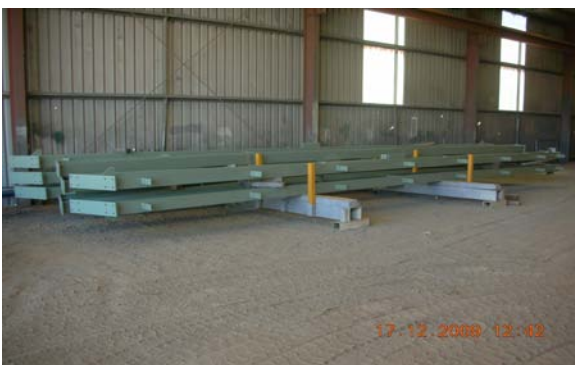
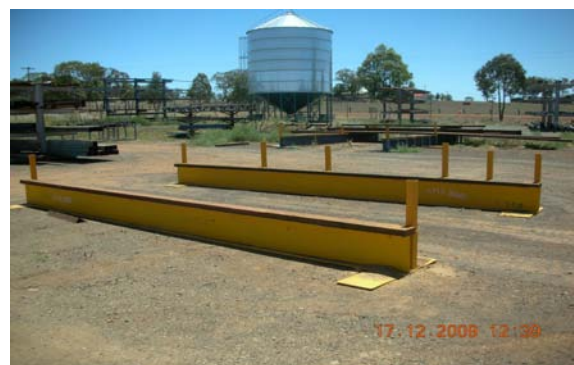
- Steel rafters had been stored on timber dunnage with the extended cleats and end plate preventing the beams from resting securely. Subsequently a rafter tipped forward onto the worker's ankle fracturing two bones and causing muscle and tendon damage.

- Steel products may not be secure on timber dunnage or racking creating the possibility of the steel section rolling over or falling.
- Dunnage size and position may not allow for the cleats welded to the steel section.
- Uneven ground needs to be assessed for suitability of racking or storage of steel sections including vehicle movements for the loading and unloading.

- Racking needs to be suitable to store a variety of steel sections and configurations. This could include upright bars, rubber or timber to prevent slippage, movement or rollovers of steel sections.
- Compaction of work areas should be considered to create a hard surface suitable for vehicle movements to load and unload steel sections from the racks with suitable foundations for the racks.
- Develop and Implement procedures, training and induction processes for storage of steel sections to ensure safe dunnage usage and exclusion zones.
