SAFETY ALERT

AUSTRALIAN STEEL INSTITUTE
SAFETY GROUP

Number:	SA0029
Subject:	Motor falls from overhead crane
Date:	October 2007

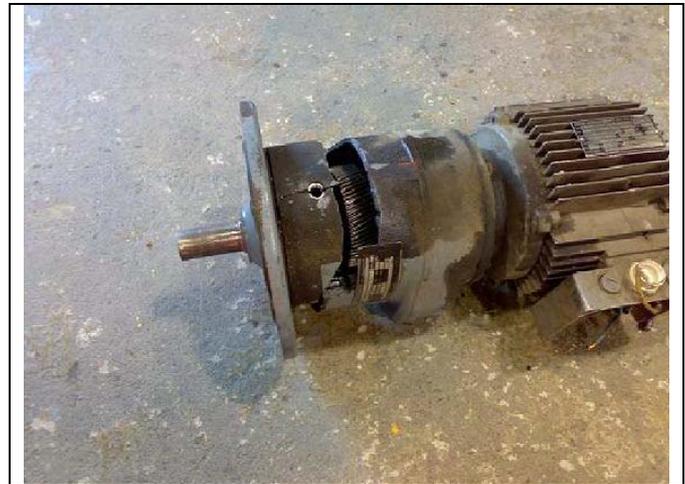
A shaft snapped and resulted in a drive gear dislodging, which in turn resulted in the gear casing breaking. This caused a motor and the electrical connection to be dislodged. The gearbox motor then continued to fall approx, 6.5 metres to the factory floor. The weight of the gearbox is approx 25 kgs.

In the picture opposite. This motor fell to the ground. The broken pieces have been re-assembled to show how the motor fits together.

Crane maintenance contractors advised.
Investigation is continuing with corrective actions yet to be determined.

Make this Safety Alert known and available to your crane maintenance team or contractors.
