Lessons emerge from Cyclone Debbie aftermath

The findings from the technical report into damage to buildings from Tropical Cyclone (TC) Debbie in northern Queensland released in late June reveal there are still issues associated with affixing flashings and cladding, loosened debris from garden sheds and steel fencing, but that roller doors meeting the revised standard prove more resilient.

As such, the Report undertaken by the Cyclone Testing Station (CTS) at James Cook University has important lessons for those building with steel in cyclone-prone regions of Australia.

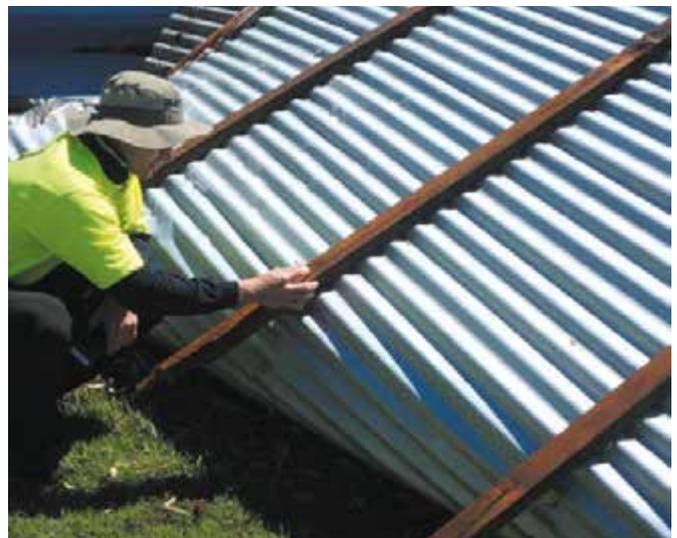
Previous investigations following severe wind events have found that flashings fastened with pop rivets have often detached from buildings. Flashings that were fastened with screws on all sides performed well. In a few buildings assessed during the investigation, loss of flashings contributed to partial loss of the adjacent roof sheeting.

The report recommended that AS 1562.1 (Standards Australia, 1992) should specify minimum requirements for flashings and their fixings to resist applied wind loads. HB39 currently recommends appropriate screws (not pop rivets) at a maximum of 600 mm centres and on horizontal and vertical faces of barge flashing.
