THE ART OF CORROSION RISK MANAGEMENT

N. Tripathi

Roads and Maritime Services, Transport for NSW, Australia

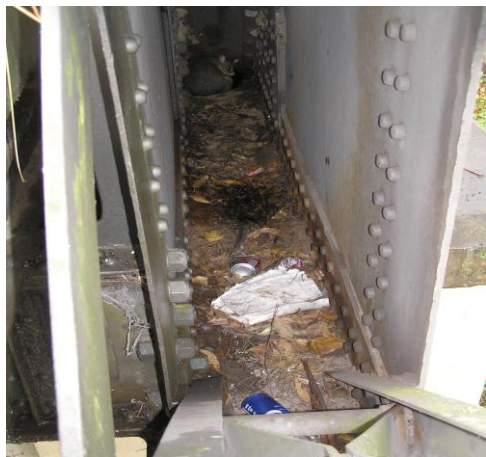
Several lattice truss girder bridges were designed and constructed in NSW in the late 19th century [Fig 7]. The truss structure has a plated hollow section, similar to a boxed section with one side removed, at each end of the truss [Fig 1]. As is evident, there is accumulation of debris and dirt in this area. In many cases, it also provides shelter to the local fauna. The bottom chord of the trusses is typically 'U' shaped fabricated (riveted) section and, similar to the plated section, is prone to accumulation of debris [Fig 2]. Needless to say that these areas are very much prone to corrosion. The complex geometry of the truss, with a large number of connection points due to the lattices, makes recoating work a challenge. Since these trusses are heavily fabricated, there are a number of crevices present that could easily lead to crevice corrosion, if not maintained adequately. This type of design detail is not used in the current steel bridges. In fact, the recent trend is to use steel trough or box girder that provide a flat exterior surface, thus facilitating not only easy application of paint coating but also avoiding the likelihood of local corrosion.

Figure 1 Accumulation of debris in plated section at the end of a lattice truss girder

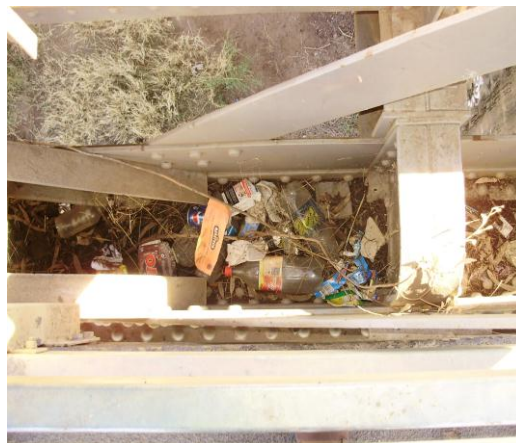
Figure 2 Accumulation of debris in fabricated bottom chord of a lattice truss girder

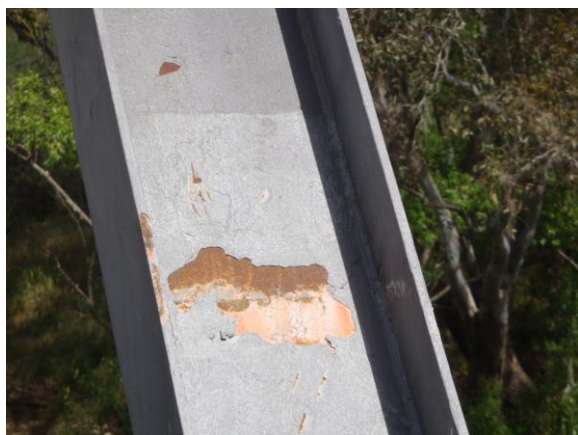
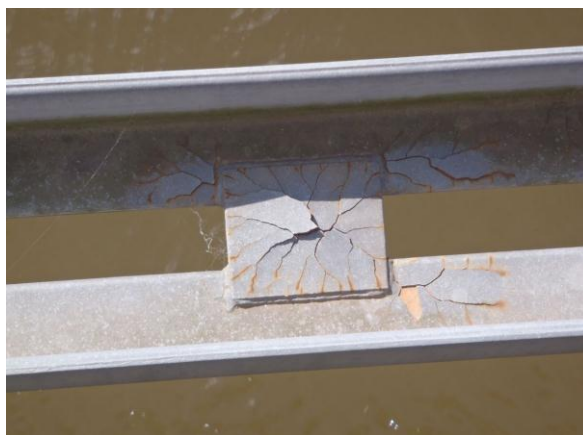
Fig 3 and Fig 4 show elements of a bridge with premature failure of the paint coating. The project specification required application of a zinc rich epoxy primer followed by MIO epoxy top coat. The coating developed cracks, flakes and blisters prematurely. The follow up investigation revealed that:

1. In some areas, the zinc primer was initially found to be low. These areas were re-coated to make up for the low film build and, in the process, the resulting primer thickness was significantly more than the specified nominal requirement.
2. Painting of the elements commenced in mid May and the paint coating was applied generally in the late afternoon.
3. The overall thickness of the coating was generally much in excess of the specified thickness.
4. The records indicated that the painting work continued during intermittent shower.
5. There was evidence to the fact that removal of the spent abrasive from the surfaces was not satisfactory.
6. The work was carried out in rush.

Figure 3 Premature coating failure

Figure 4 Premature coating failure

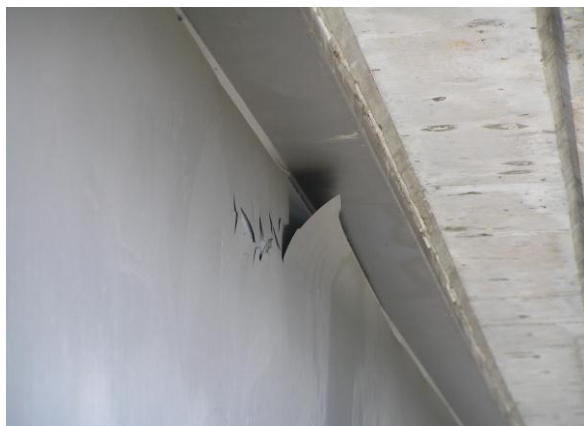
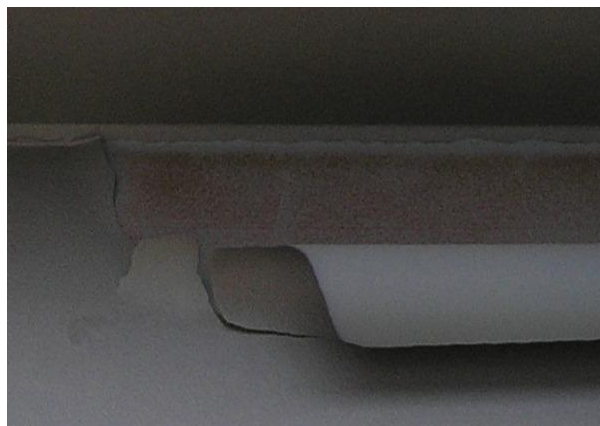
Fig 5 and Fig 6 show paint coating failure on another bridge. In this instance, the coating was found to have been delaminated. The delamination was observed to be at the interface of primer and the intermediate coat. The investigation included dry film thickness measurements that were found to be excessive at some locations. The report noted the possibility of inadequate curing of the primer.

It is worth noting here that in both the above cases, the project specification did not include an upper limit on the dry film thickness. The current version of RMS specification for protective treatment of steel work stipulates an upper limit on the DFT.

Figure 5 Coating delamination

Figure 6 Coating delamination

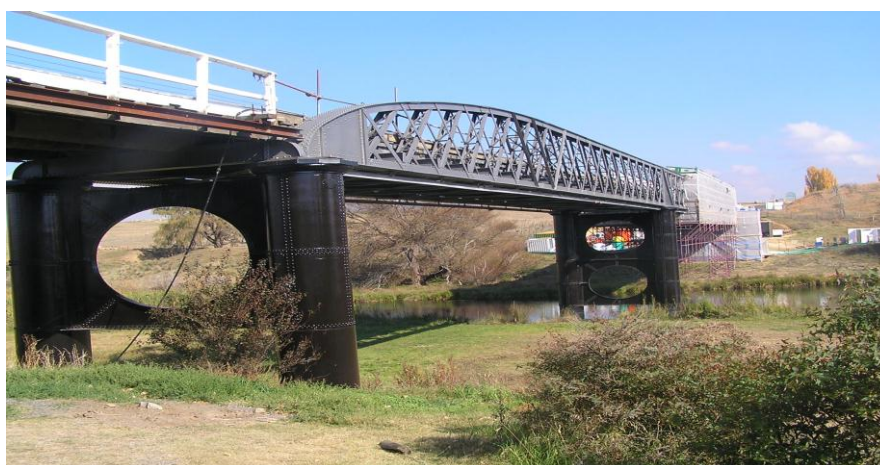
The bridge shown in Fig 7, constructed in 1888, was last recoated in the year 2008. A project specification was developed to address the project specific needs. The specification generally required application of the primer on a surface prepared to class AS 1627.4 Sa 2½. This was to be followed by the intermediate and the top coat.

Figure 7 Lattice truss girder bridge recoated in 2008

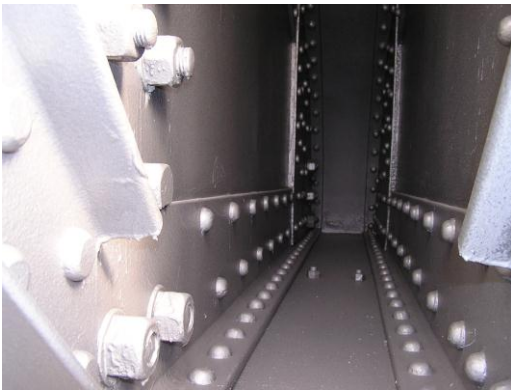
Prior to tender, a site inspection was carried out to identify the limitations of the work and the site constraints. The bridge consists of lattice Wrought Iron truss girders with a box at each end of the girder [Fig 8]. The box was approximately 400 mm wide and accessing the inside of the box was a difficult task. Similar access difficulty was identified with the top

Figure 8 Painted plated section

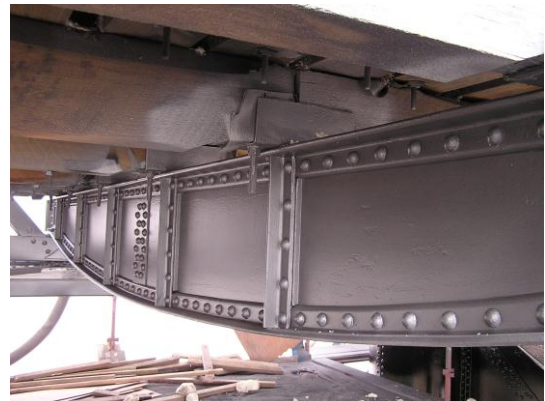
flanges of the cross girders beneath the timber deck [Fig 9]. Due to the complexities inherited from the design, some other areas were also identified as areas that can be accessed with difficulty [Fig 10]. The specification called for the use of surface tolerant epoxy primer in the areas that could not be prepared to class Sa 2½ due to access difficulty.

Figure 9 Typical cross girder under the deck

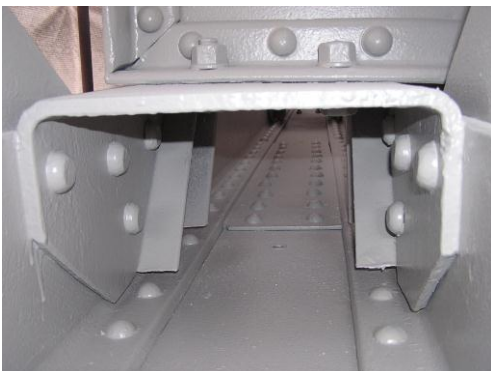
Figure 10 Area identified as 'difficult to access'

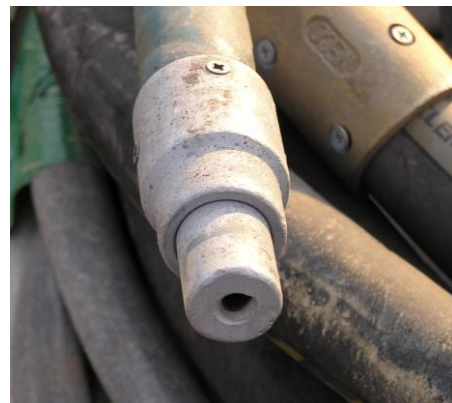
Figure 11 Nozzle used to blast the plated section

During the tender meeting, these issues were brought to the attention of the prospective contractors. Once the tender was awarded, the site was again visited by RMS project team and the contractor to arrive at an agreed way to address the project issues. The contractor proposed to use smaller nozzle [Fig 11] to blast the plated section at the end of the trusses. The environmental conditions were closely monitored by the RMS surveillance officer on site during the cold weather in May.

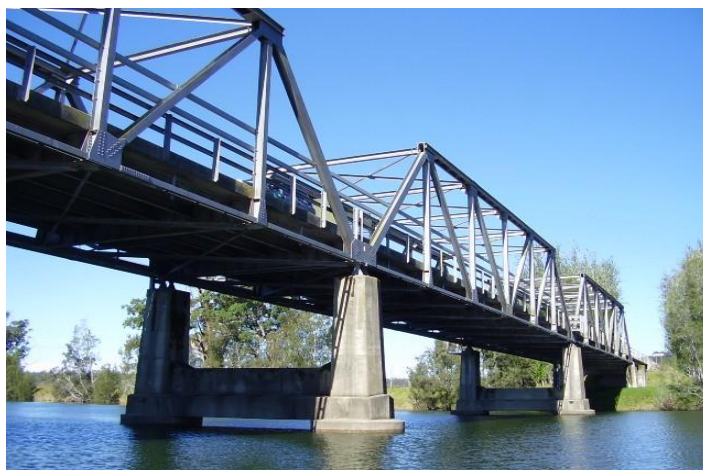
Figure 12 Through truss bridge

The through truss bridge shown in Fig 12 was repainted in the year 2010. A project specification was developed to address the project specific needs. The process adopted was similar to aforementioned. During the tender meeting, the site was visited by the project team and the prospective contractors who attended the meeting. The structure was simpler than the lattice truss girder bridge in the first example. However, it was difficult to access some of the areas. Considering the difficulty in achieving class Sa 2½ finish, provision was made in the specification for the use of surface tolerant epoxy primer in these areas. The specification also nominated a maximum value for the dry film thickness for each coat.
