CORROSION OF GALVANIZED FASTENERS USED IN COLD-FORMED STEEL FRAMING

Contractor : Steel Framing Alliance
Principal Investigator: Larry Williams
Co-Investigators: Don Moody, Jay Larson

Sub-Contractor: University of Hawaii Dept. of Civil Engineering
Principal Investigator: Dr. Ian N Robertson

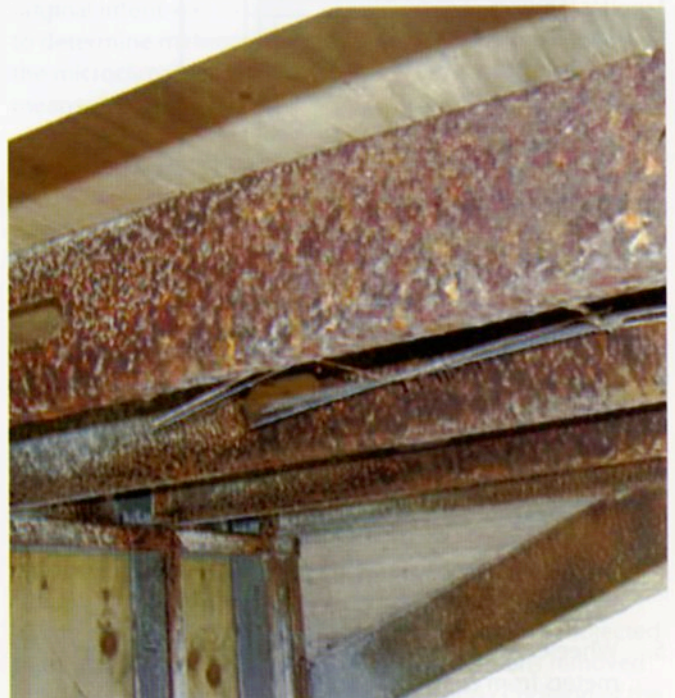
Crawl space exposed floor joists - MCBH Coastal site after 16 months.

In contrast, fully exposed CFS members and fasteners in the crawl space of the coastal enclosure at MCBH showed initiation of corrosion after as little as 5 months exposure. This corrosion proceeded rapidly so that by 28 months, the exposed floor joists and supporting posts and cripple wall have experienced severe corrosion. Areas of the floor joists that were enclosed by plywood sheathing show very little signs of corrosion except where exterior air has leaked into the enclosed space through unsealed edge joints.

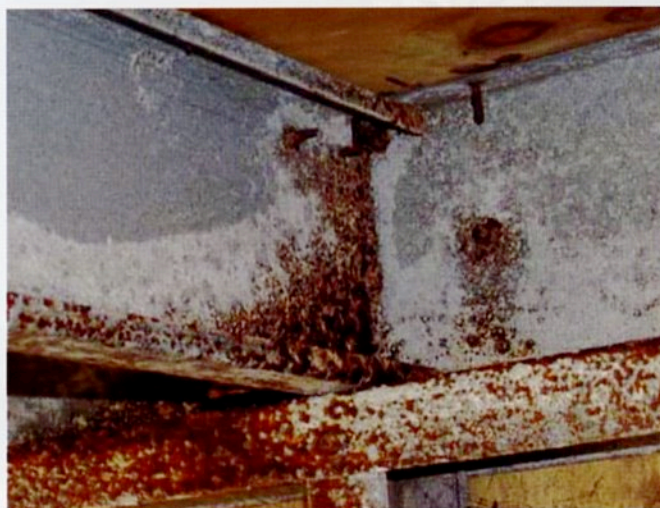
Crawl space exposed floor joists, MCBH Coastal after 21 months.

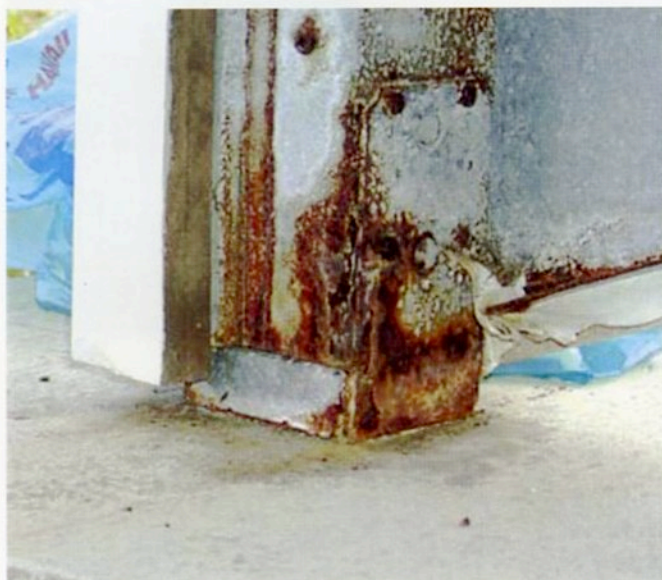
Crawl space cripple wall and post, MCBH Coastal after 28 months.

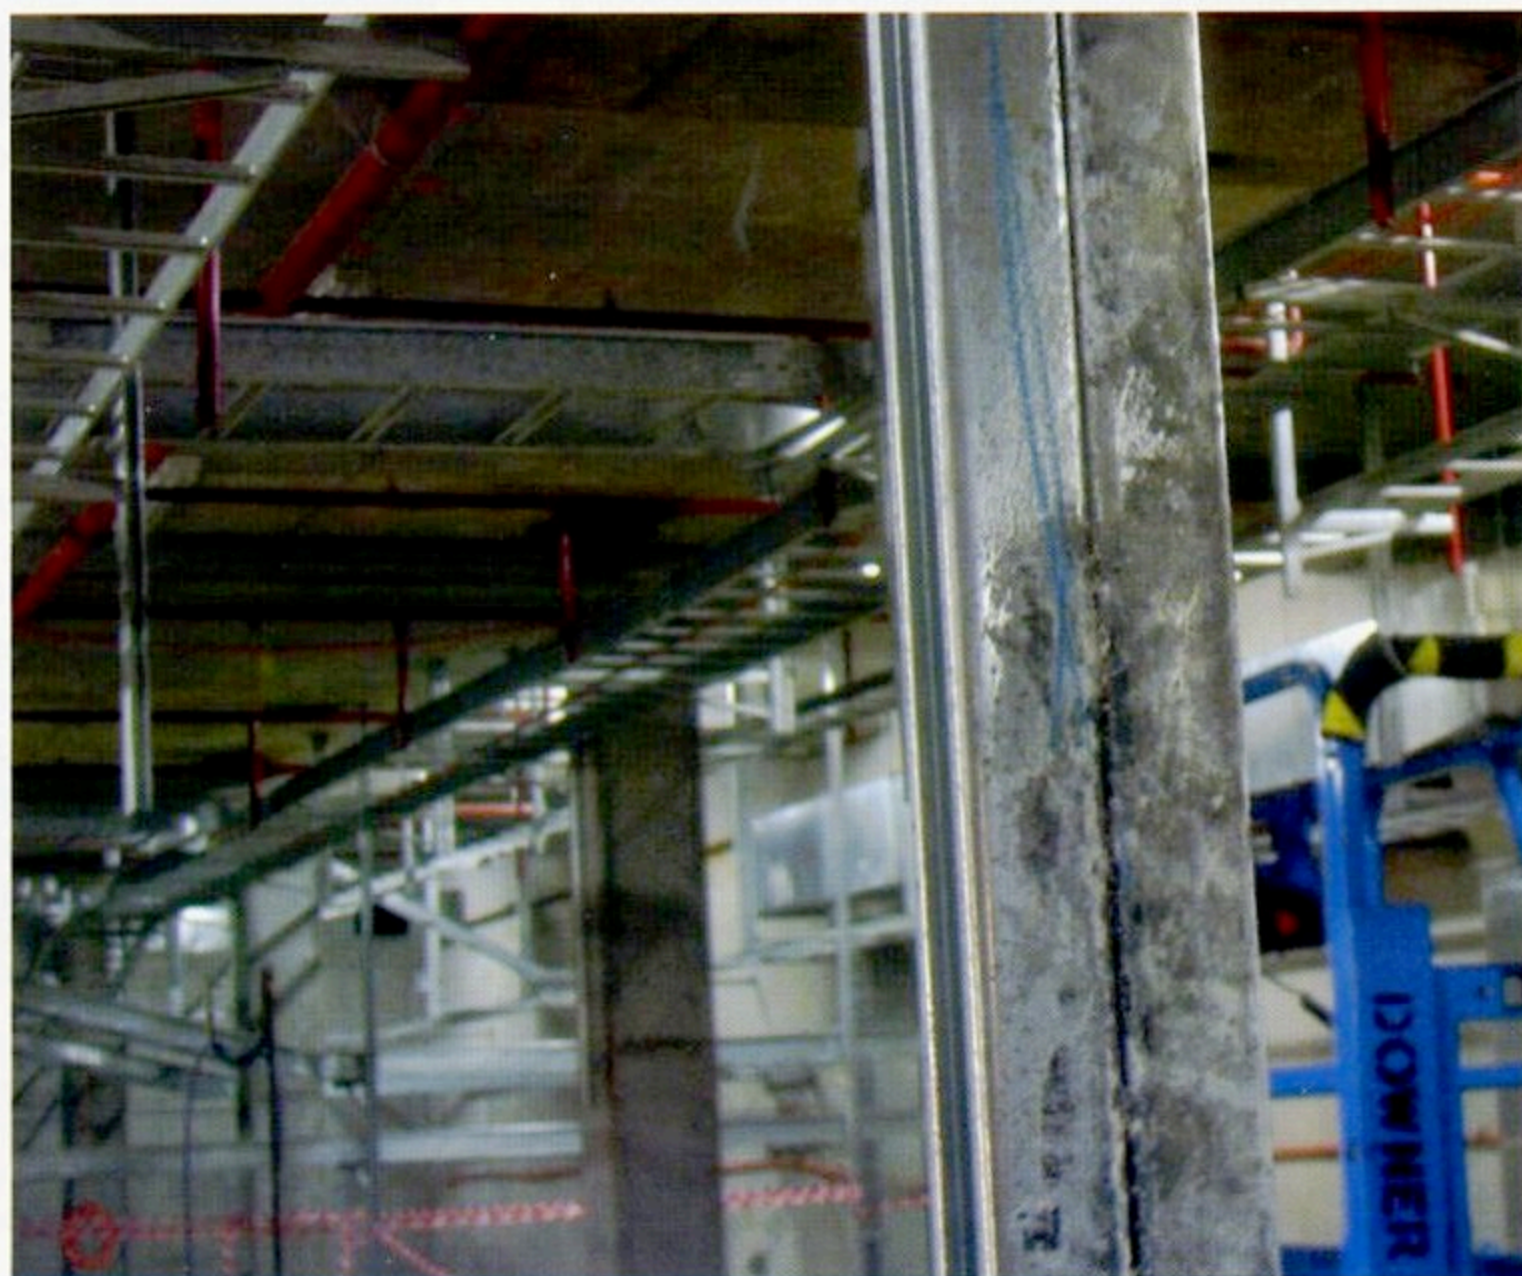
This cable tray column is badly stained by 'white rust' caused by prolonged storage on site in packs during a period of wet weather. Where does the responsibility lie? - Page 24
