Shoalwater and Roleystone WA tornadoes  
Wind damage to buildings

Report: TR54  
August, 2008

**TECHNICAL REPORT NO. 54**

Authors: G. Boughton (TimberED Services, Perth)  
D. Falck (TimberED Services, Perth)

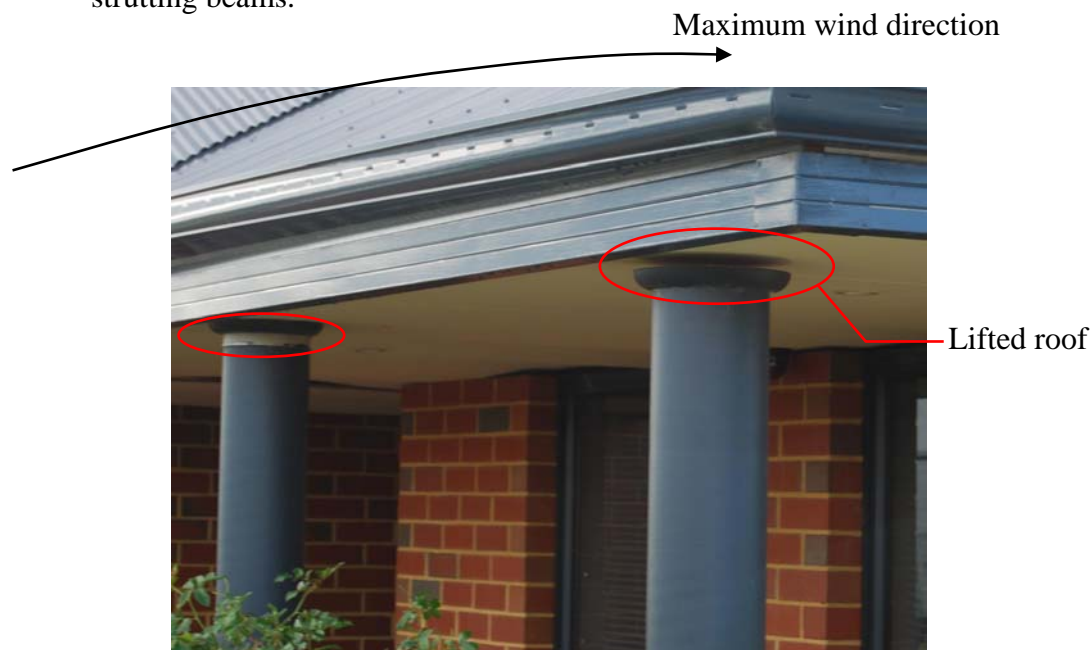
Wind speeds at roof height were estimated at between 110 and 120 km/h or 32 to 34 m/s. This building was less than three years old and had sustained considerable damage including:

- Damage to front door fixings that meant the front door blew in as the strong winds first arrived.
- Loss of part of the roofing near a hip (roofing had battens attached).
- Partial separation of part of the roof structure from the walls including lifting of some bricks to which the top plate had been fastened.
- Partial separation of batten to rafter connections throughout the roof.
- Partial separation of some underpurlins from struts and some struts from strutting beams.

**Figure 3.1 External (front) view of sheet roof house**

Figure 3.1 shows a general view of the house viewed at 90 degrees to the direction of peak winds. There is no debris damage in this view, but the lifted roof is obvious by the gap over one column and the movement on the other. While the roof has moved, it did not become detached as a whole.

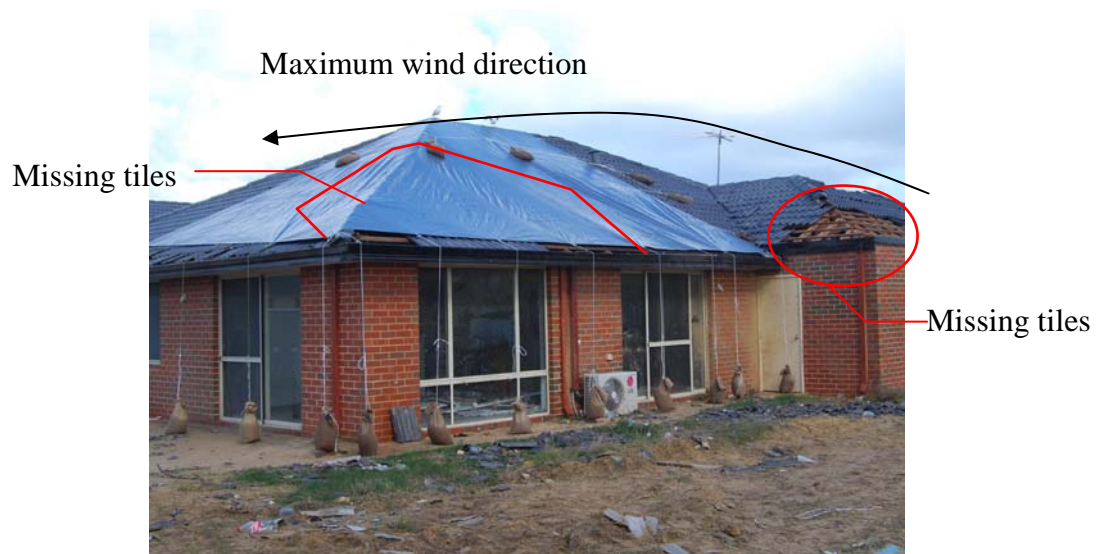
- Loss of some tiles near the hips.
- Subsequent collapse of ceiling due to water ingress.

Figure 3.2 shows a general view of the house showing damage to roof tiles near hips.

**Figure 3.2 Damage to tiled roof due to wind loads**

The tiled roof used for wind speed estimation and illustrated in Figure 3.2 also experienced wind damage to tiles. In all of these cases, relatively small areas of roof were affected by the tile damage. It was only parts of the roof close to the intersections of roof planes (hips and ridges) that were subjected to tile loss. This indicates that at the design load, the highest loaded regions of the roof are close to their capacity.

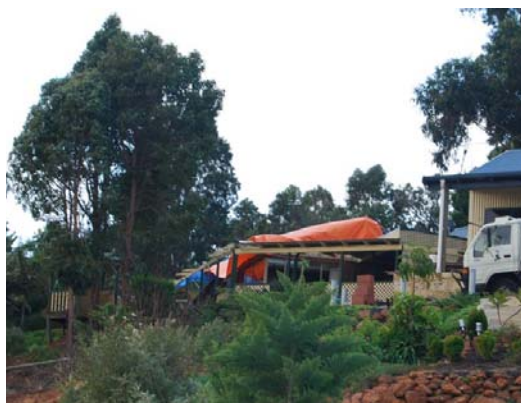
- In the first half of its path, the Roleystone tornado had a lower wind speed than the Shoalwater tornado. Here only branches less than 100 mm were broken and leaves remained on most trees in its path. Some deciduous trees even retained some autumn leaves.
- In the second half of its path, the Roleystone tornado had a higher wind speed than the Shoalwater tornado, but there were no buildings that were in the direct path of the tornado in this half. There were a number of buildings that were close to its path and some of these were damaged. An estimate of the wind speed in the wall of the tornado was 180 to 200 kph as some trees in excess of 400 mm diameter had been broken half way up the trunk.

(a) Damage in first half of path

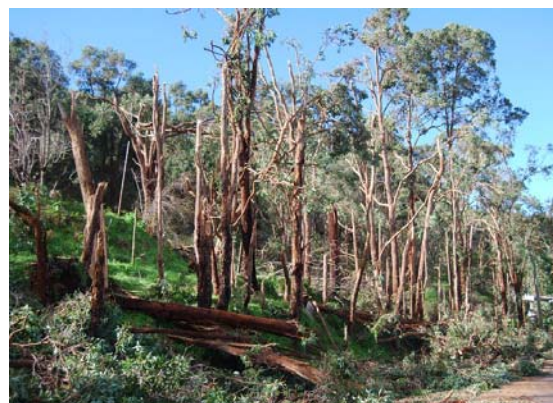
(b) damage in second half of path

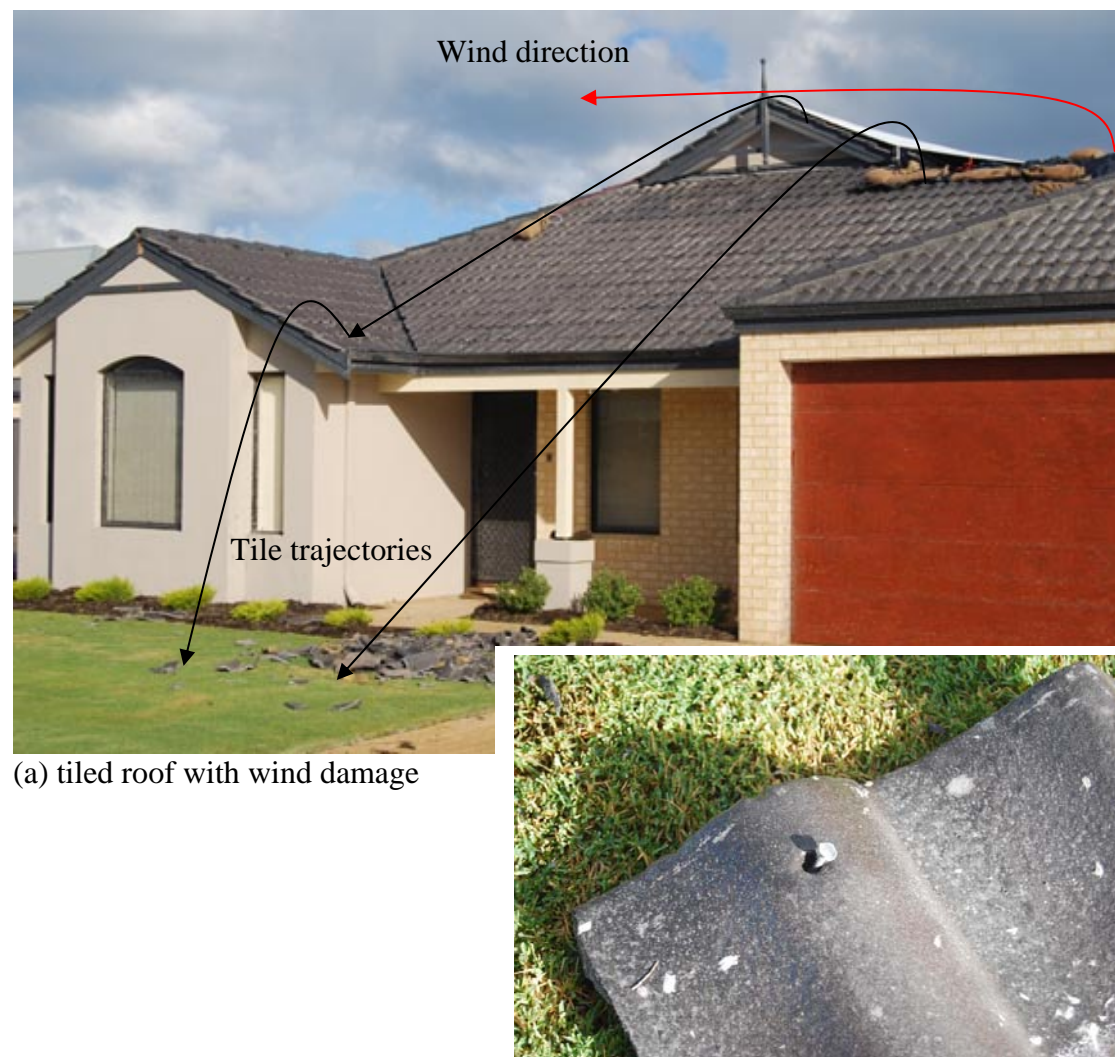
(a) tiled roof with wind damage

(b) tile with nail in place on the ground

**Figure 4.1 Wind damage to tiled roof**

Figure 4.1 shows a roof with incidental tile damage in areas of the roof that would have experienced very high suctions under wind actions alone. In the affected area, there was no sign of debris impact and many of the tiles had been removed with little breakage. In some cases, the nail used to anchor the tile was still in place in the tile.

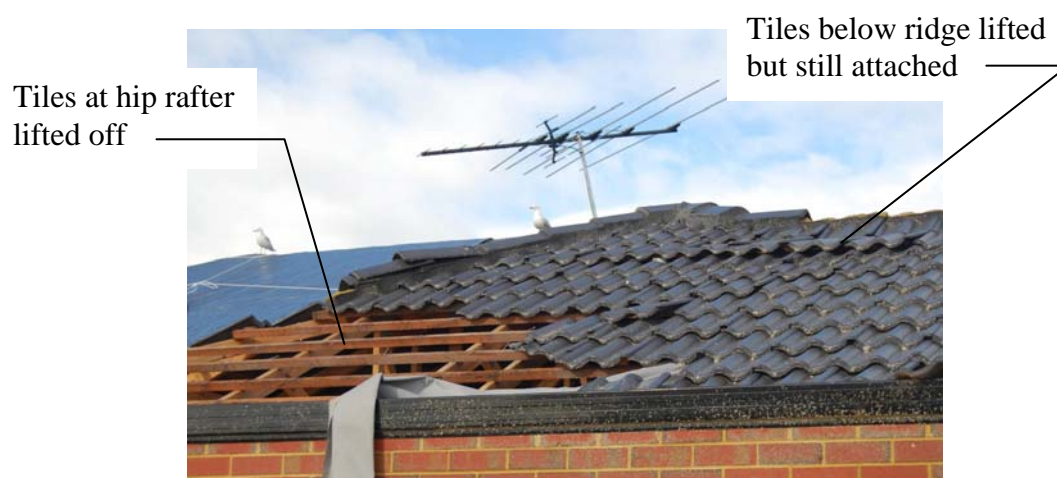
Figure 4.2 shows a roof panel that experienced particularly high suctions, and it can be seen that while the tiles just below the ridge are still intact, they have almost lifted off. The tiles near the hip have been lifted by the wind.

**Figure 4.2 tiles in high uplift regions of the roof.**

The estimated tornado wind speed was sufficient to lift individual tiles under external suctions. As the estimated tornado wind speed was close to the design wind speed for this location, the design wind speed is also sufficient to lift individual unfastened tiles. In peak suction areas of hip roofs, uplift forces exceed the weight of the tile at gust wind speeds of between 25 and 30 m/s.

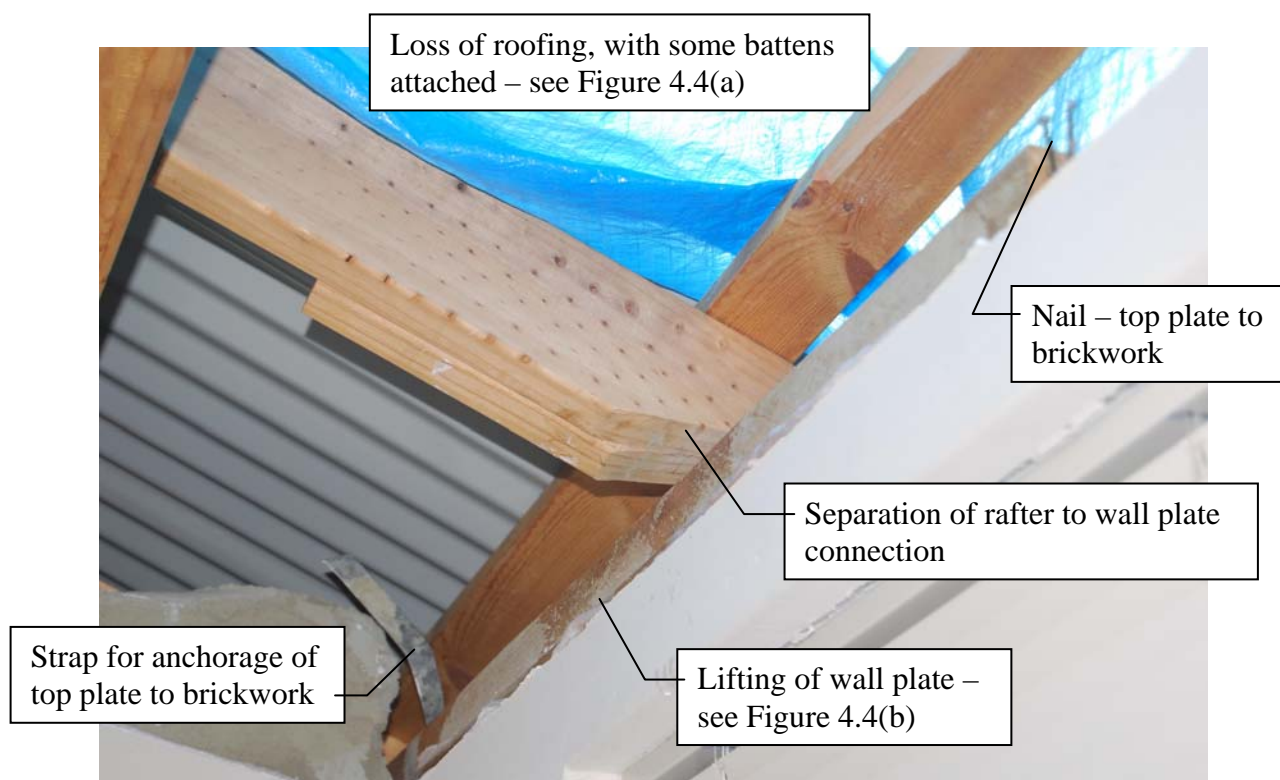
Figure 4.3 shows a view of the roof from inside the house. The most obvious problems are that the roof has lifted over the room from which the photo was taken, and the ceiling has collapsed with the subsequent water damage. However, a more detailed investigation inside the roof showed that many of the structural connections in the roof had been significantly compromised and the whole roof structure was very close to a comprehensive failure. Figures 4.4 and 4.5 were taken from inside the roof space in an area in which the roof sheeting was still attached, and where from an external perspective, there were no problems.

**Figure 4.3 Wind uplift damage to sheet roof**

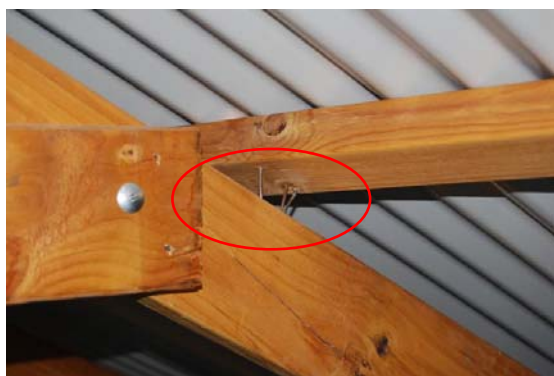
Figure 4.4 (a) shows a batten to rafter connection in which three gun driven nails had been used. In other parts of the roof, only two nails were used. However, where the roof had detached, battens and the roof sheeting remained together. The batten to rafter connection was a weakness in the outer roof structure. In some places on this house, rafters had also separated from the wall plates.

(a) batten to rafter connection

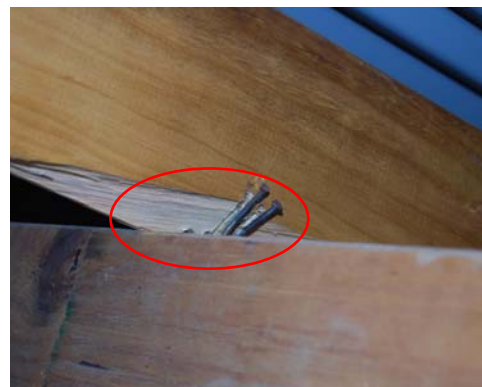
(b) rafter to top plate connection

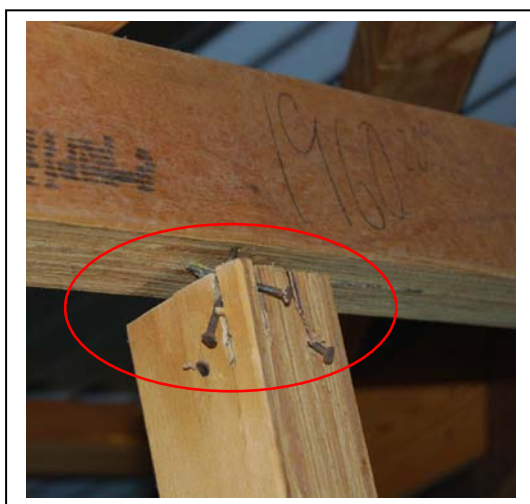
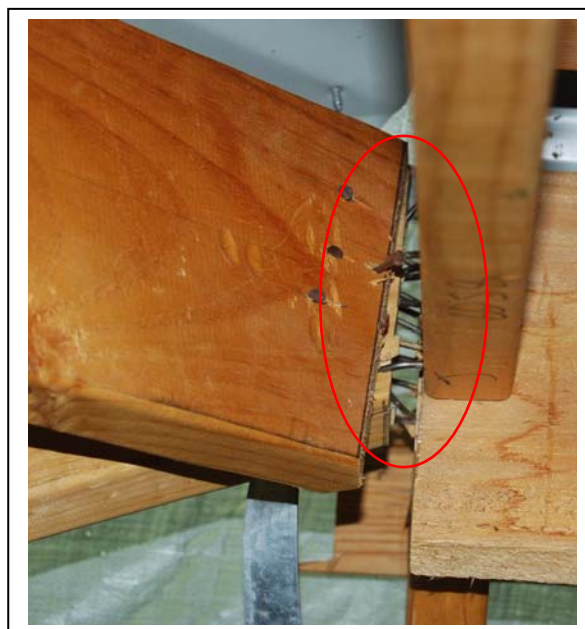
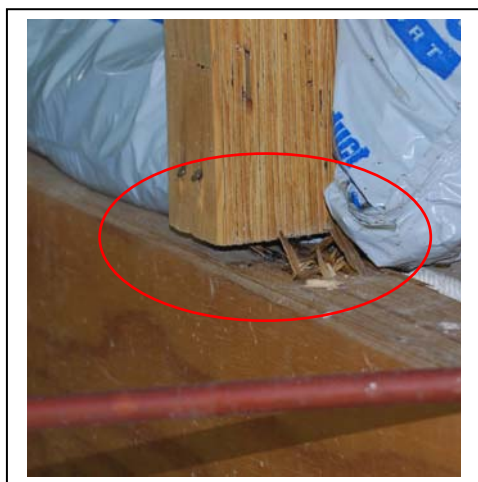
(a) connection at top of strut

(c) connection at hip rafter

(b) connection at bottom of strut

**Figure 4.5 Separation of connections in the inner roof structure**

In this house only 25% of the roof was lost due to failure of 2 nail batten to rafter connections. However, elsewhere in the house, where the roof remained attached to the roof structure, there was significant distress to the connections between underpurlins, struts and strutting beams. Figure 4.5 shows the movement opened up at these joints in spite of the use of a large number of skew nails.

In the strutting system, roof carpenters can appreciate the load path when the roof is loaded with gravity loads, but do not provide tie down through the same load path for uplift loads. With lightweight roof systems, wind uplift can be significantly more than the dead weight of the structure. AS1684.2 [5] has details for anchorage of underpurlins and struts under wind loads (AS1684.2 [5] Table 9.23). These details were not seen on any stick-built roofs in this study.

In light weight (sheet) roofs, uplift forces exceed the weight of the roof at or below the design wind speed. Tie down of all structural elements in the roof is essential. A range of appropriate details of tie down connections in stick-built roofs is given in AS1684.2 [5]. However, there was little evidence of them being used in the badly damaged buildings in these events.

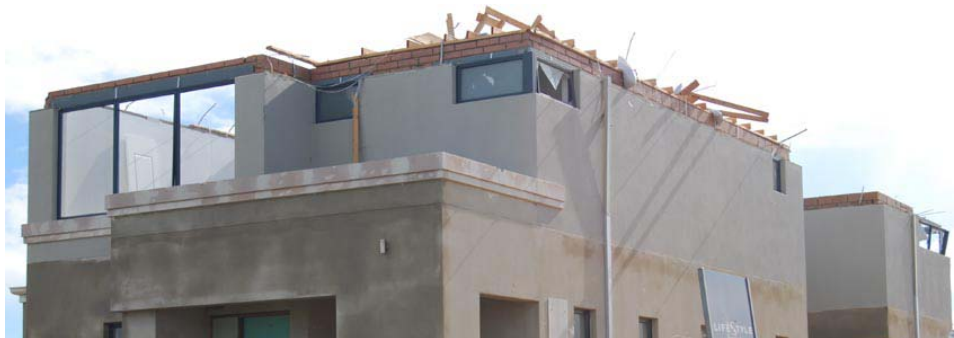
(a) Upper storey with loss of most of roof structure

Figure 4.6 shows another stick-built roof in which almost the entire structure was lost. The house was under construction at the time. In this case, the rafter to top plate connections had failed, and the tie down from the struts was ineffective as well. Most of the struts had been lost with the house. In many rooms, the ceiling structure remained intact, but water damage to the plasterboard meant that it had fallen in.

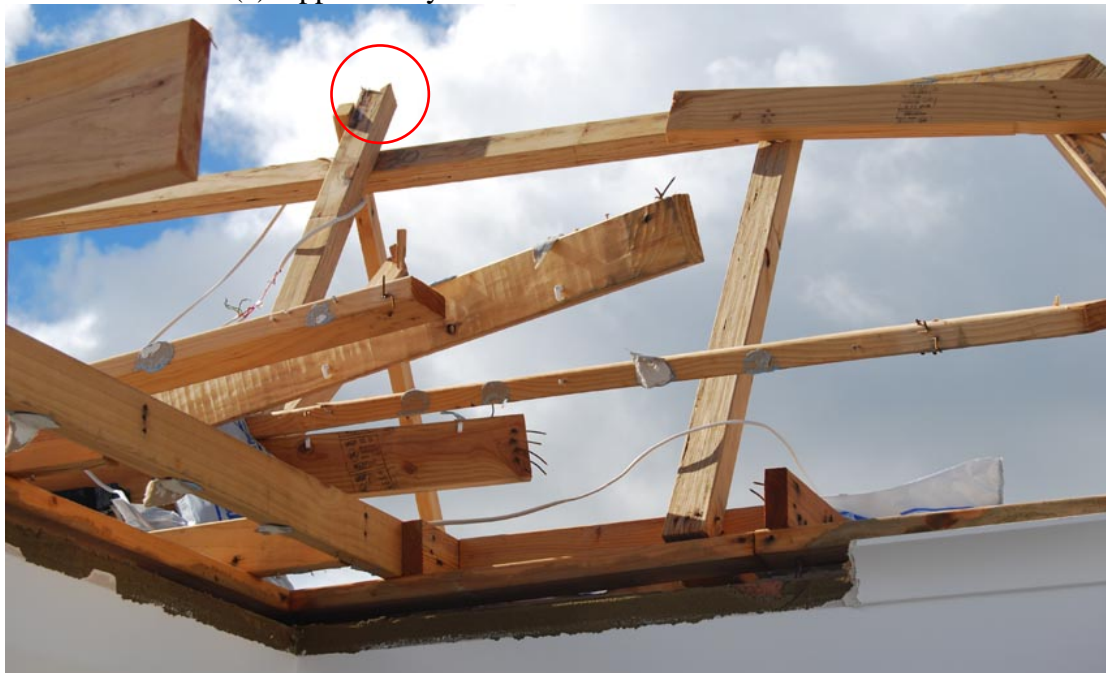
(b) Detail where parts of structure remained

Figure 4.6(b) shows enough detail of the structure remaining to identify it as a stick-built roof. Throughout the second storey, the top plate had lifted from the brickwork, but over much of the house, the weight of the ceiling and the action of the strap had kept it attached. However, the rest of the roof structure had largely been lost. This included lifting of the rafters at the eaves and struts in the central part of the roof. Over much of the roof, the struts, underpurlins and rafters were missing with the roof debris.

There was no sign of prescribed AS1684.2 [5] tie downs on struts in this house. The red circle in Figure 4.6(b) shows the top of a strut where the underpurlin has been lifted off the strut.

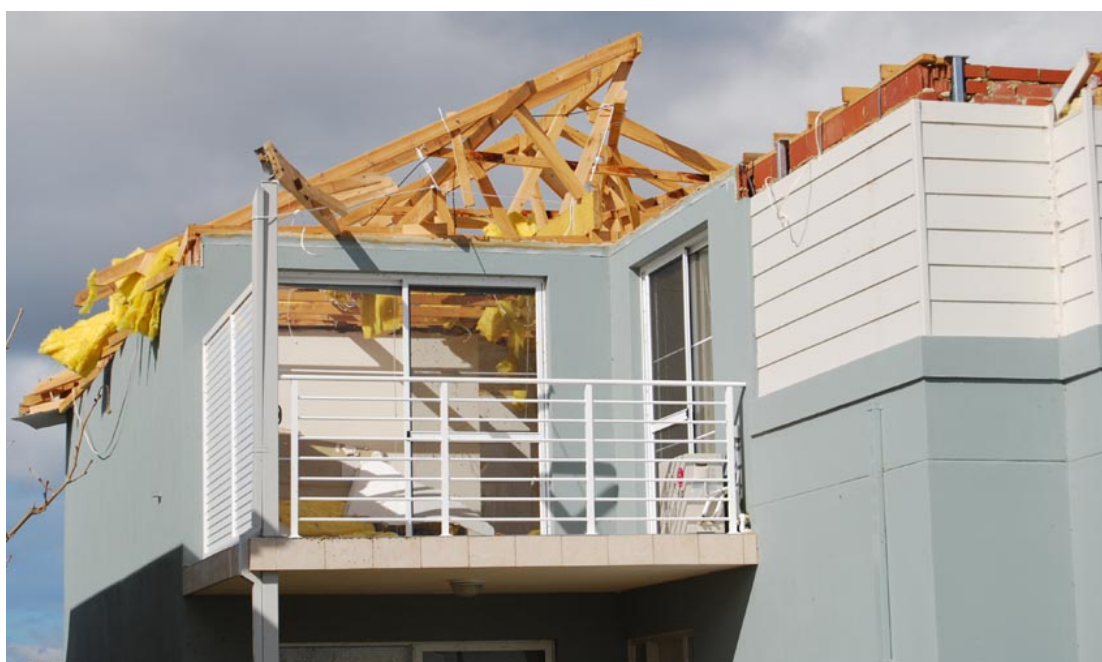
**Figure 4.7 Loss of roof structure – two storey house**

Figure 4.7 shows another house of recent construction in which most of the roof structure had lifted. Again, sufficient timber was left to be able to identify the construction as stick-built. On the little part of the roof structure remaining, the batten to rafter connection had failed.

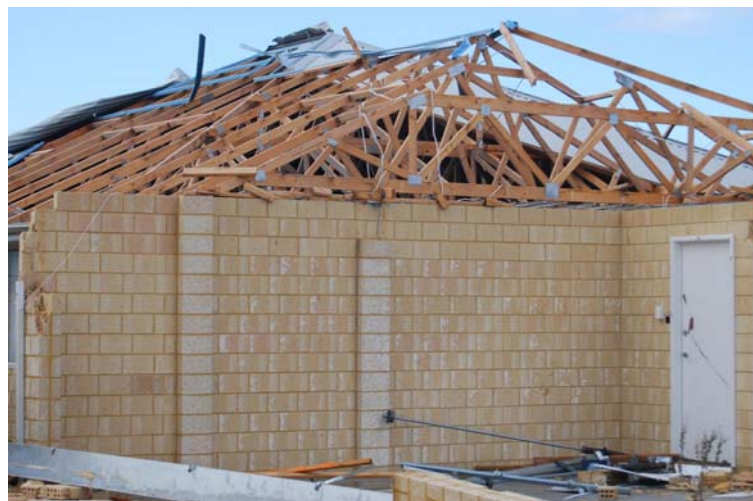
A number of sheet roofed houses that were substantially damaged had trussed roofs. Figure 4.8 shows one in which the roofing and battens have lifted.

(a) roof batten loss

In this case, the battens were light gauge top hat sections, and the light gauge steel tore over the batten fasteners. The trusses were nailed into timber top plates which were anchored by direct nailing to the brickwork and steel straps. Figure 4.8(b) shows that the top plate has lifted in some places, but the straps had held sufficiently to keep the roof attached to the top of the walls.

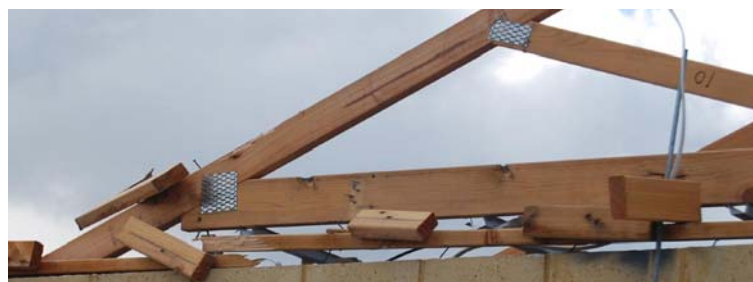
(b) lifting of timber top plate at truss heel joint

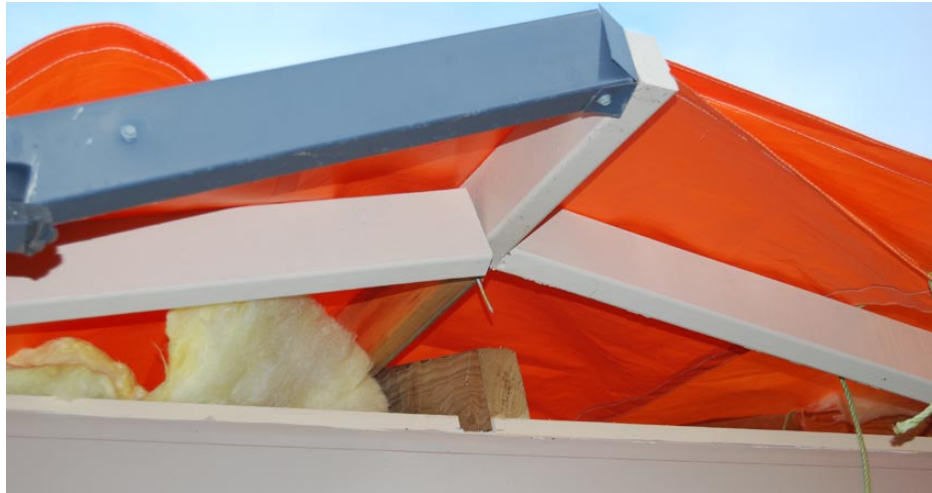
Figure 4.8 showed a house that had very recently been occupied and where the trusses were tied to brick walls. Figure 4.9 shows details of a house that had been occupied for around two years and the trusses had been anchored to framed walls.

(a) failure of truss anchorage

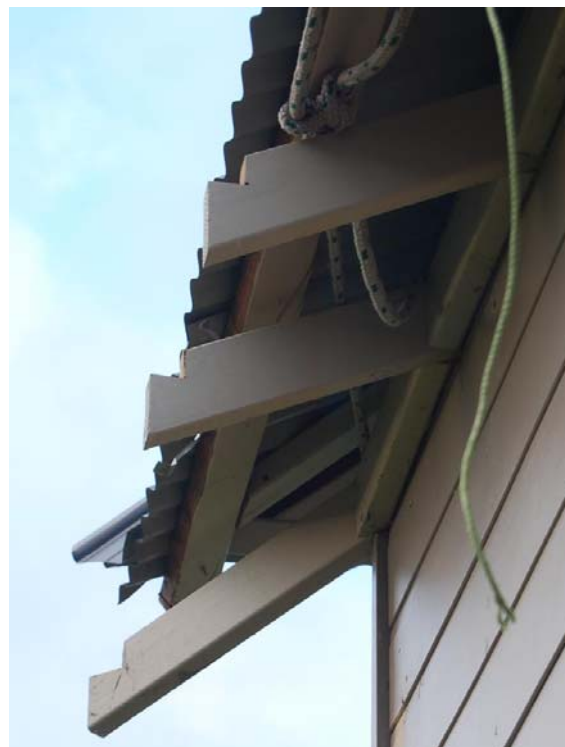
(b) lifted roof battens near corner of roof

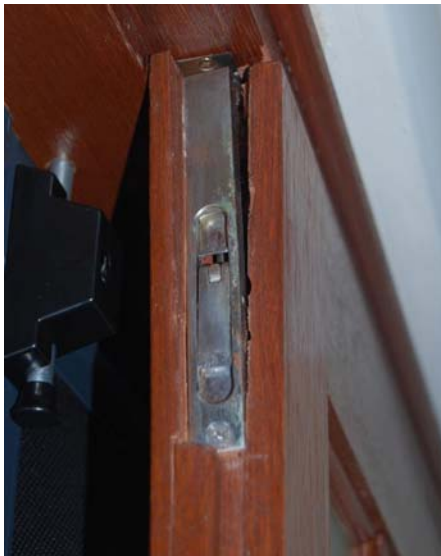
The failure of doors and windows admitted high pressures through the windward wall and contributed to roof and wall loss.

(a) broken door furniture

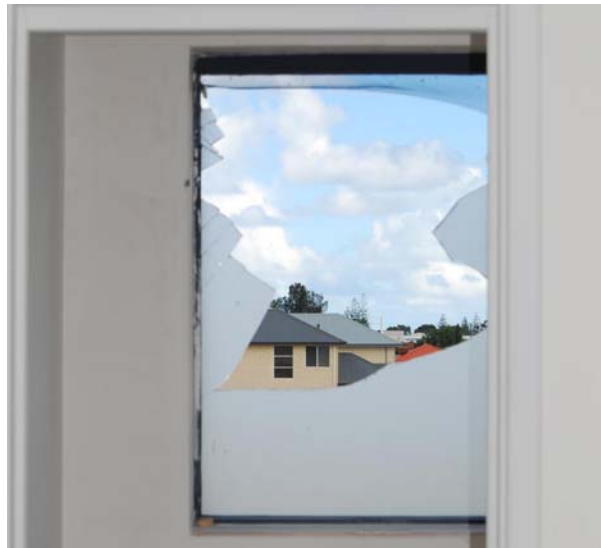
(b) broken glass blown inwards

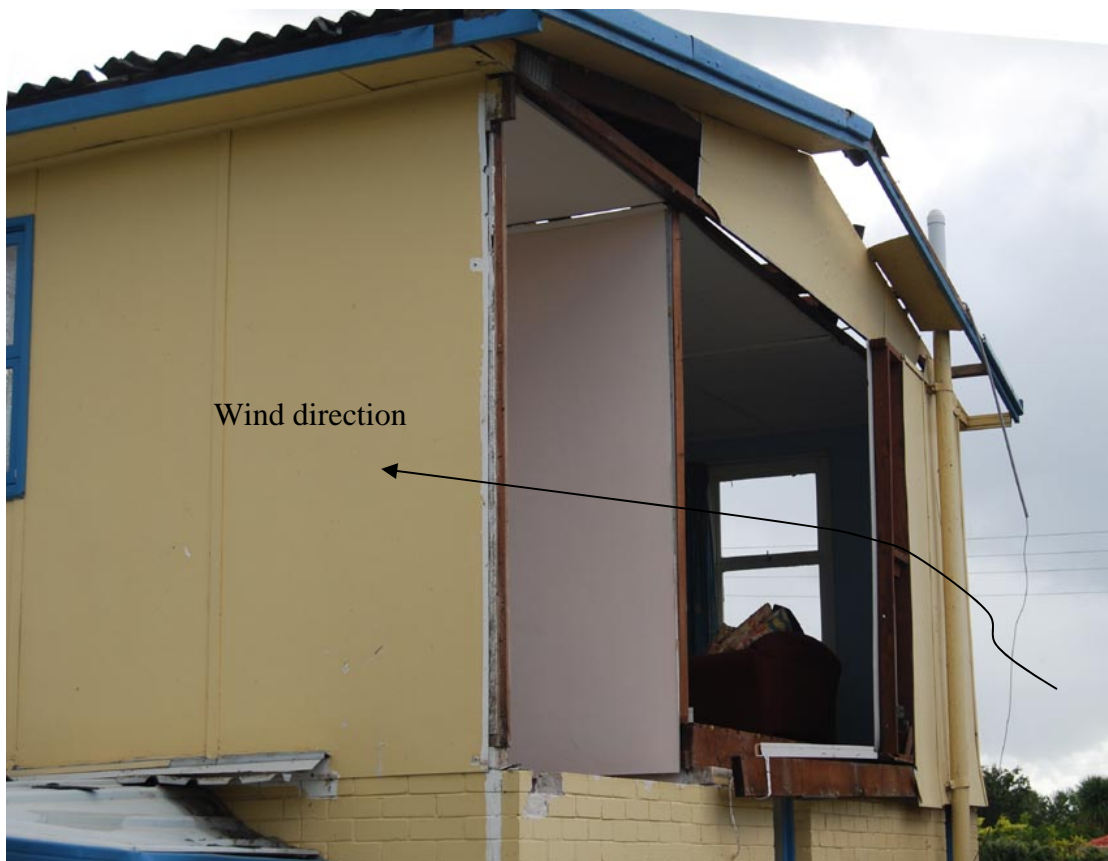
Figure 4.12 shows a two storey house in which high external suctions on a side wall combined with high internal pressures to remove a wall panel. Parts of the roof were also taken off this house. A small gap between the roof and the remaining ceiling can be seen showing that the ceiling itself had lifted.

**Figure 4.12 Loss of a side wall under combined internal pressure and external suction**

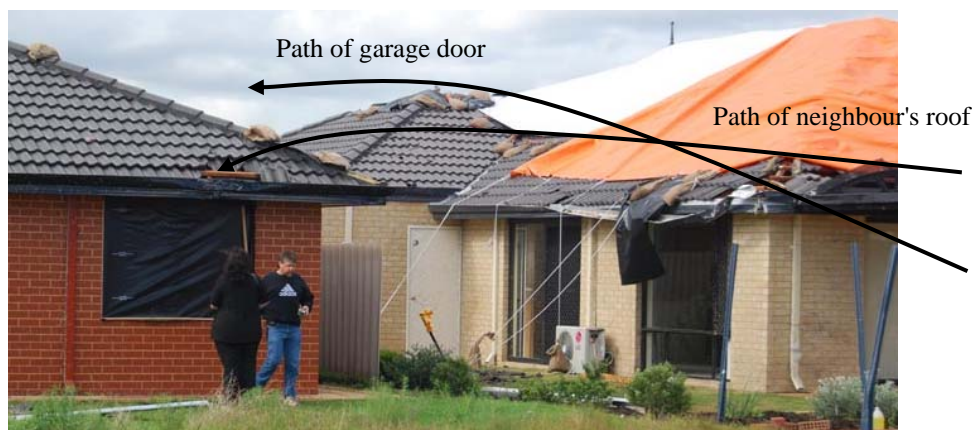
**Figure 4.13 Debris damage to tiled roofs**

In Figure 4.13, the house on the left was clear of the tornado's path, but sustained debris damage to both the roof and window from sections of a neighbour's roof. The houses on the right were subjected to the tornado winds, and also sustained damage from a neighbour's garage door.

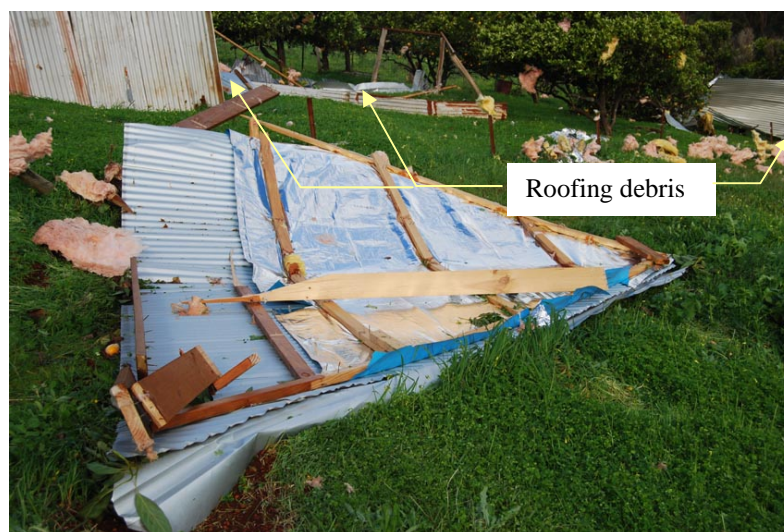
**Figure 4.14 Debris strewn more than 50 metres from house**

Figure 4.14 shows debris from just one house that produced at least five large sections of roof. Three of these can be seen in this photo together with some of the roof insulation. It is fortunate that this house was located in a rural setting, as it is clear that the debris generated would have substantially damaged any building it struck. However, in suburban areas, windows were broken by flying debris as shown on the left of Figure 4.13.

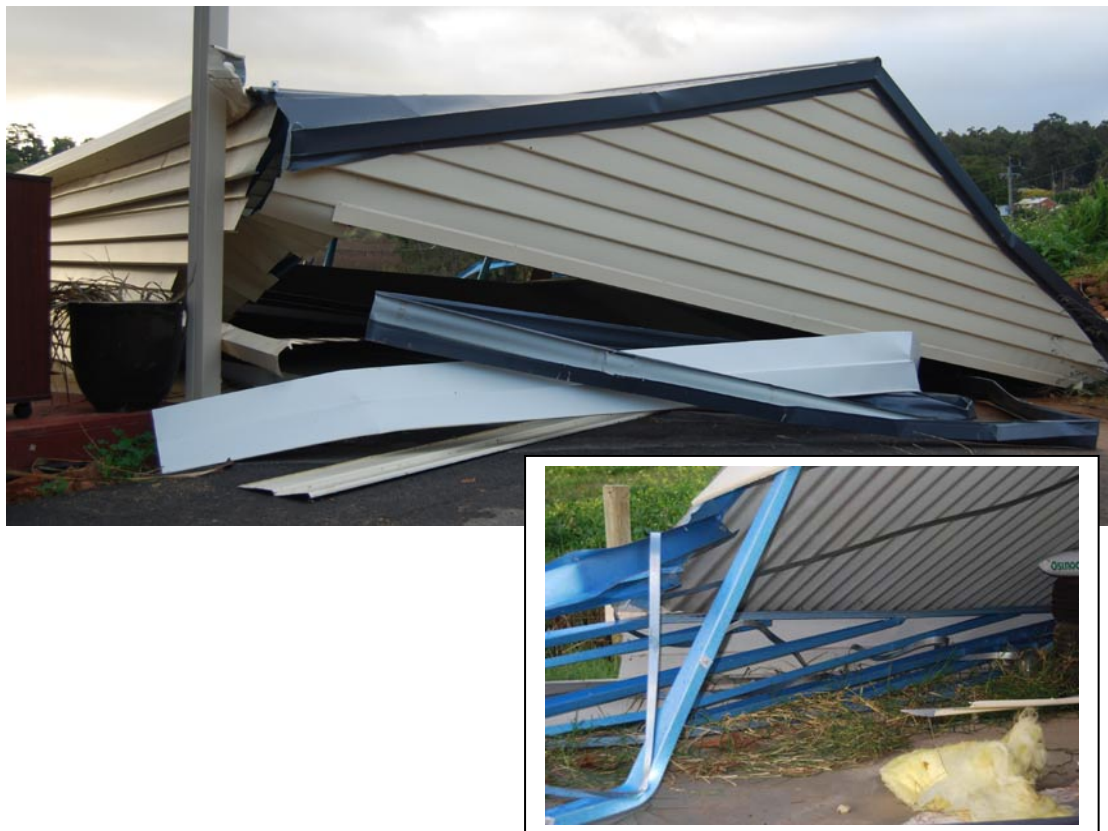
The failure was due to inadequate fastening of the bracing. The bracing appeared to have been intended for squaring the garage during construction. rather than for resisting the wind forces. The single skin cladding was a weatherboard type product that was incapable of offering any resistance to racking.

**Figure 4.15 Racking failure of garage**

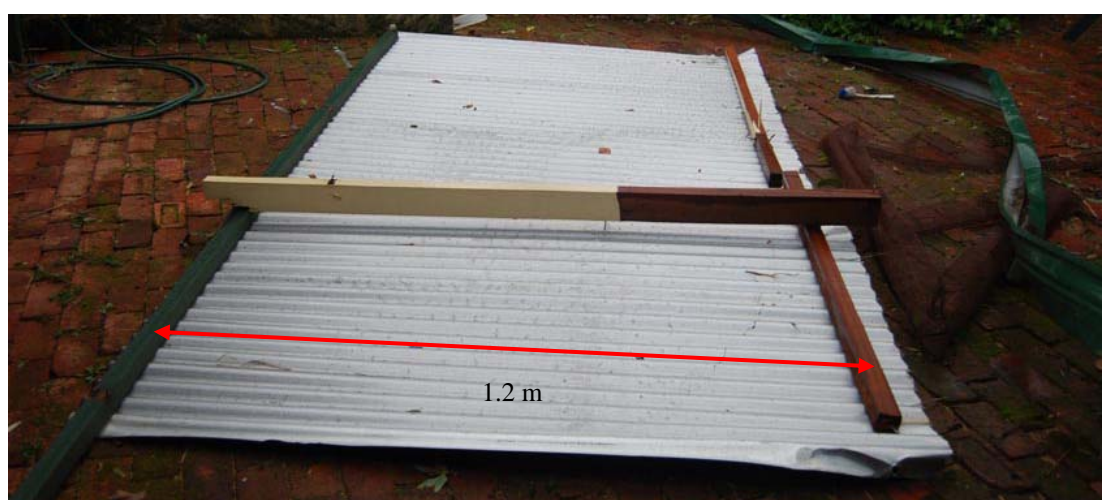
Figure 5.1 shows a verandah with batten spacings of 1.2 m when the house to which it was attached had spacings of 0.9 m.

**Figure 5.1 Batten spacing on verandah**

The spacing of verandah battens and rafters must be smaller or equal to the spacings used in the main roof. Batten to rafter connections must have the same or greater capacity as the batten to rafter connections in the main roof.
