DURABILITY & LIABILITY

INTRODUCTION

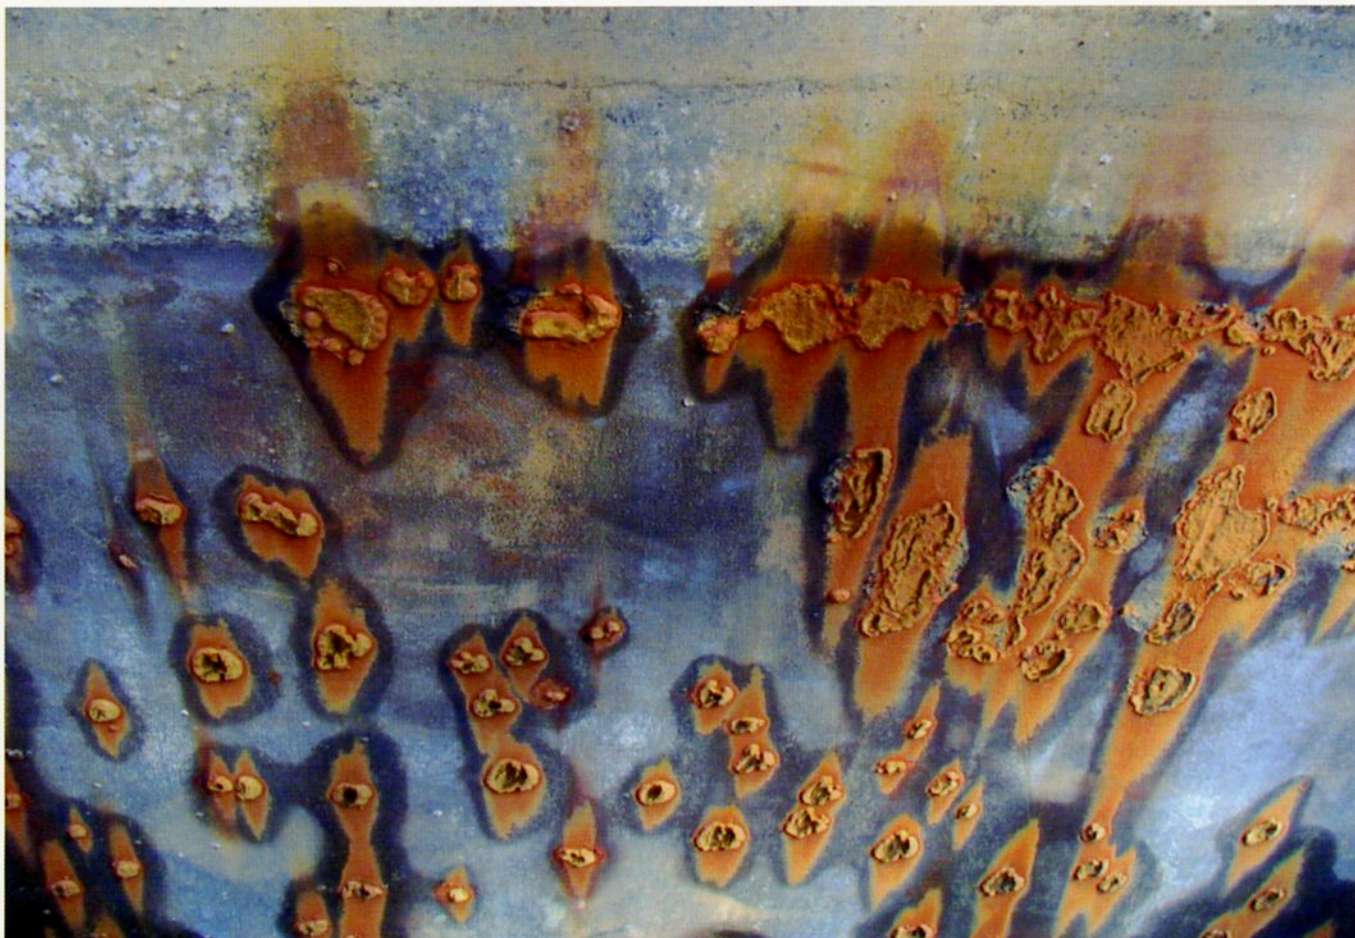
Rapid microbiological corrosion in a cooling tower water tank for a boiler used for steam generation for a high-technology autoclaving operation caused rust staining of the product being autoclaved. The owner took action against the boiler manufacturer resulting in lengthy and costly litigation.

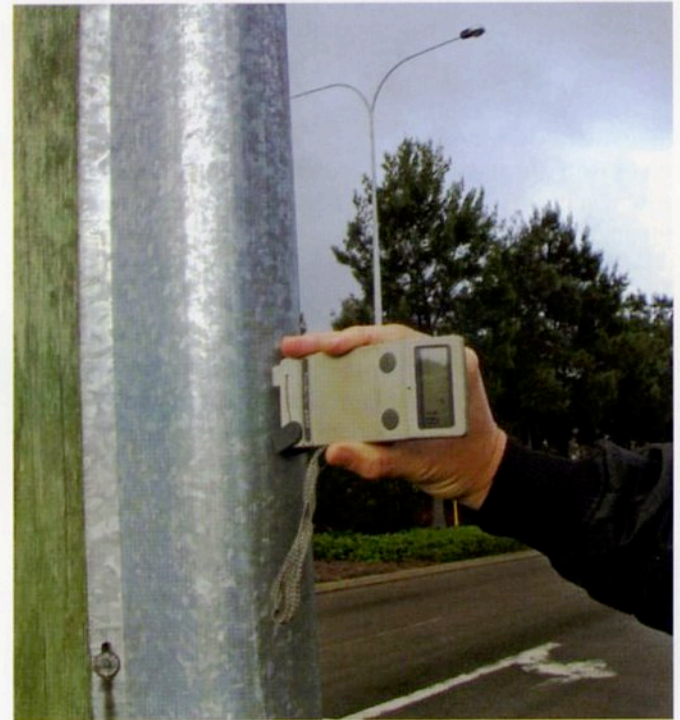
Galvanized coatings can be confusing, with proportional performance. The galvanized cover at left is manufactured from pre-galvanized steel – coating thickness 18 microns. The light pole, of similar steel thickness is hot-dip galvanized. Coating thickness 54 microns, which will have 3X the durability.

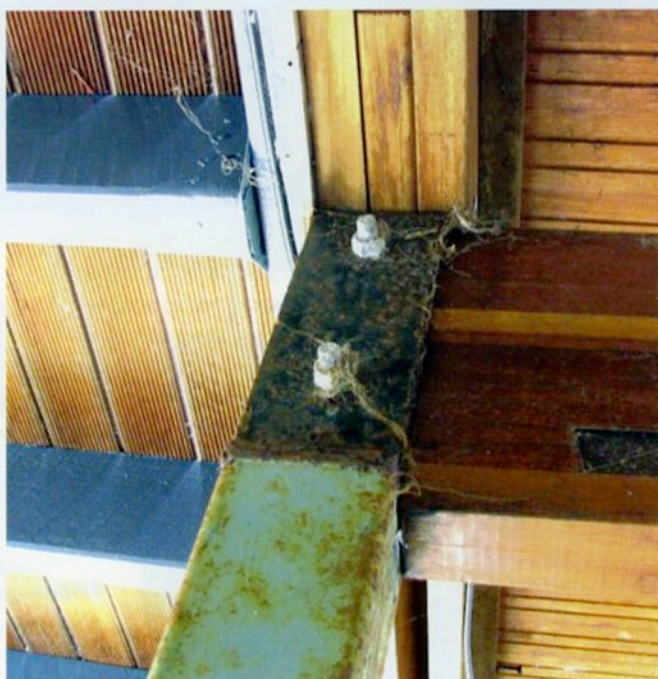
A dwelling located in the Gosford area of NSW, built on a sloping site, had steel framed flooring system and supporting columns. The flooring system and supporting steelwork was manufactured from continuously galvanized tube which has a zinc coating thickness of approximately 20 microns. The location of the dwelling was about 400m from a salt water estuary and about 8km from the ocean surf.

The owners took legal action against the builder because the floor supplier's manual stated that the product should not be used within 1km of salt water. Corrosivity testing at the dwelling indicated that the corrosivity classification was low. The proximity to salt water is not an indication of corrosivity, as ocean surf is required to produce the airborne salts that accelerate metallic corrosion.

The initial claim for replacement of the flooring system and supporting columns was in the order of \$175,000.

Corrosion on several columns and splice plates on a small residential dwelling on the NSW north Coast led to a \$175,000 claim against the builder when the building was 7 years old.
