PERFORMANCE OF HOT DIP GALVANIZING IN COASTAL ENVIRONMENTS: A REVIEW

A. Sheehan¹

¹Galvanizers Association of Australia, Melbourne

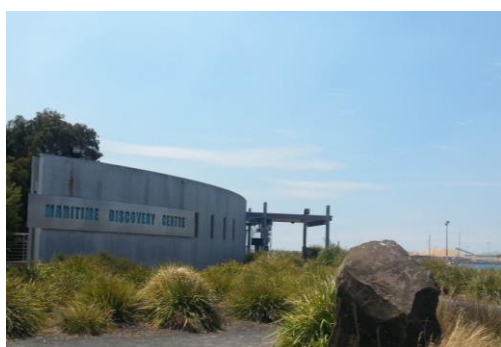
In the original case study, the galvanized steel was 9 years old and was said to have performed well with no maintenance [1]. Now it is a little over 15 years old with no maintenance, some of the galvanizing still looks barely weathered with the original spangle or bright shiny finish still evident on the surface (Figure 6 and Figure 10), while other areas show an even weathering, sporting an overall dull grey appearance (Figure 7, Figure 8, Figure 9 and Figure 11). There are good design aspects to the Discovery Centre as well, with structural beams mounted on concrete bases with sloped sides to assist drainage (Figure 6 and Figure 7). The stainless steel wire, used as a safety barrier on the outside decking, passes through the hot dip galvanized stanchions with insulating rings separating the different metals to prevent bimetallic corrosion (Figure 8 and Figure 9).

Figure 5 Portland Maritime Discovery Centre

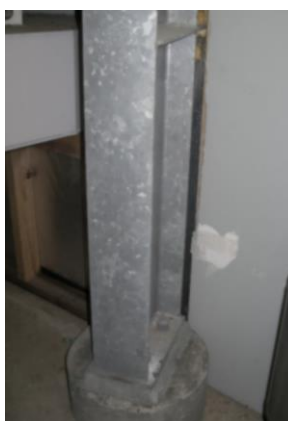
Figure 6 Discovery Centre Plant room, under main floor

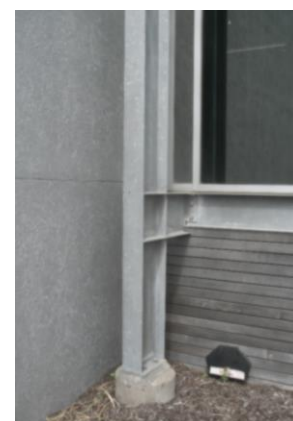
Figure 7 Structural beam exposed to the bay

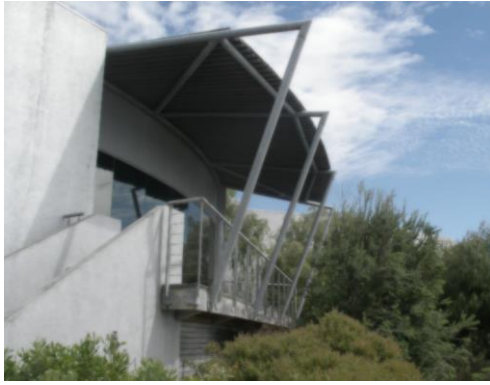
Figure 8 Decking of the Portland Maritime Discovery Centre

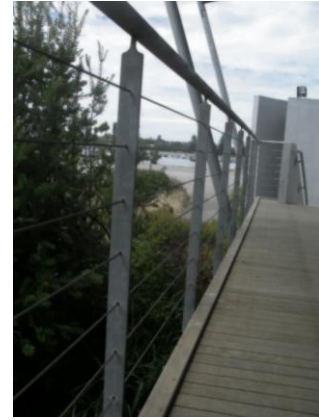
Figure 9 Stainless steel wire and hot dip galvanized stanchions make up decking guard rail

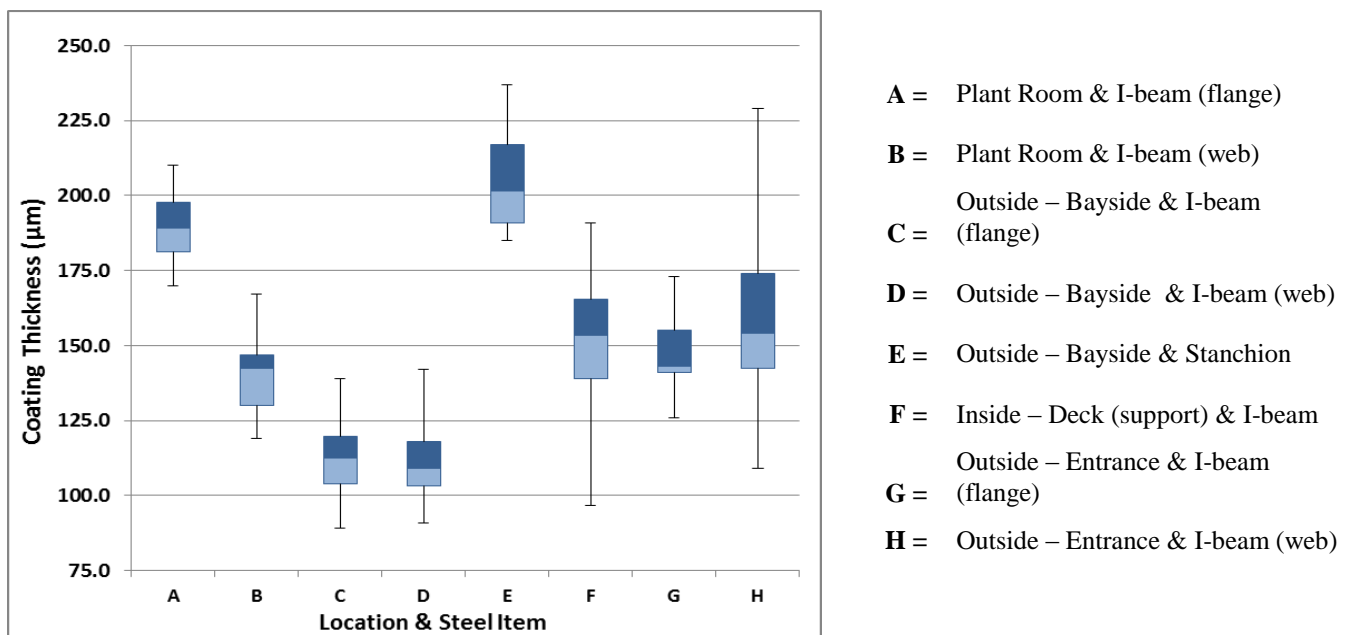
The average coating thickness of the structural steel from the first study was stated as 2 to 3 times (160-220 μm) the required level of AS/NZS 4680[1]. During this visit, the galvanizing thickness was measured in various locations around the Discovery Centre, both inside and out. Average coating thicknesses ranged from 111 μm to 206 μm on various galvanized items (See the Appendix for details). The spread of coating thickness measurements on the various steel items can be seen in Figure 12. The coating thicknesses of the galvanizing were still well above the required minimums in AS/NZS 4680 for the different steel thicknesses present in the structure.

Based on this data, the existing coating thickness will protect the steel from corrosion for approximately a further 15 to 30 years prior to the need for maintenance, affording an estimated total of 30 to 50 years of protection for the main structure.

Figure 12 Coating thickness measurements of the hot dip galvanized items at Portland Maritime Discovery Centre

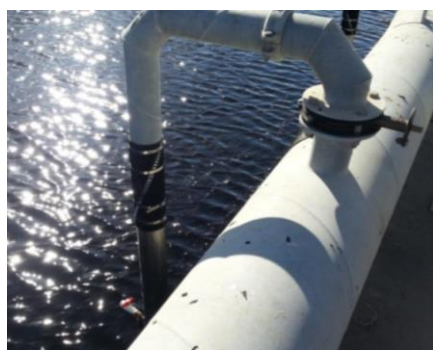
Figure 15 Neoprene sleeves separating hot dip galvanized pipe from immersed stainless steel pipe

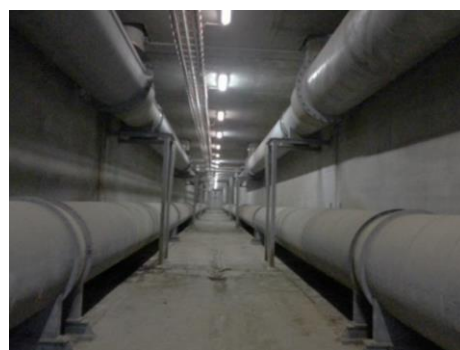
Figure 16 Heated air in hot dip galvanized pipes below ground

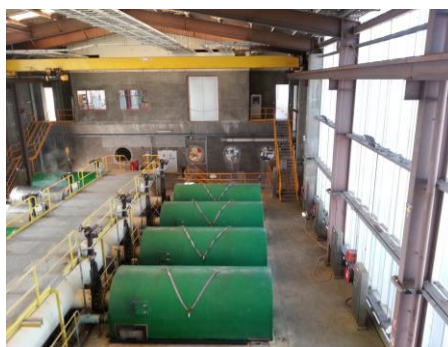
Figure 17 Fine screening building with duplex coated stairs and handrails

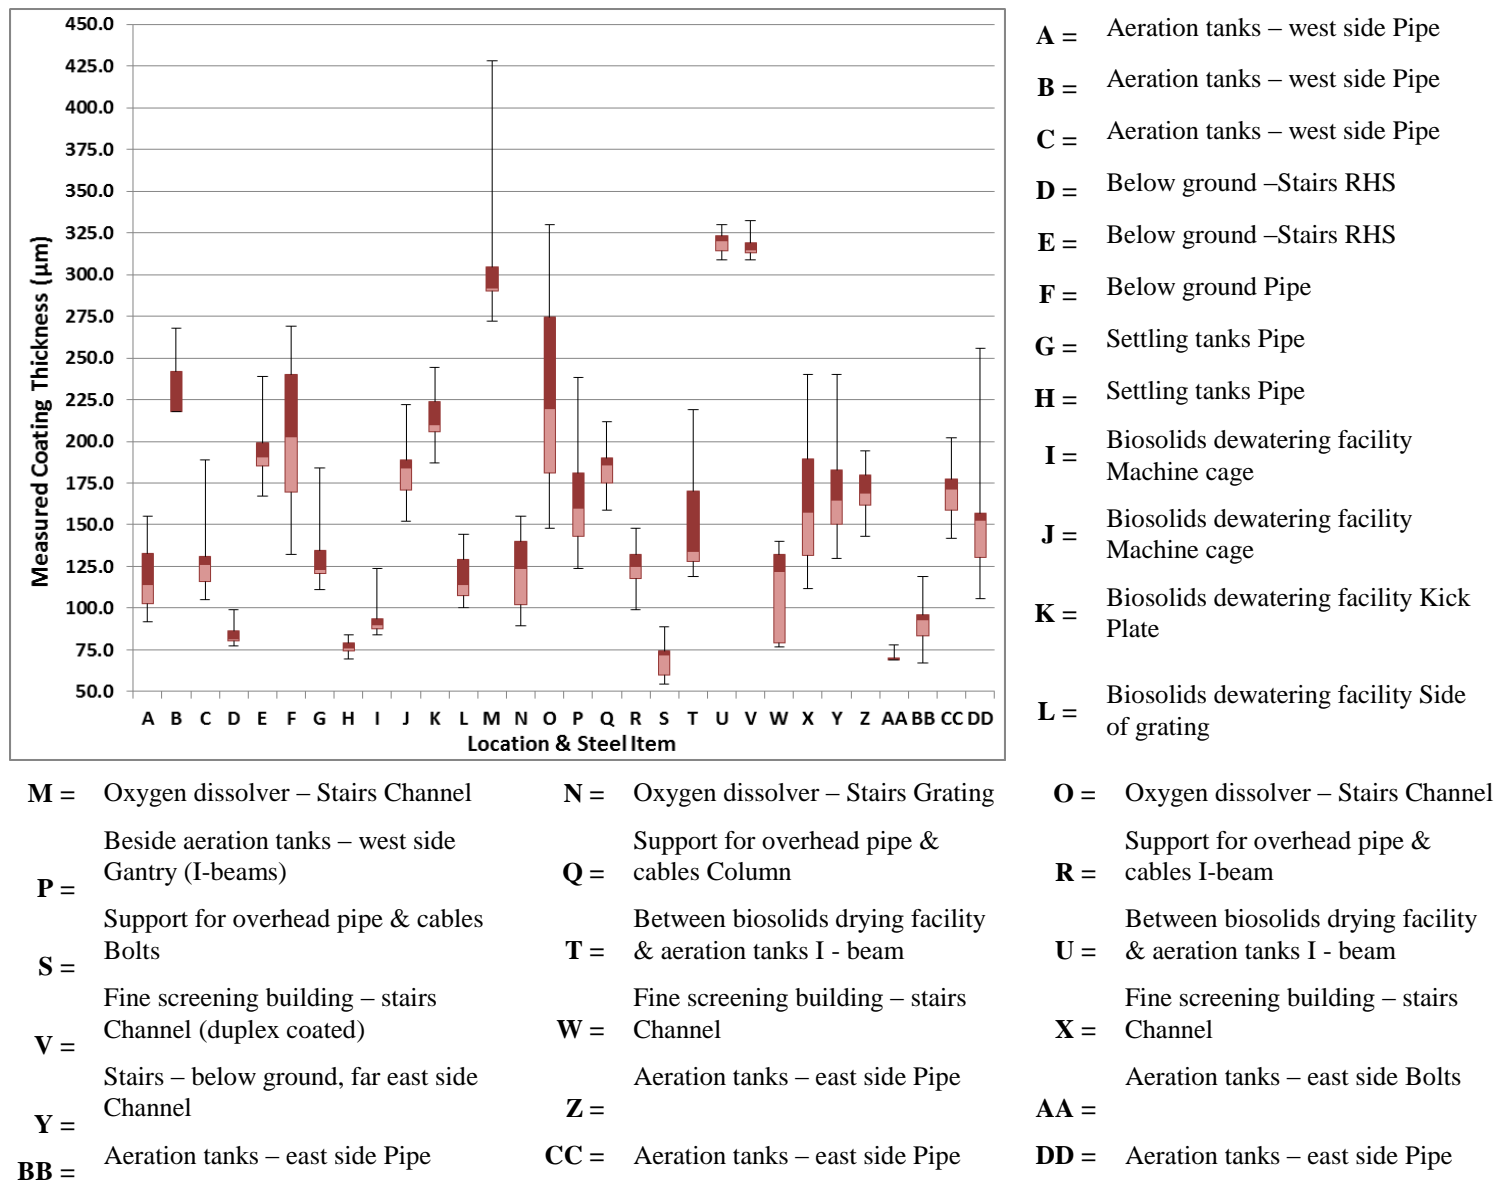
In addition to the remaining large coating thicknesses measured on the galvanized steel, in most areas there were little to no signs of corrosion. This can be attributed in part to good material selection and design. The pipes delivering air into the aeration tanks use both hot dip galvanizing and stainless steel for the exposed and immersed sections respectively. In order to prevent bimetallic corrosion, a neoprene sleeve is used to electrically isolate the two metals and provide a connection between them (Figure 15). In the locations closer to the relatively raw sewage and H₂S sources, such as the filtration area and the primary settling tanks (Figure 13), there was more evidence of corrosion, with some lightly rusted areas. On the whole, after nearly 20 years or more in service, the hot dip galvanized coatings have performed fittingly and will continue to perform their purpose in this environment for many years to come.

Figure 18 Coating thickness measurements of the hot dip galvanized items at Black Rock Water Reclamation Plant

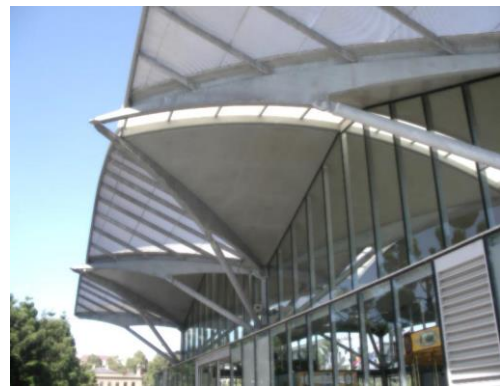
The Pavilion is located on the Geelong Waterfront (Figure 20) and its structural design (Figure 21) needed to take into account the offshore wind loading. The design consciously considered potential corrosion issues with the use of bolting and other detailing (Figure 22). The expanded metal roofing, designed to reduce wind loading [1], has the added benefit of allowing rain to have a washing effect on the external steelwork (Figure 22 and Figure 23).

Figure 22 Curved roof of Pavilion with bolted joints

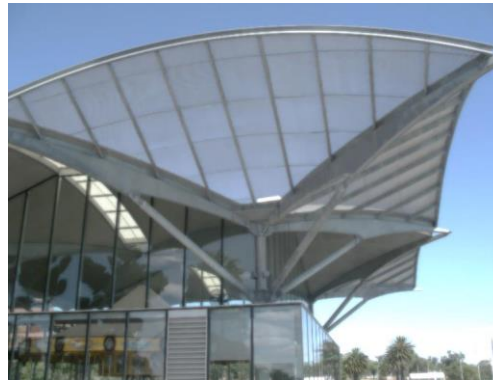
Figure 23 Curved roof to decrease wind loading and allow rain washing

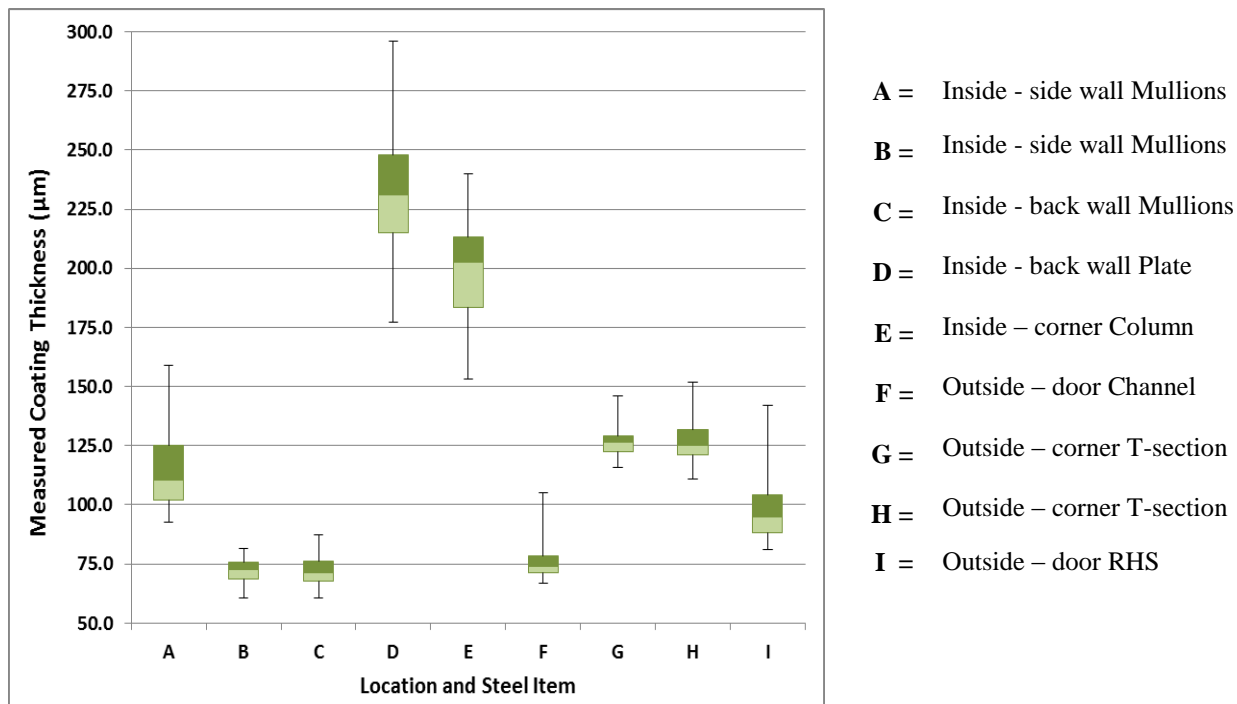
The Carousel Pavilion had been open for 6 years when the last case study was performed and the steelwork was said to be in excellent condition, with all of the galvanizing being 2 to 3 times in excess of the levels required by AS/NZS 4680 [1]. A further 6 years, 12 years in total, and the hot dip galvanized coating, although weathered to a dull grey and accumulating dirt in some of the higher areas of the structure, is still performing with no signs of coating degradation. The average coating thicknesses measured were between $72\mu\text{m}$ and $233\mu\text{m}$ on steel items of varying thicknesses. (Refer to Appendix for details.) This indicates a life to first maintenance of 25 – 50 years for the structural elements of the Pavilion. The spread of coating thickness measurements on the various steel items can be seen in Figure 24.

Figure 24 Coating thickness measurements of the hot dip galvanized items at Geelong Carousel Pavilion

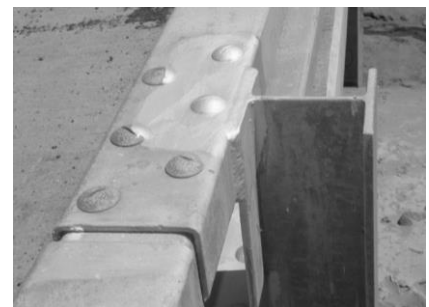
Figure 27 Repaired weld on bridge rail at Jamison River

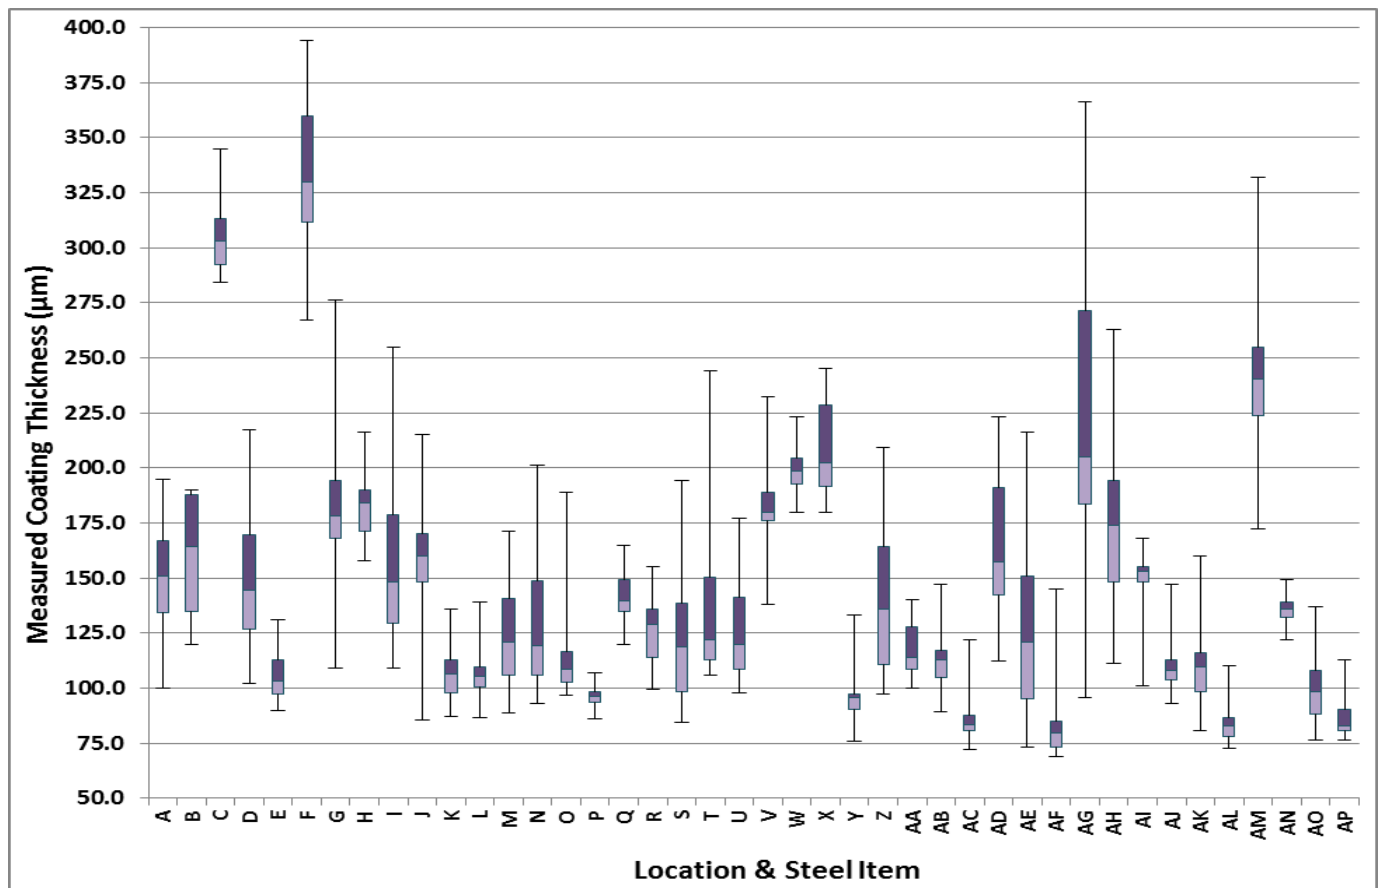
The average measured coating thickness on the bridge rails were mostly still well above the required minimum average coating thickness stated in AS/NZS 4680. The average coating thickness on the bare galvanized rails ranged from 83µm to 224µm, with base plate thicknesses from 126µm to 333µm and the thickness of duplex painted rails were between 184µm to 348µm. See the Appendix for details on average coating thicknesses. Figure 28 shows the spread of coating thickness measurements for the bare galvanizing items and Figure 29 shows the spread of measurements for the duplex coated items.

Figure 28 Coating thickness measurements of the hot dip galvanized items at various locations along the Great Ocean Road

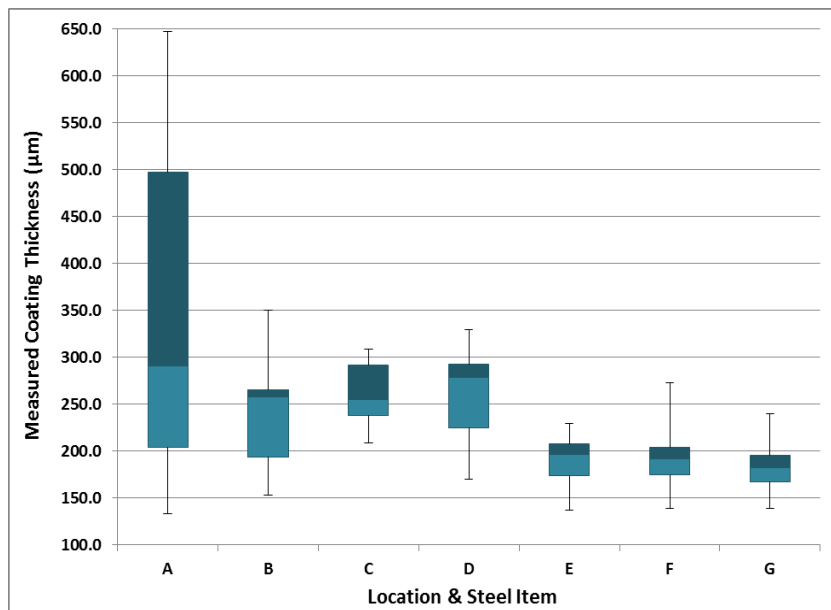
Figure 29. Coating thickness measurements of the duplex coated items at various locations along the Great Ocean Road

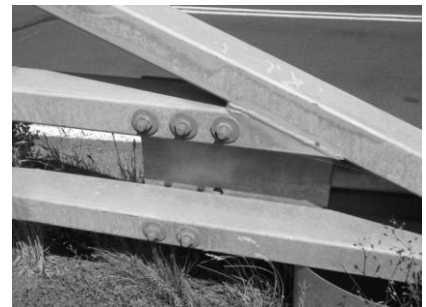
The rails examined were generally located approximately 100m to 1km from the breaking surf on the coastline and many were over estuarine waters. Due to their close proximity to the ocean, many of the rails were encrusted in salt deposits or had developed a rough patina (Figure 33). Some of the rails had been cut or welded after galvanizing and subsequently repaired with a zinc rich paint. Some of the repairs were performing with no rust visible, some looked to have been re-coated (Figure 27) and others showed visible signs of rust. Where the rails had been designed without the need for welding or cutting after galvanizing, such as when bolted connections were used (Figure 32), there were little to no signs of rusting.

Figure 32 Bolted joints & welding before galvanizing in bridge rail

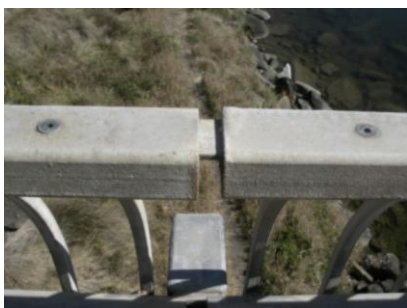
Figure 33 Symthe Creek bridge rail with salt encrusted galvanized coating

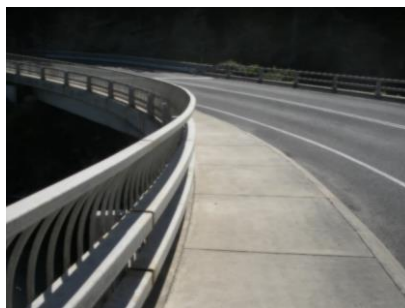
Figure 34 Symthe Creek bridge rails - 15 years old

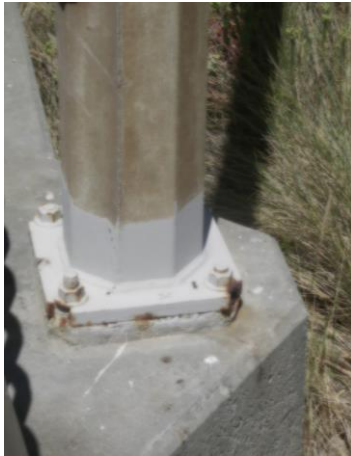
Figure 36 Painted bottom of lightly rusted, salt encrusted galvanized light pole

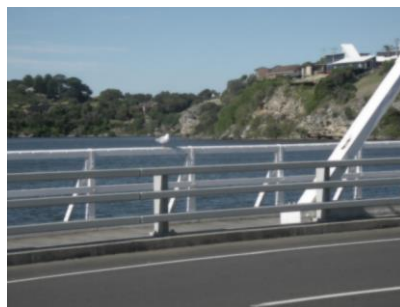
Figure 39 Duplex coated bridge rails at Hopkins River supports for footbridge
