# Wet storage staining on galvanized steels

**By Coating Development Manager, OneSteel Australian Tube Mills,  
David Harrison**

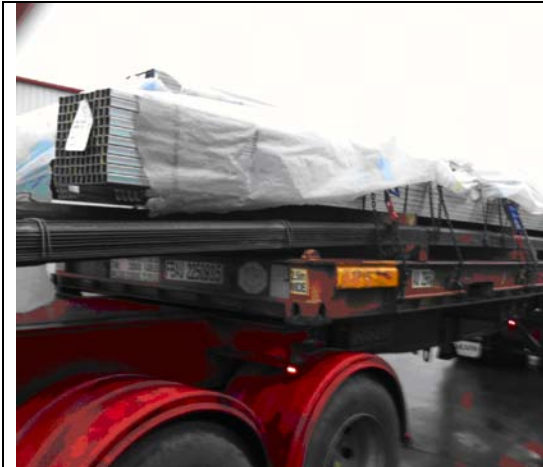
*Inadequate tarping during local transport is a major cause of wet galvanized product and associated white rust.*

1. Always tarp the load. Tarps should be applied in such a manner to prevent the ingress of water from rain and/or road spray;
2. Apply secondary cover, such as light-weight plastic, during exposure to inclement weather;
3. Keep tarps dry and do not apply a wet tarp to a load;

4. Only use dry/seasoned timber (or timber with rubber surfaces) dunnage;
5. Do not load wet product; and
6. Be aware of the potential for condensation during sudden temperature changes and high humidity. The use of a desiccant to absorb condensation is strongly recommended for long haul journeys and containerisation.

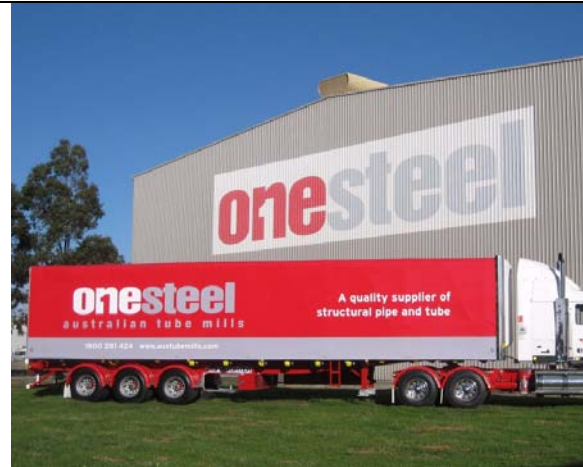
*Covered prairie wagons provide excellent protection from water ingress*

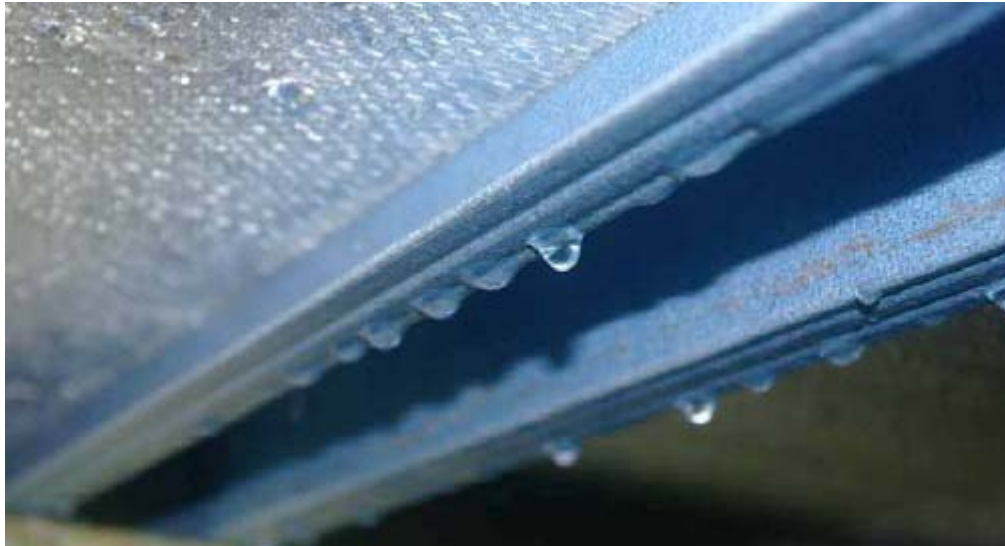
1. Leaking roof particularly from skylights, smoke vents and internal box gutters;
2. Water ingress from broken louvers and open doorways during high winds and storms; and
3. Condensation, either dripping from the underside of a steel roof or forming directly on the galvanized products. The Australian Building Codes Board<sup>2</sup> has published an informative handbook in order to provide additional information, detail and advice relating to the management of the risk of condensation in buildings.

*Condensation on the impermeable foil sarking and steel purlins*
