38 - LIQUID METAL ASSISTED CRACKING OF GALVANIZED STRUCTURAL STEEL SECTIONS

01 - SPECIFIERS MANUAL – THIRD EDITION

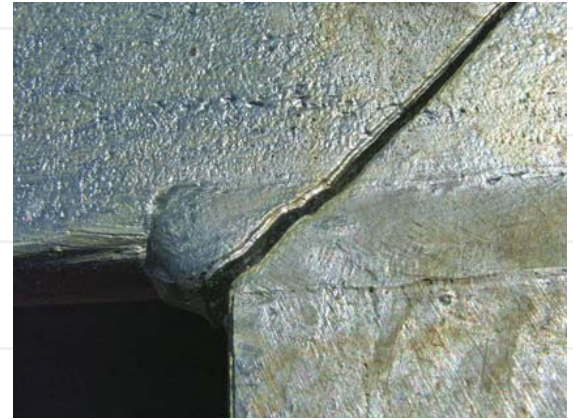
Crack propagated from the corner of this angle frame after galvanizing is suspected of arising from liquid metal assisted cracking.

One known incident has been reported to Industrial Galvanizers of what appears to be an LMAC event on a light (100x100x10 mm) angle frame that had cracks propagating from the HAZ adjacent to the welds. All of these smaller merchant sections are produced from scrap-fed electric furnaces.

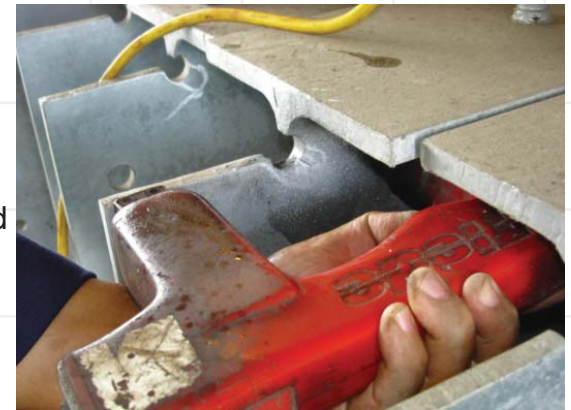
These large galvanized beams, galvanized in Malaysia, have all been affected by 'cope cracking' in the circular (coped) area of the beam webs. Steel sourced from electric furnace sources is more prone to this form of liquid metal assisted cracking than steel sourced from blast furnaces. This phenomenon has never been reported in Australia as all the locally produced structural sections are manufactured from blast furnace sources.

If LMAC is identified in a structural section after galvanizing, procedures are available to remediate the affected area by gouging out the cracked area, re-welding and repairing the coating in the weld zone.
