Damage investigation of buildings at Minjilang, Cape Don and Smith Point in NT following Cyclone Ingrid

Report: TR50 September, 2005

TECHNICAL REPORT NO. 50

By David Henderson and Cam Leitch

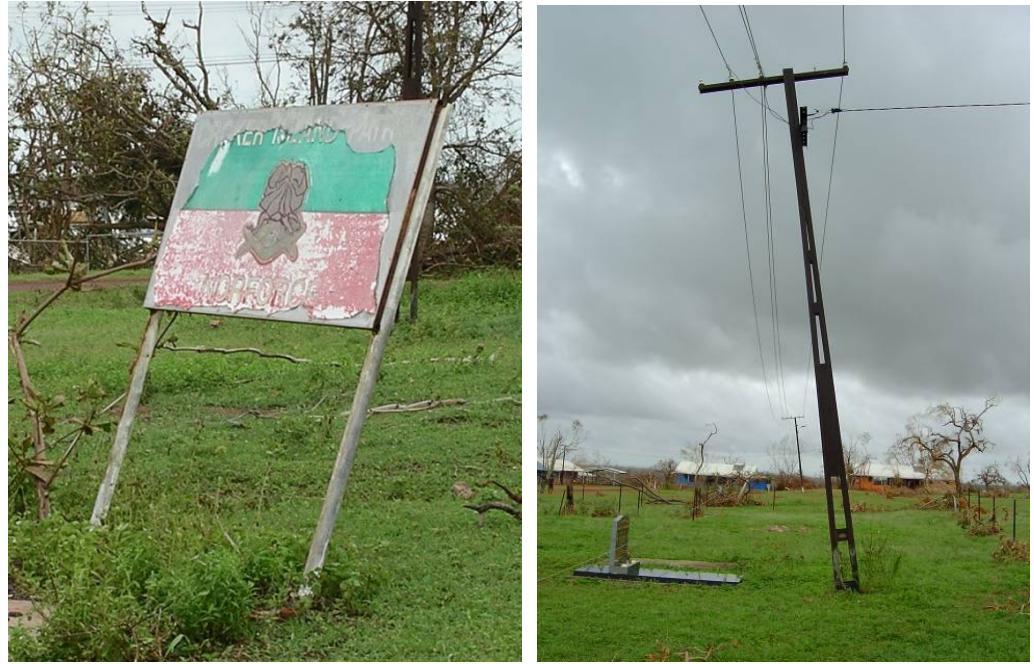
Figure 5: Footing failures - poor 'windicators'

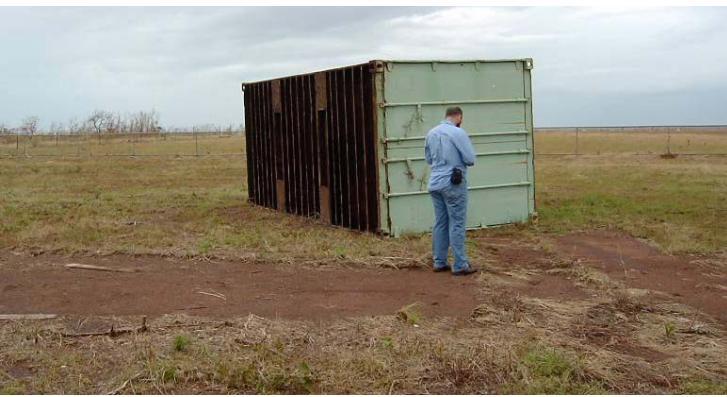
Figure 6: Empty container (lifted and overturned as no drag marks observed)

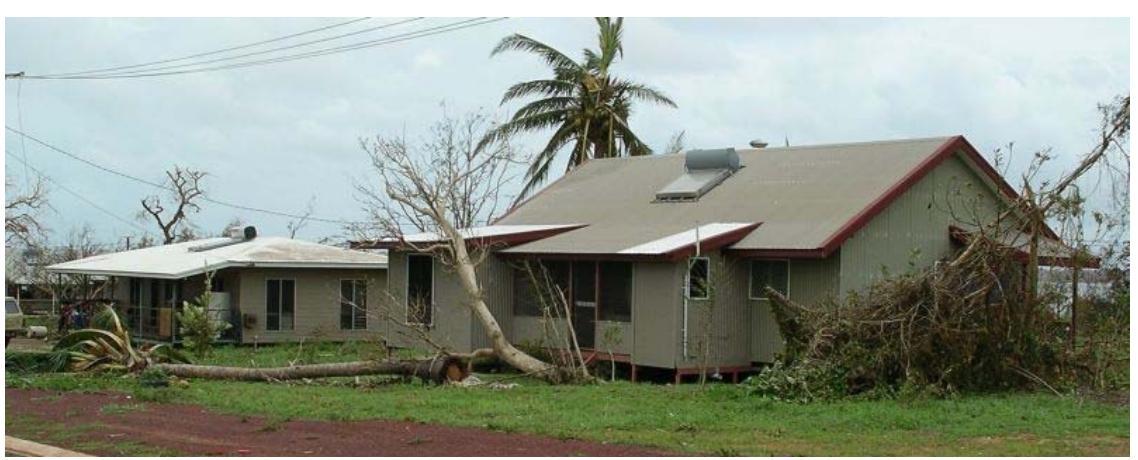
Figure 10: Minor tree damage to post Tracy houses

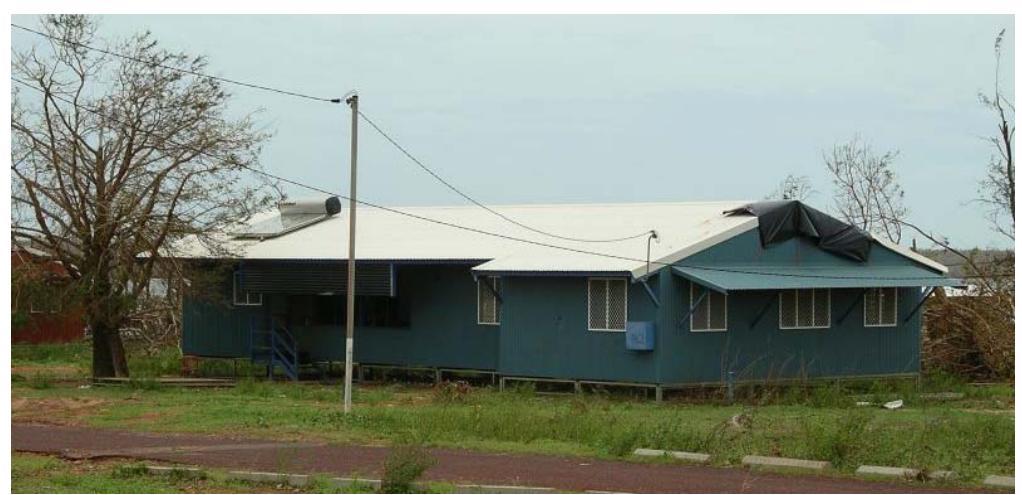
Typically housing that was constructed in the past 10 to 15 years survived with minimal structural damage from wind loads observed (Figure 9 and Figure 10). Impact from wind driven debris, fallen trees, flashing loss (Figure 11) and soffit loss was noted.

Figure 11: Minor loss of flashing

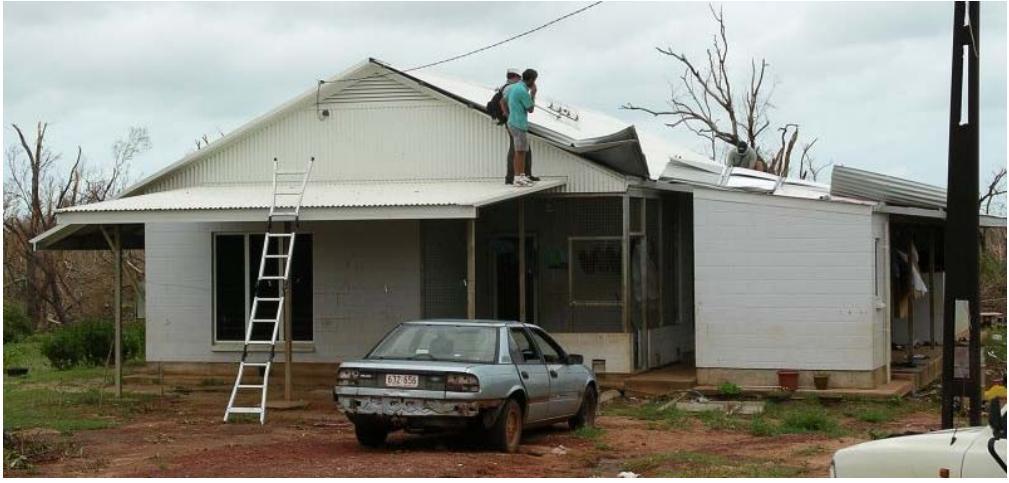
One noted exception was a reinforced masonry block house that was built within the last couple of years (Figure 12). Part of the roof had peeled back, as shown in Figure 13, from the windward edge. It is postulated that a missing nut on a rafter hold down allowed the edge rafter to lift over the hold down rod.

Figure 12: Roof structure damage to new house (windward wall)

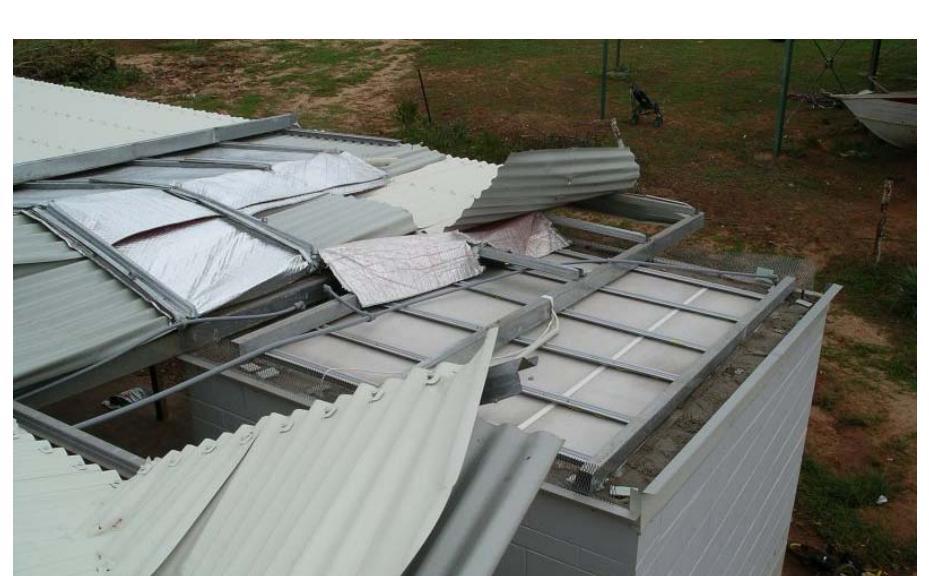
Figure 13: View of damaged roof on new house

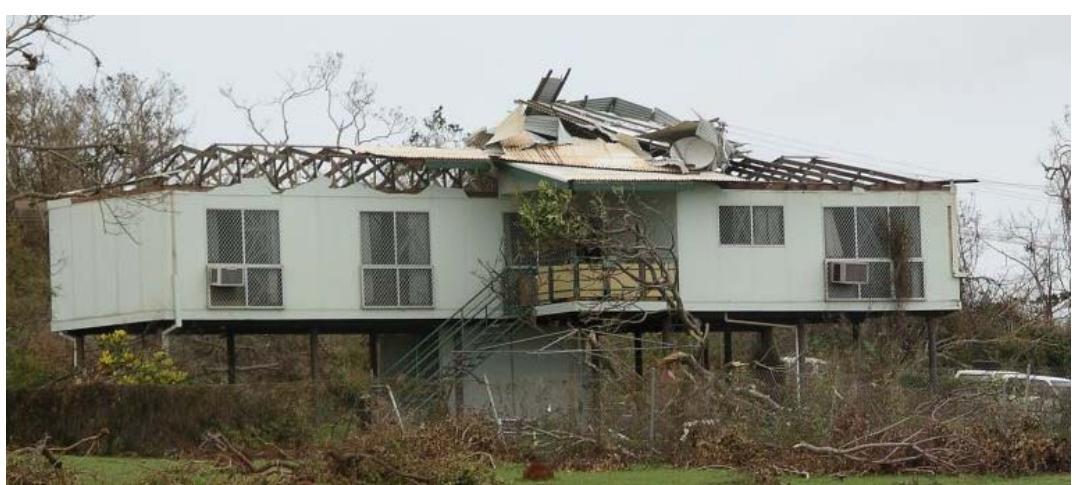
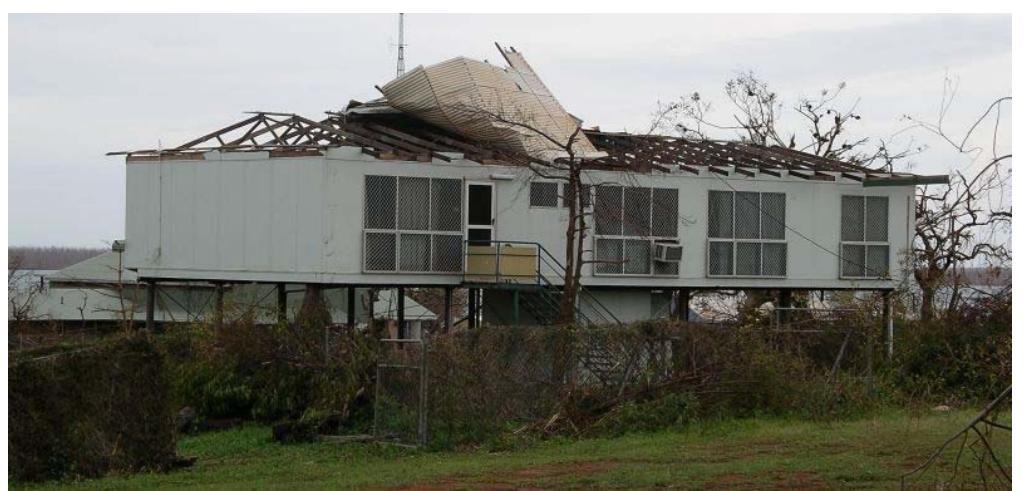
The highset fibro clad rectangular plan house suffered loss of roof cladding and battens (Figure 14 and Figure 15). It was advised that the house had been retrofitted as per some of the houses in Darwin that survived Cyclone Tracy.

Failure was initiated by missing hold down connectors between the battens and trusses. Corrosion of batten straps along the exposed eaves (Figure 16) and some batten to truss fixings not installed in the body of the roof space were observed. A truss to top plate hold down Z bracket was lying on the ceiling (Figure 17). So if the cladding had held on, part of the roof structure may have been blown off due to inadequate truss hold down. A section of the roof from this house was found 200 m to the South East (Figure 40).

Figure 14: East face (photo looking NW)

Figure 15: West face (photo taken looking SE)

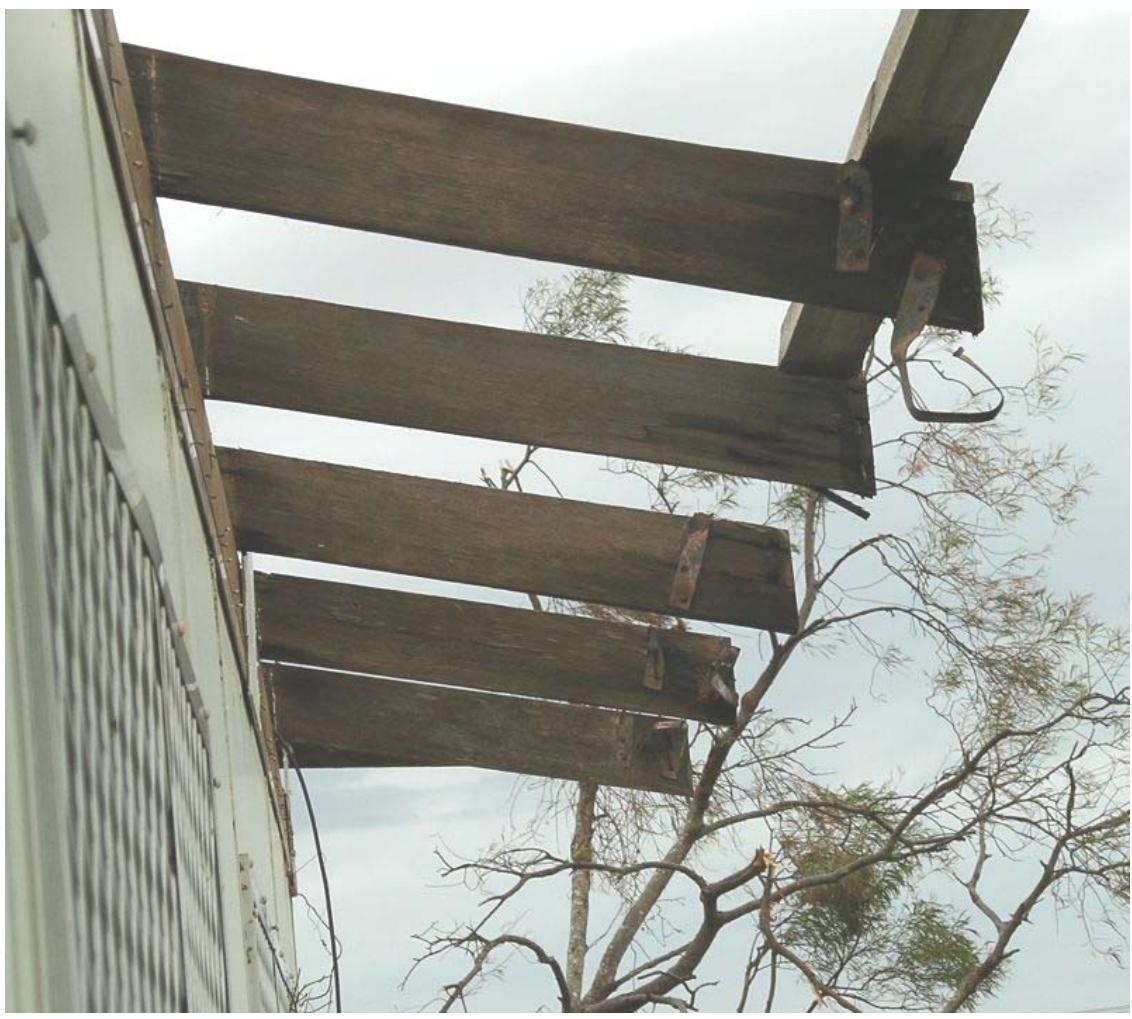
Figure 16: Corroded batten hold down straps

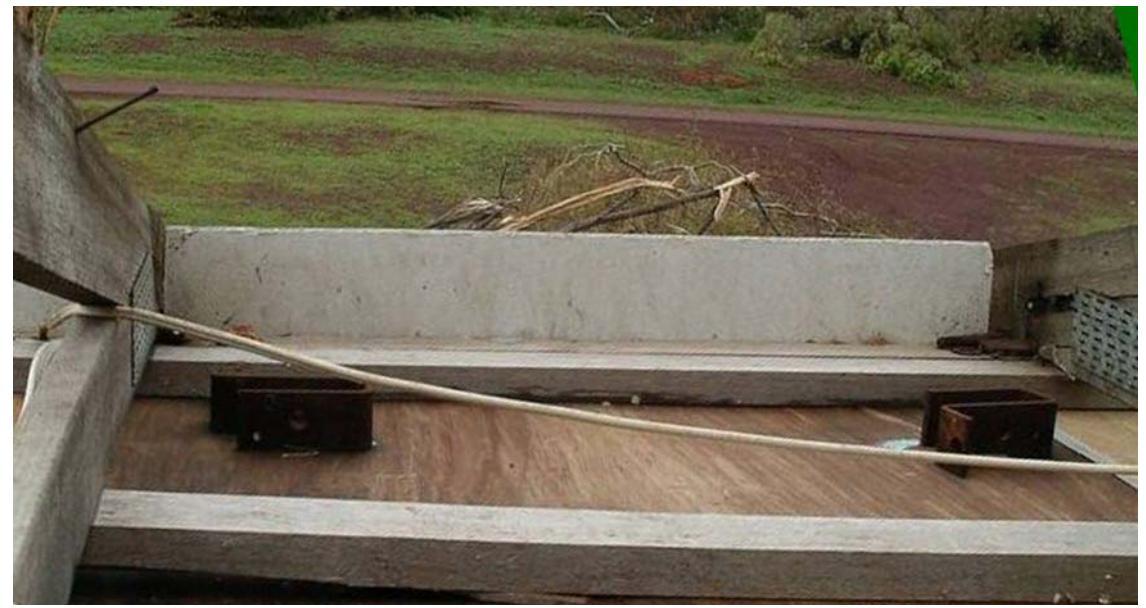
Figure 17: Truss hold down brackets not installed to a couple of trusses

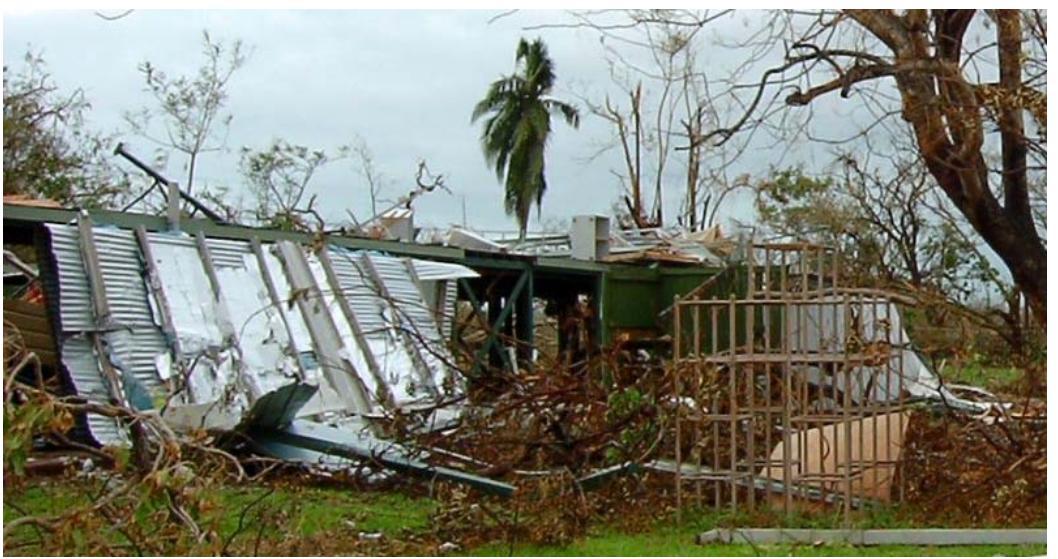
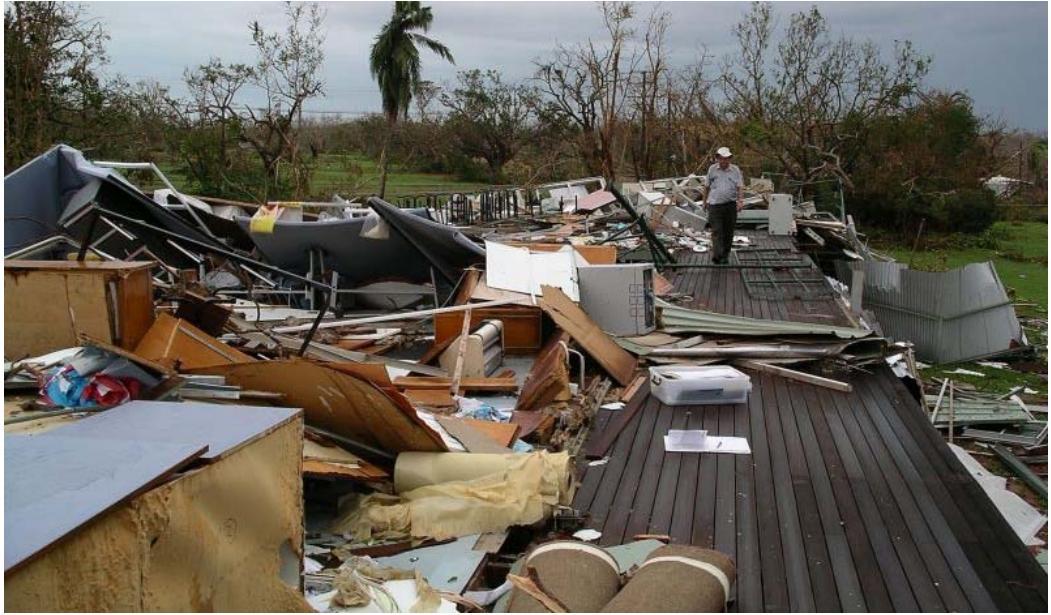
The high set school lost all top storey wall and roof structure as the wall frame was unable to resist the uplift forces (Figure 18 and Figure 19). It was advised that the classrooms were a 1950s aluminium framed 'kit' structure which was built on the elevated timber framed floor.

Figure 18: Elevated school platform (roofing screwed to I beams)

Figure 19: Remains of classrooms

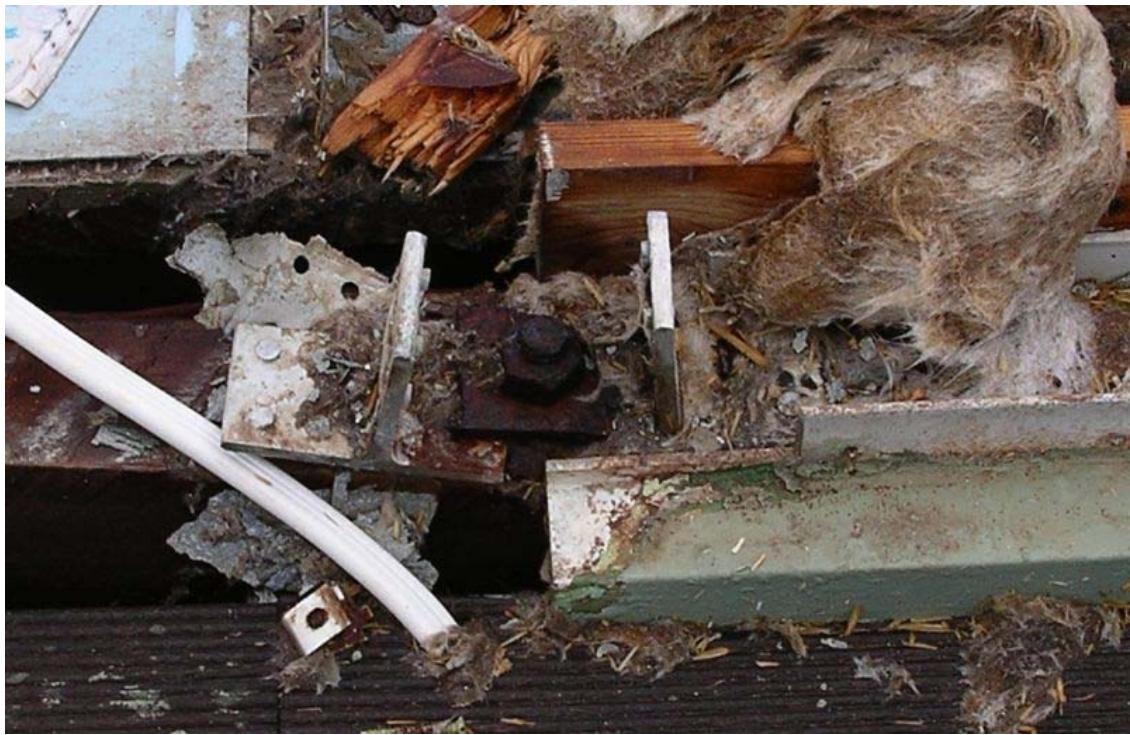
The roof of the building had been re-roofed with corrugated G550 cladding and fixed to the existing aluminium I beams with Type 17 screws with cyclone assemblies. No other post Cyclone Tracy retrofitting was evident. The classrooms wall and roof framing members were made from aluminium. The top plate and bottom plates were riveted to the studs via aluminium T sections. Figure 20 and Figure 21 show sheared rivets in a T connection and a corroded bottom plate hold down bolt.

Figure 20: Aluminium inverted T brackets and rusted hold down bolt

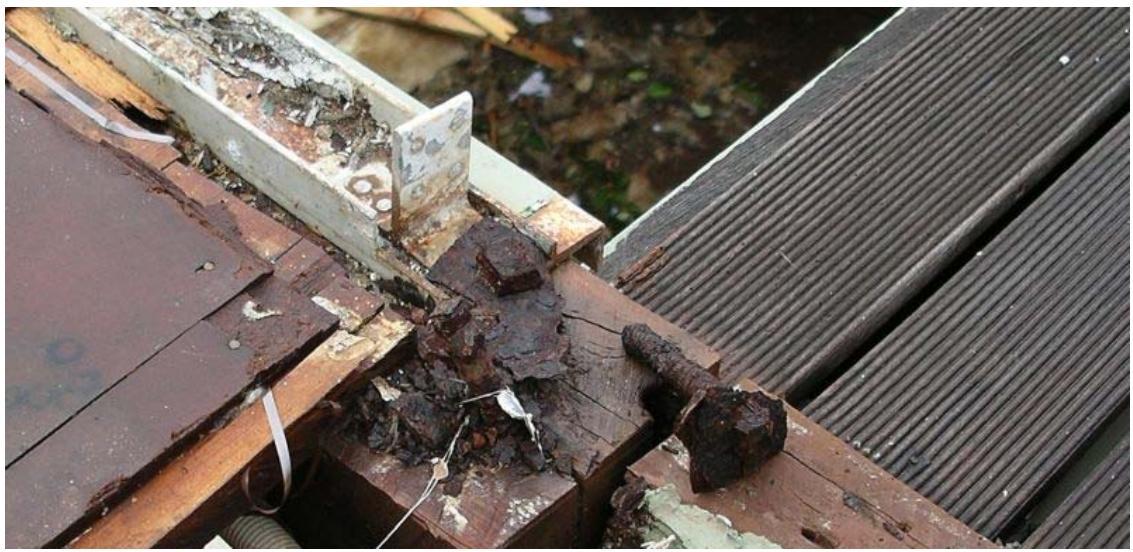
Figure 21: Aluminium inverted T bracket showing sheared rivets

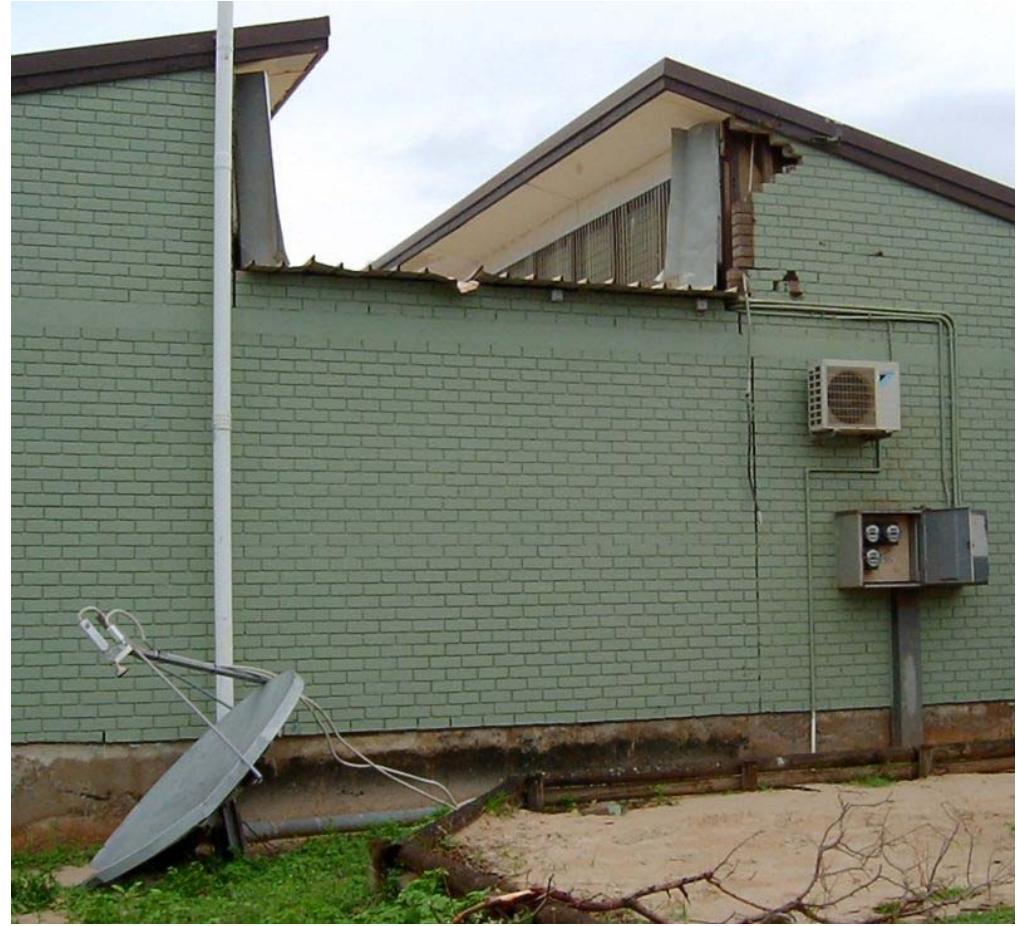
- loss of some flashings,
- damage to the brick skin adjacent to a gable truss end where a satellite dish was attached, and

Figure 23: Failure of mounting point for satellite dish

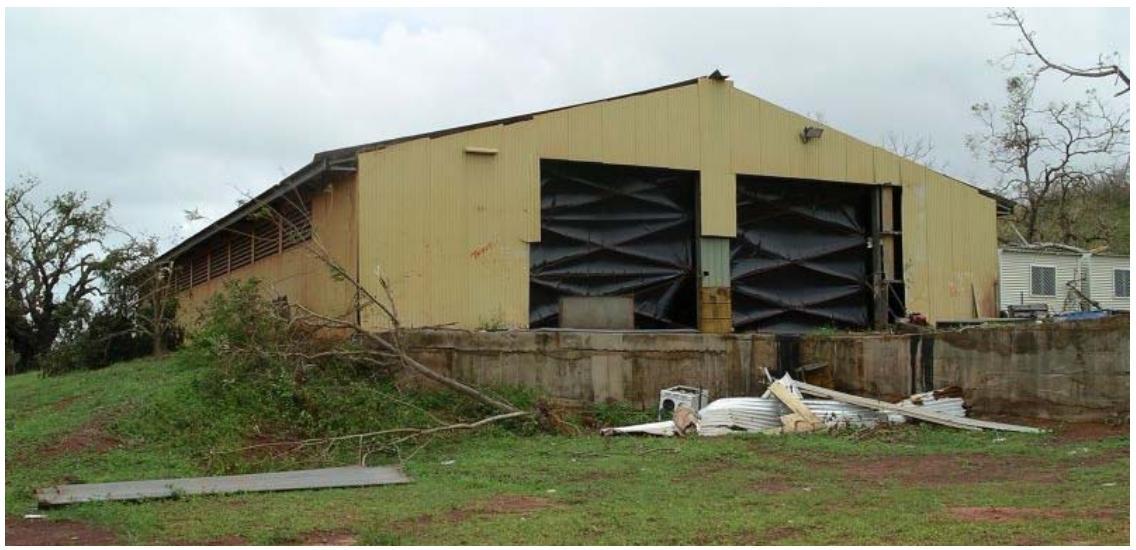
The portal framed shed in the North of the town suffered loss of roller doors, and minor cladding and flashing loss with resultant water and wind damage to contents. Tearing of the wall cladding around some fasteners was observed, however the fixing spacings were found to be larger than typical manufacturer's specifications.

Figure 24: Wind ward wall (North face) Note openings have been covered with plastic

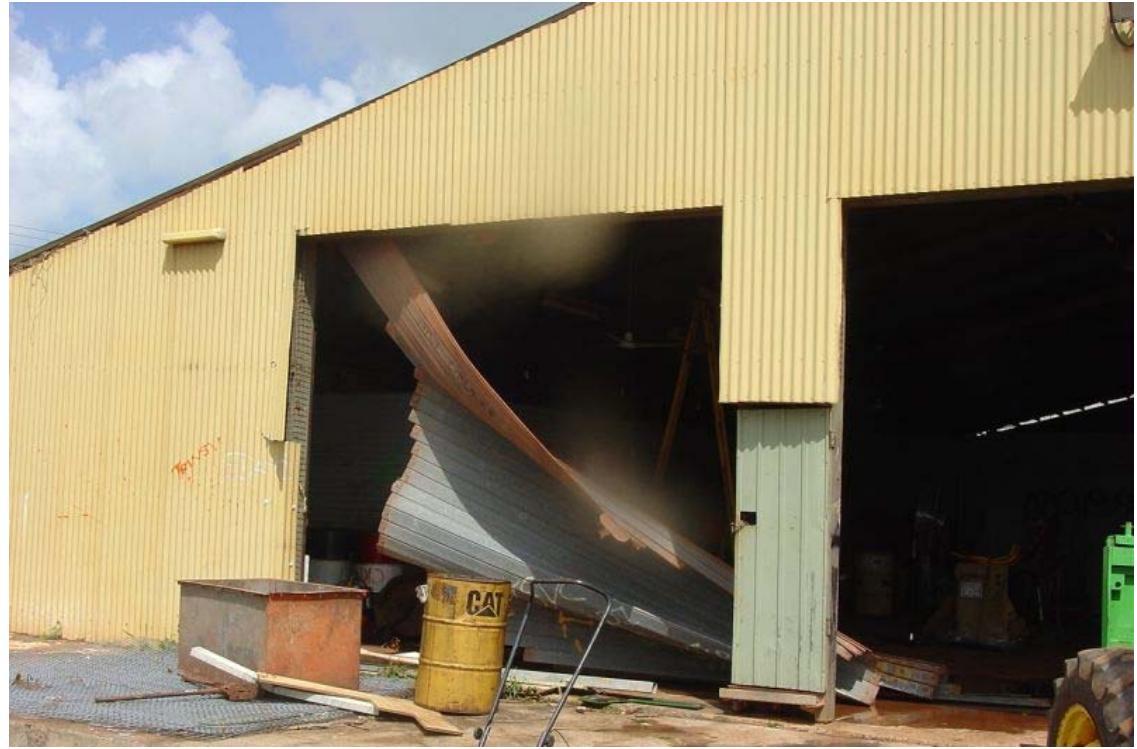
Figure 25: Roller door failure (Photo from DIPE)

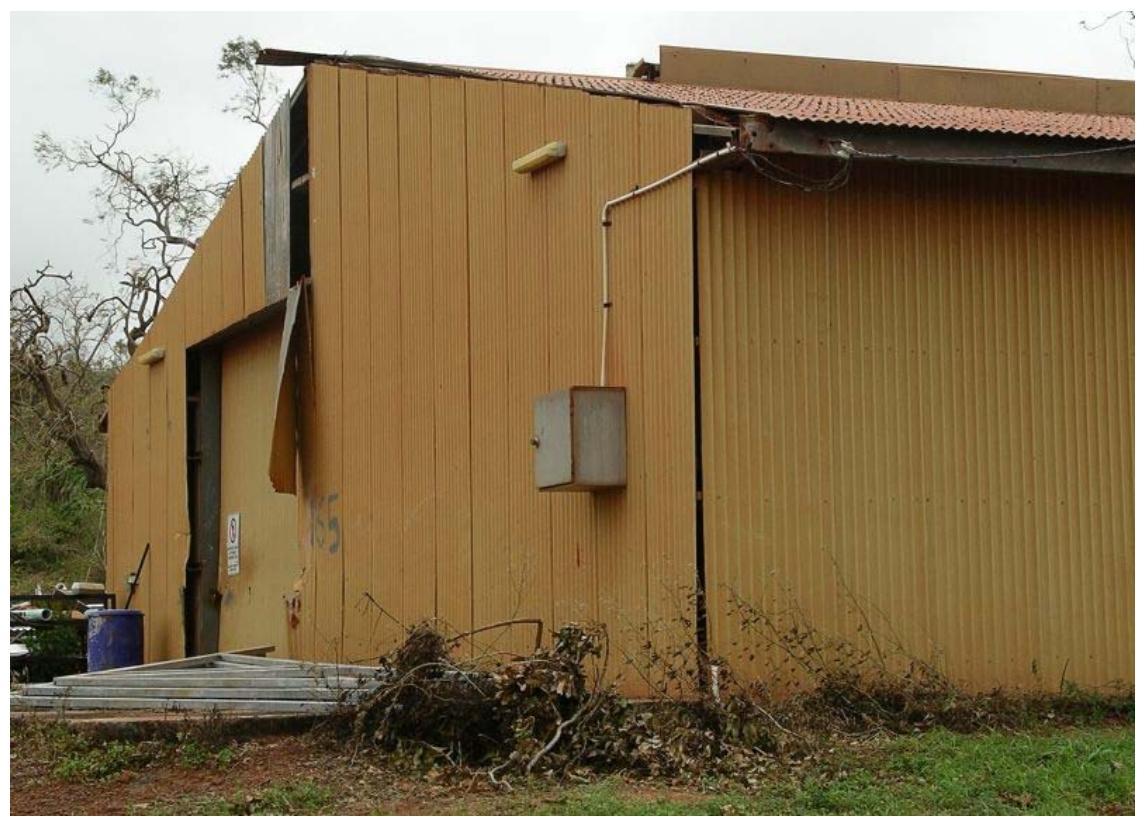
Figure 26: Leeward wall cladding and flashing failure

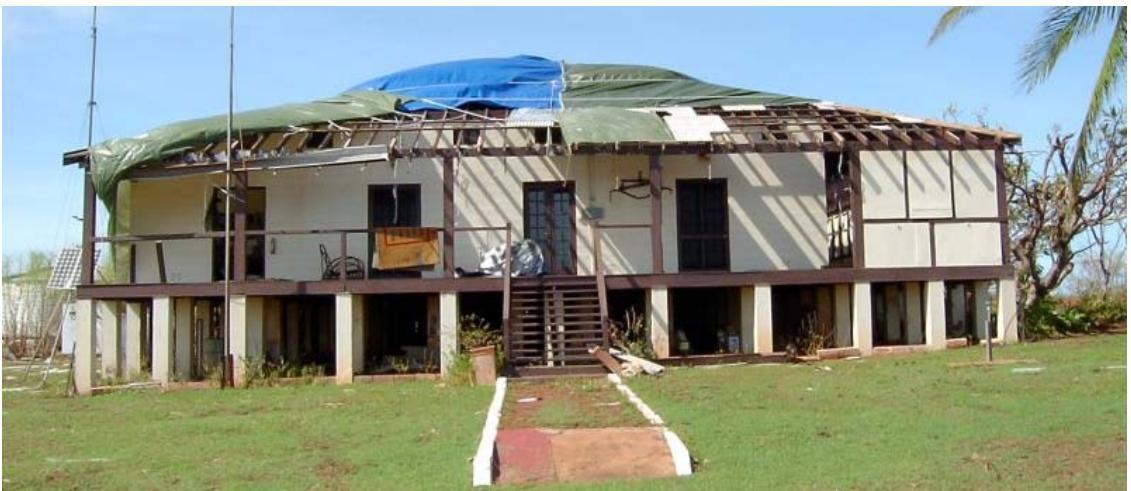
The guest lodge suffered major loss of roof cladding (Figure 27). Some of the screws fixing the corrugated asbestos cement cladding had corroded. Severe corrosion was also noted in the batten fixings and rafter connections (Figure 28). It was advised that the cleanup and removal of the asbestos cladding was going to be a major undertaking (Figure 29).

Figure 27: North face of guest lodge

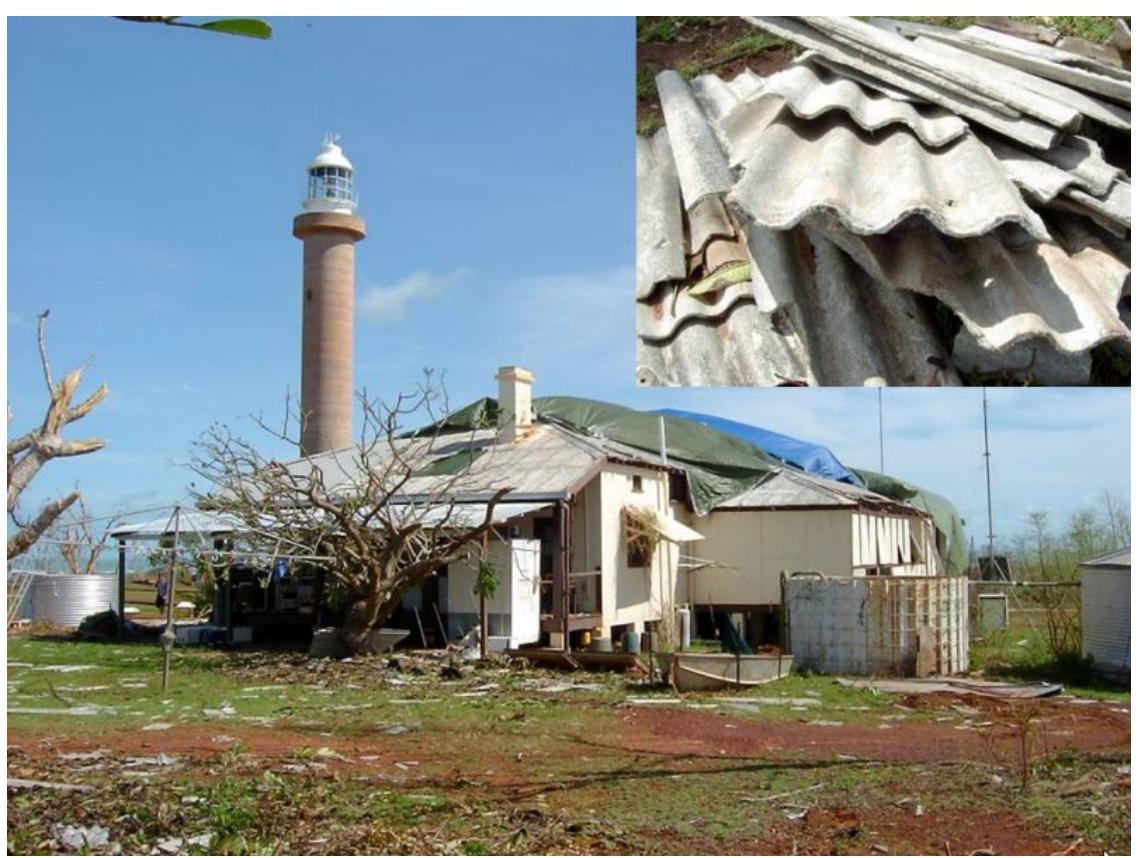
Figure 29: Rear of guest lodge with scatter of corrugated asbestos cladding

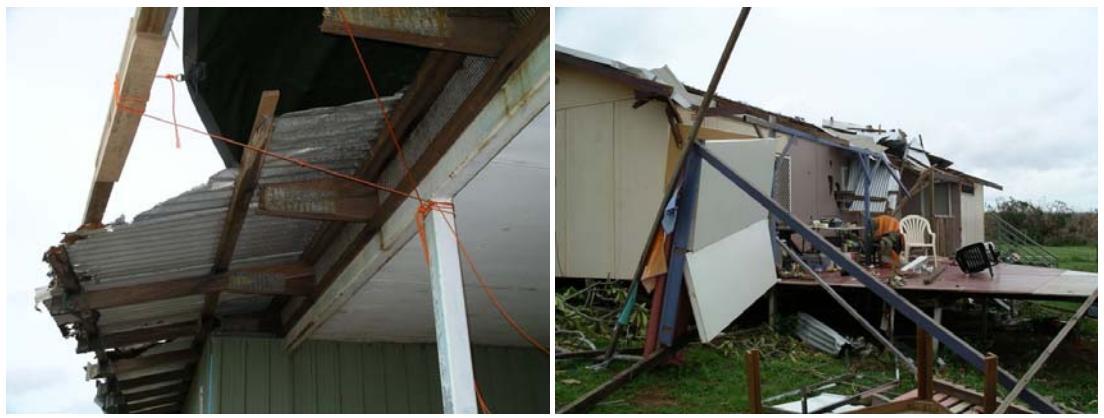
Inadequate design and attachment of elements such as fascias, awnings and soffits can lead to damage to structure, increased water ingress and contribute to wind driven debris. Figure 32 (a) shows the failure to truss top chord eaves from the awning being peeled back.

Figure 32 (a) and (b): Failure of eaves, awnings and associated damage to structures

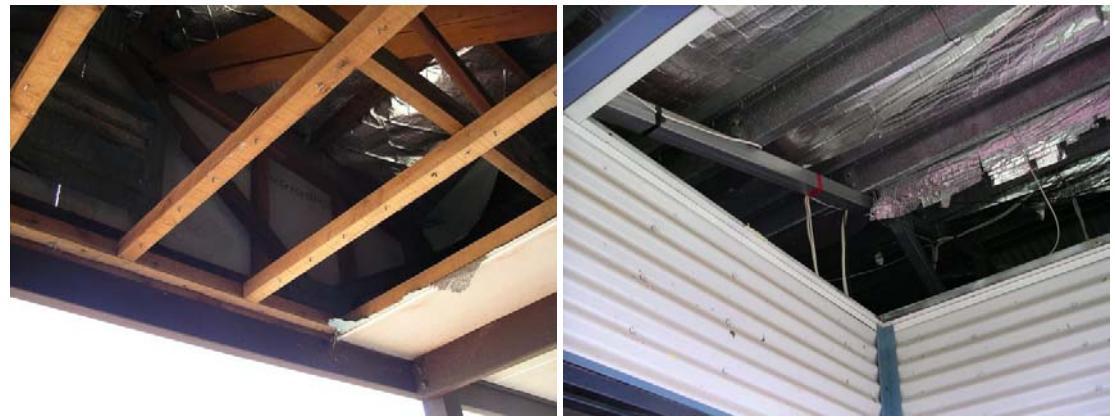
Figure 33 (a) and (b): Soffit damage at Smith Point and Minjilang

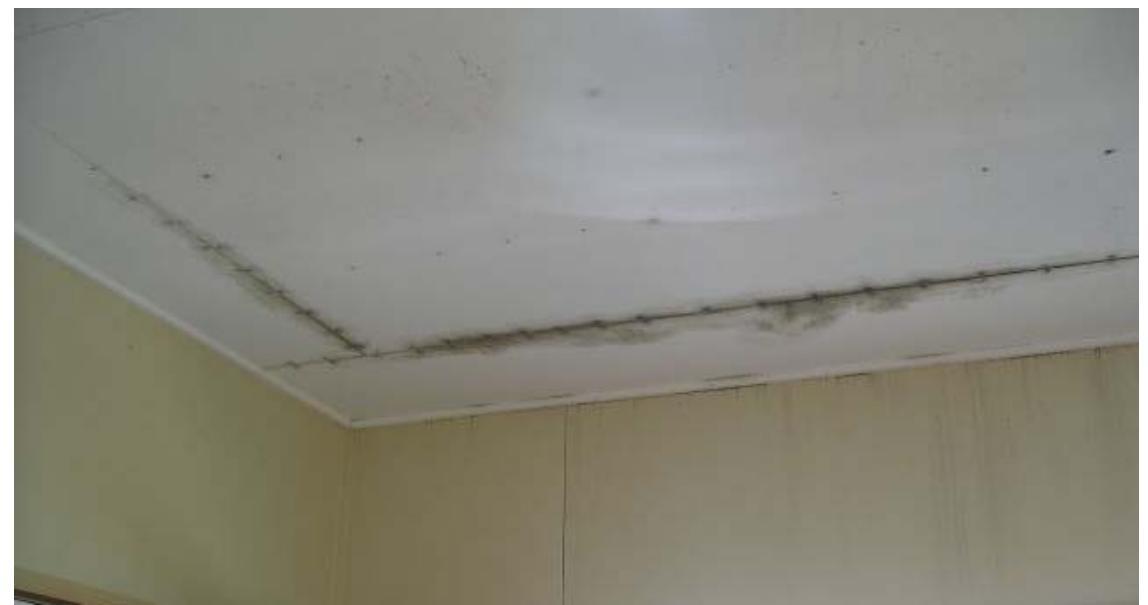
Figure 34: Water ingress at Ranger house on Smith Point

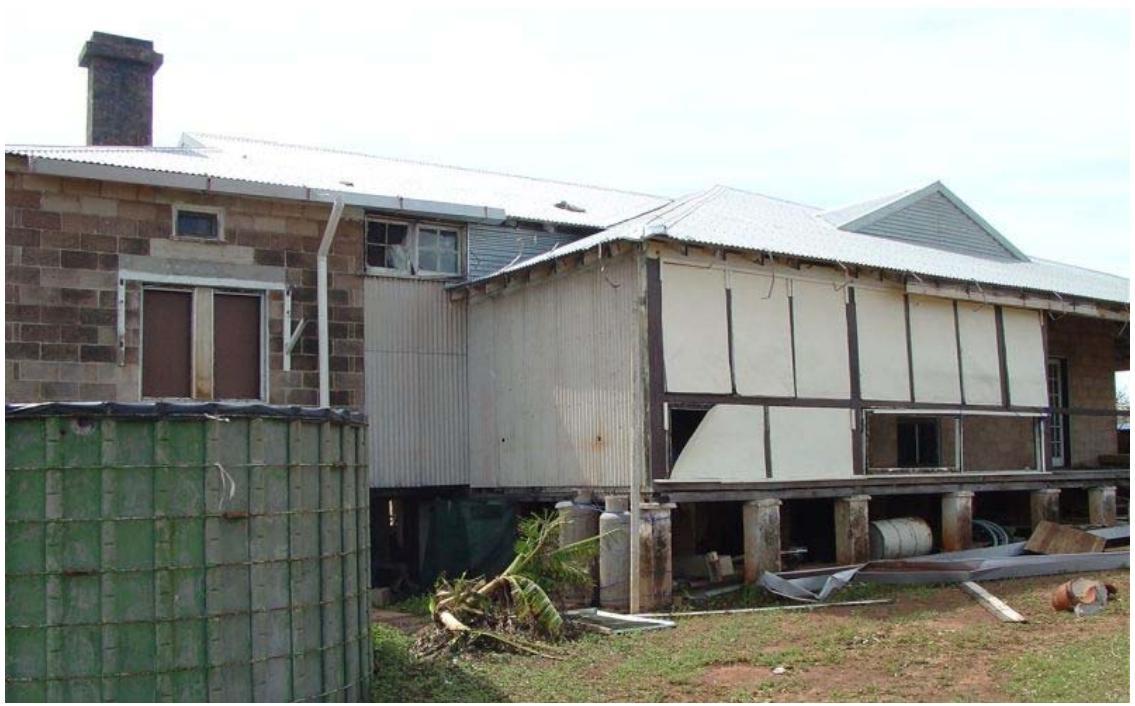
Figure 35: Loss of guttering, fascia and awnings at Cape Don (photo from DIPE)

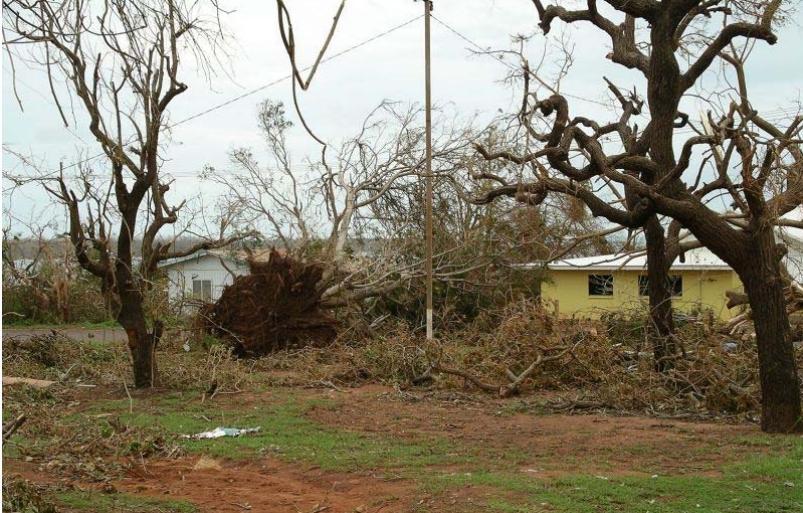
Figure 36: Fallen trees at Minjilang

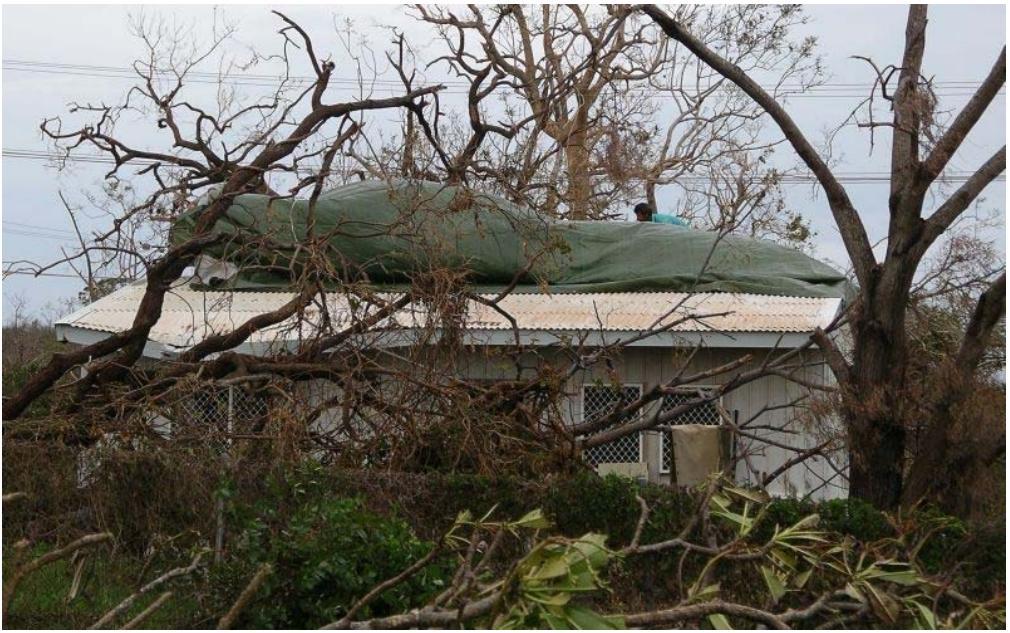
Figure 37: House damaged by tree at Minjilang

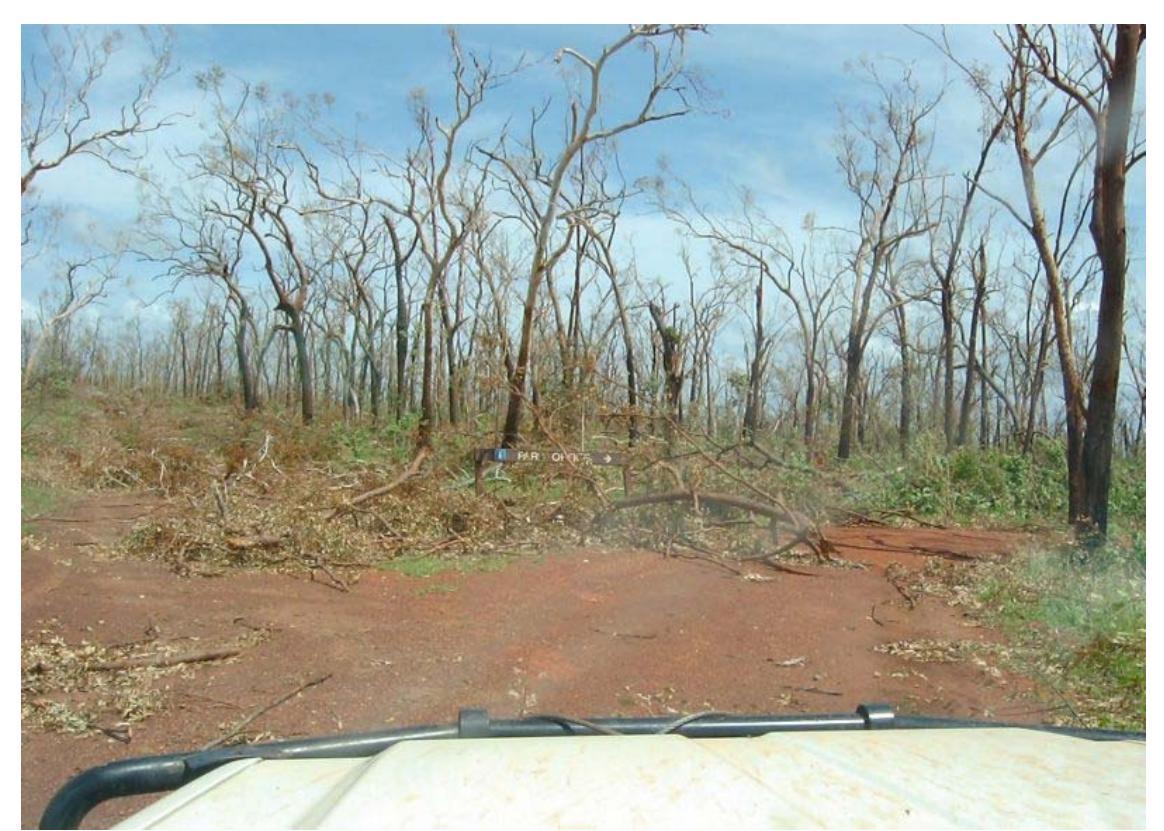
There was extensive tree damage caused by the cyclone. The National Parks advised that there would be an increased fire risk when the fallen timber dried out (Figure 38) [5].

Figure 38: Defoliation of canopy across Coburg Peninsular

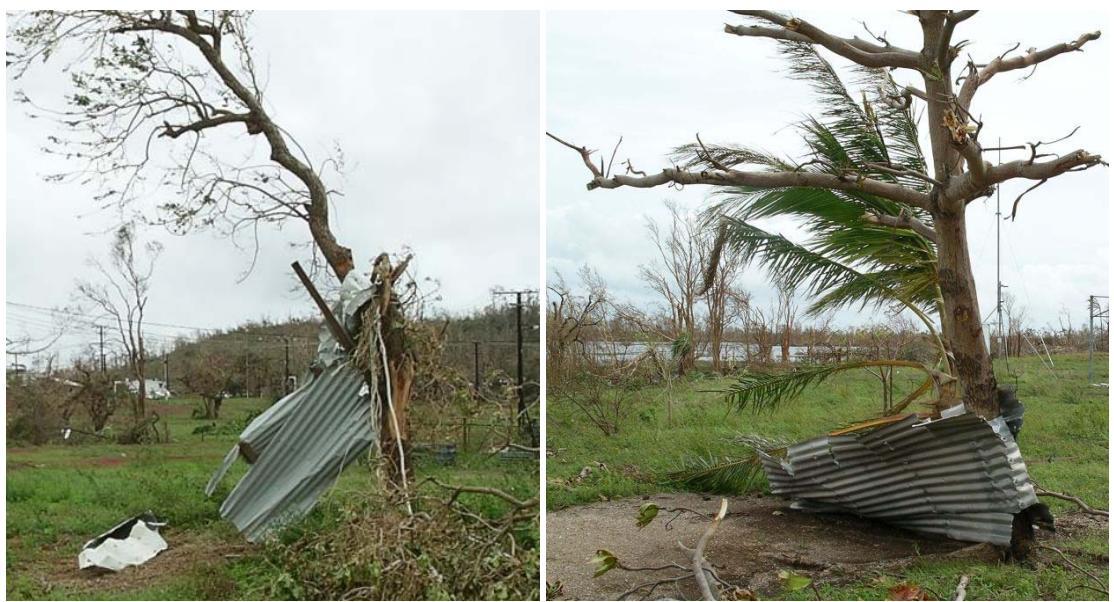
Figure 39: Examples of wind driven cladding (predominantly with battens attached)

Wind driven debris poses a risk to life and property. Correct design and installation of materials is required.

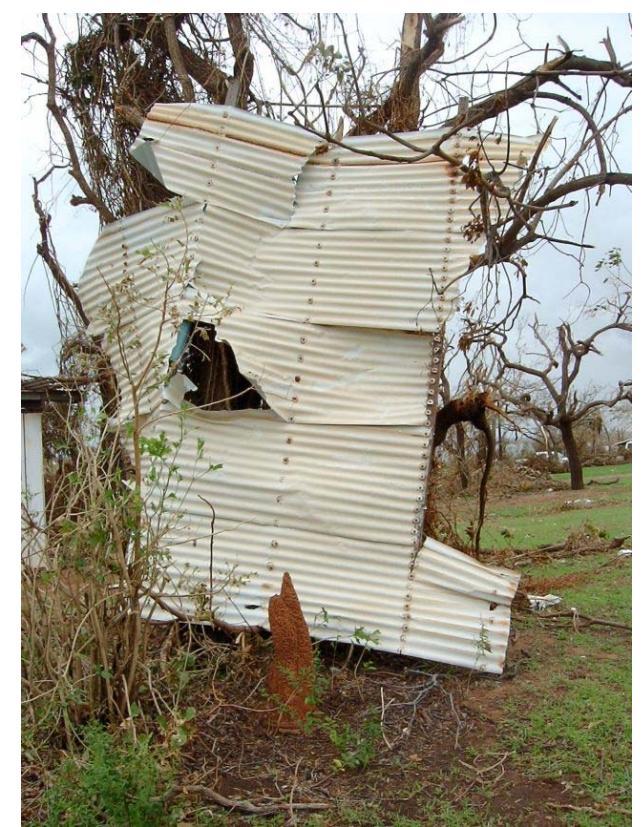
Figure 40: Part of roof from highset house in Minjilang

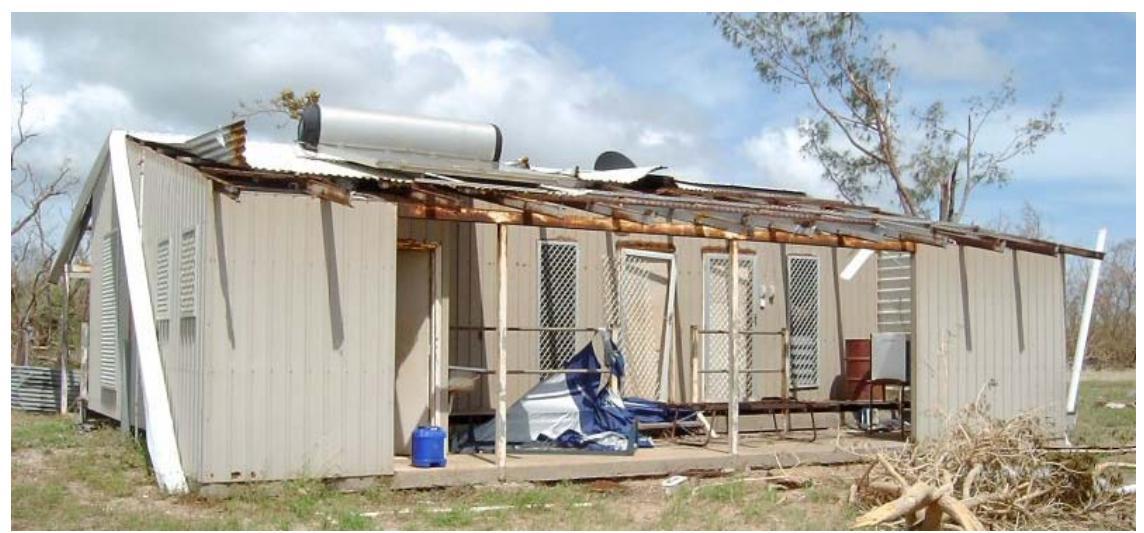
Many of the failures observed were initiated from structural elements suffering severe corrosion. Correct specification and installation of materials to suit the level of exposure along with ongoing maintenance is required for structures. The ongoing maintenance is particularly important in cyclone regions as it may be many years until a severe cyclone impacts the building.

Figure 41: Corrosion of frames, battens, fixings and claddings

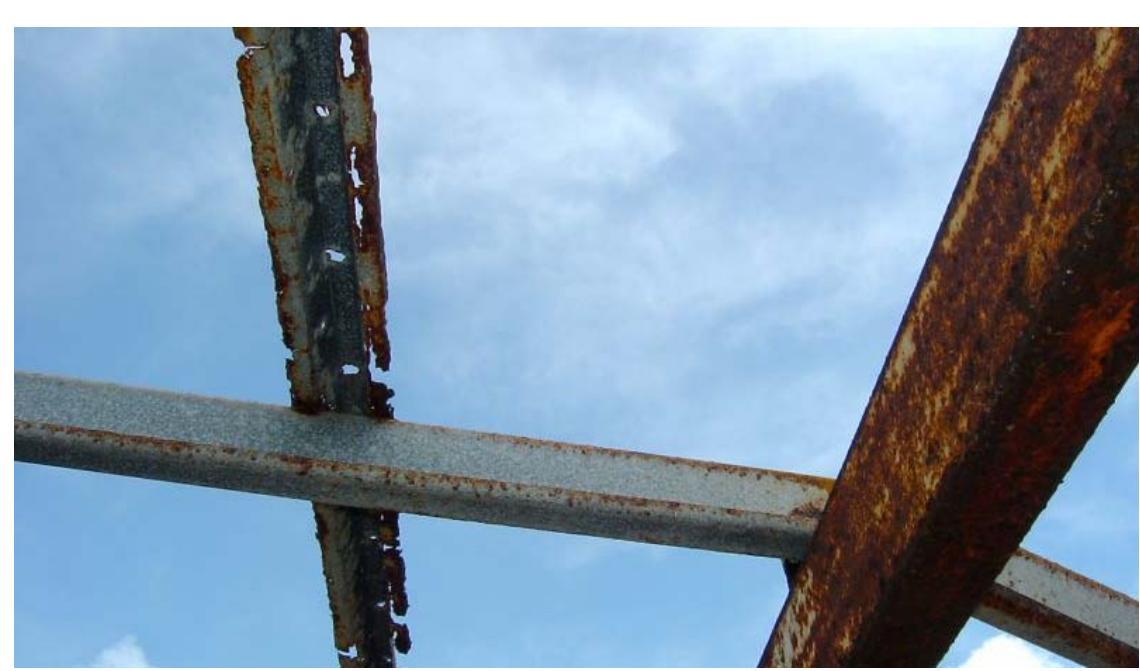
Figure 42: Detail of corrosion of top hat batten

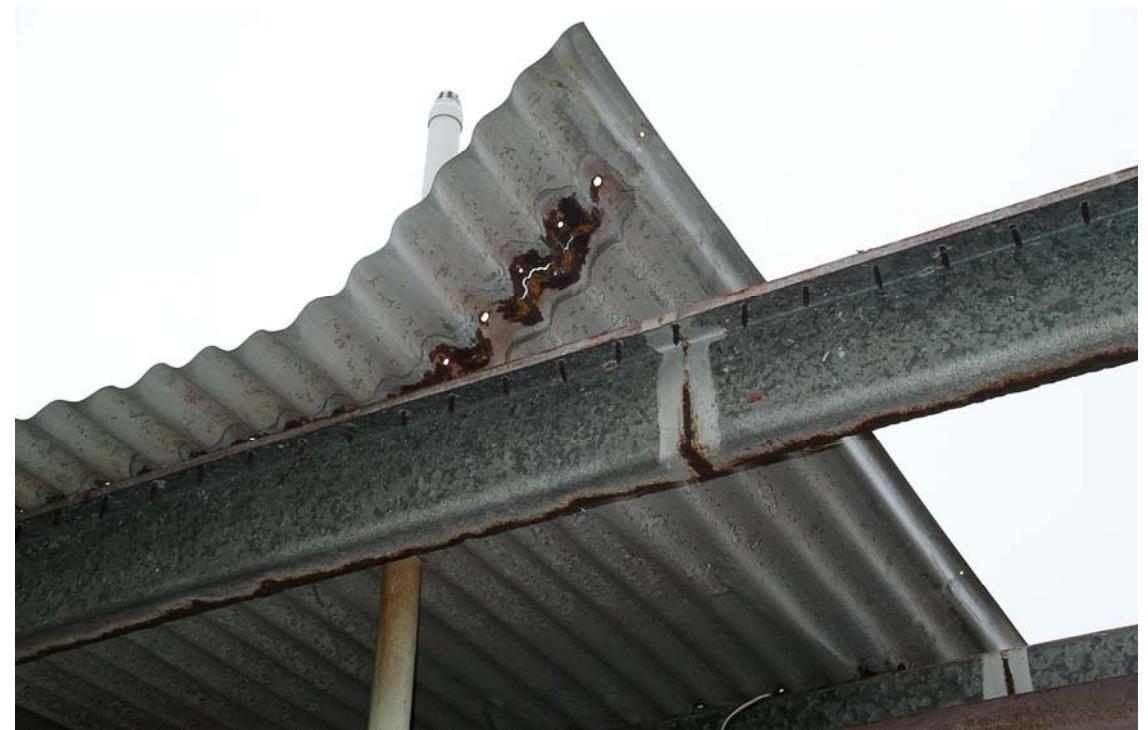
Figure 43: Corroded screws and cladding at Minjilang
