Tropical Cyclone George Damage to buildings in the Port Hedland area

Report: TR52 April, 2007

TECHNICAL REPORT NO. 52

Authors: G. Boughton, and D. Falck (TimberED Services, Perth)

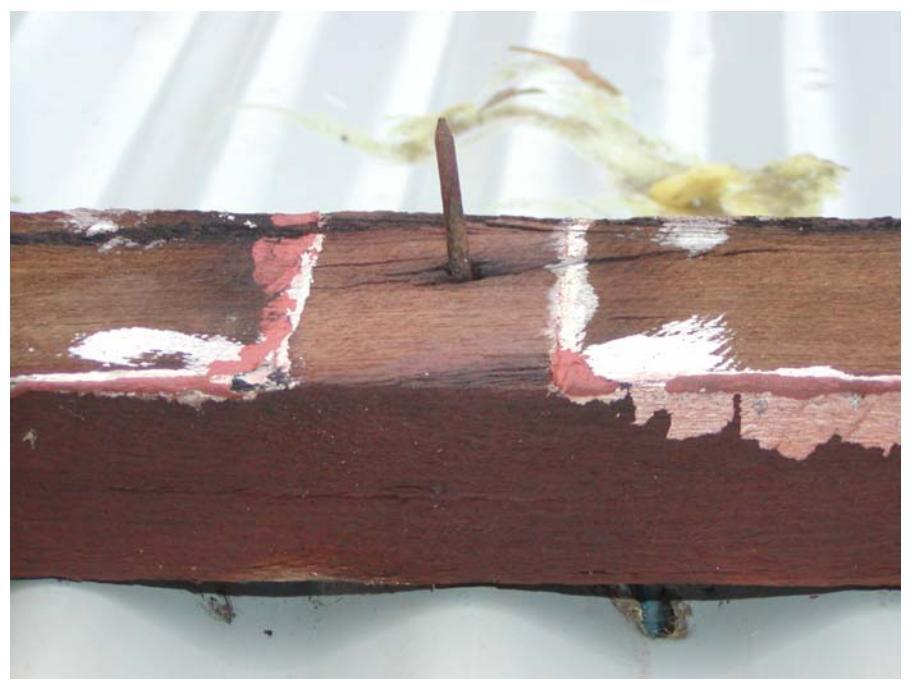
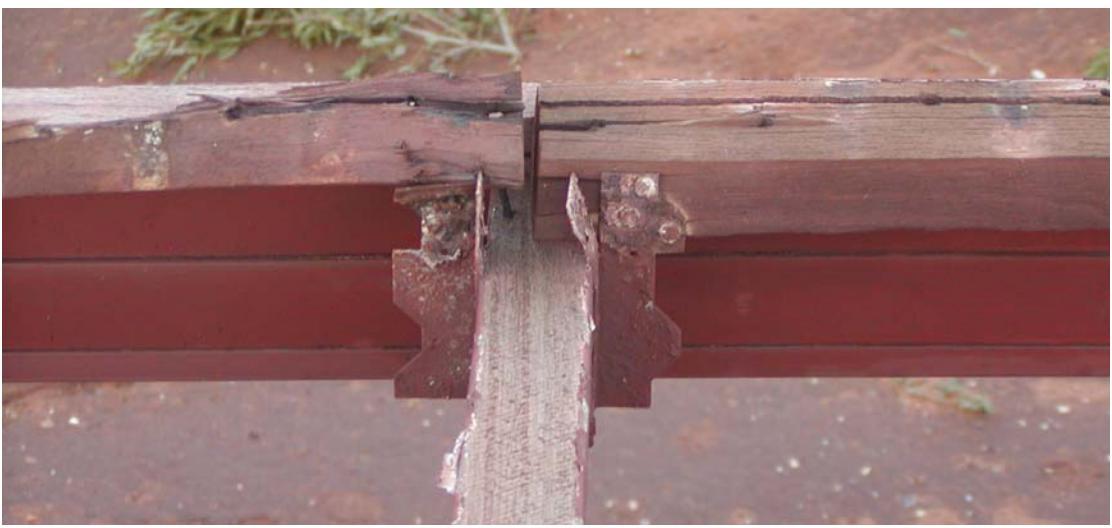
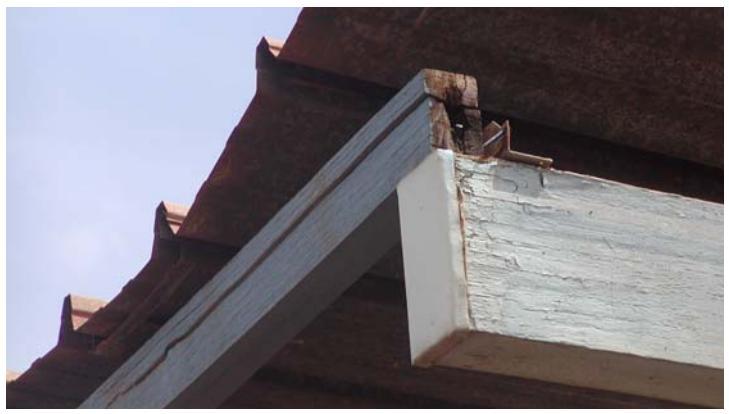
The most obvious damage in a number of older houses that had lost substantial portions of roofing was failure of the batten to rafter connections. In a number of houses, the roofing had been replaced and stronger roofing connectors installed as opposed to the spring head nails used during initial construction. However, no attempt had been made to increase the capacity of other elements in the roof structure. Figure 4.2 illustrates this type of failure.

Where these connections had failed, the rafters remained attached to the remainder of the house, but the battens were removed with the roof sheeting. The main details that had failed were simple nailed connections with one or two nails per batten to rafter connection. Current practice would require a screw, strap (locally called a pap-strap) or a framing anchor.

(c) failure of nails in rotting timber at framing anchor **Figure 4.2: Failure of batten-to-rafter connections**

lengths of batten were fixed over the rafters by framing anchors, but the outer batten had rotted near its end grain and compromised the framing anchors. The loss of the batten caused a number of sheets of roofing to "un-clip" across the roof. Figure 4.2(c) shows the failure.

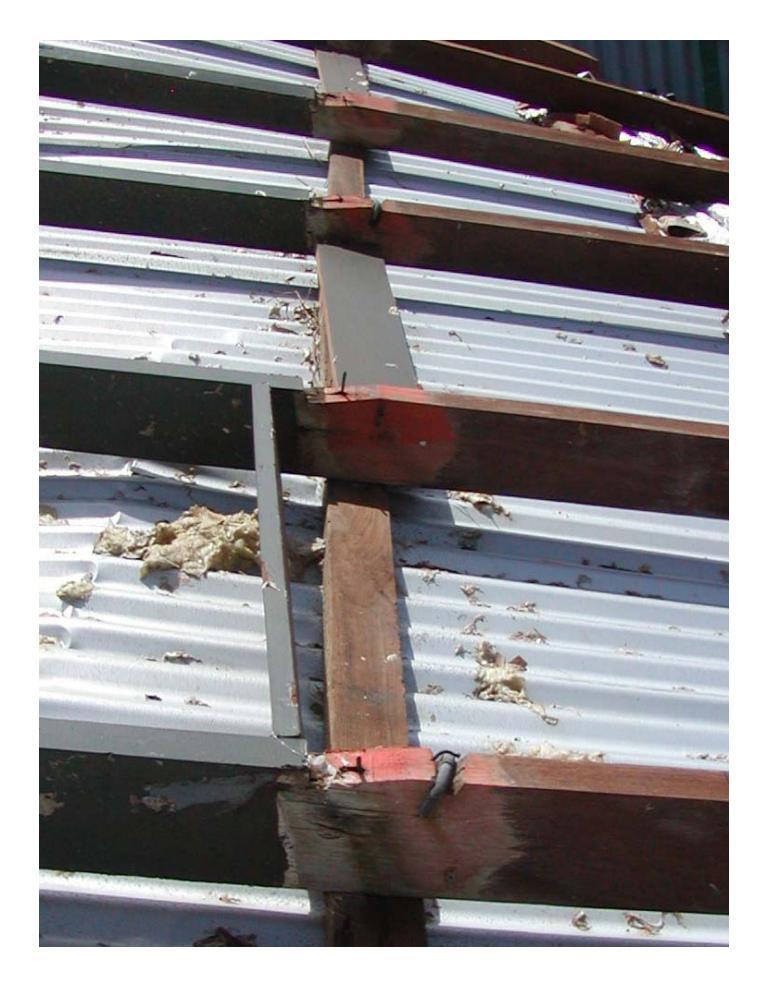
Before the 1970s, many roofs in Port Hedland were anchored to the top of walls with skew nails. Where the batten to rafter connection had sufficient strength to transmit the forces to the rafters and where there were no other systems in place to hold the roof down, the skew nails did not have sufficient capacity to resist the wind loads. Figure 4.3 illustrates this type of failure.

Figure 4.3 Failure of Rafter to Wall Connection

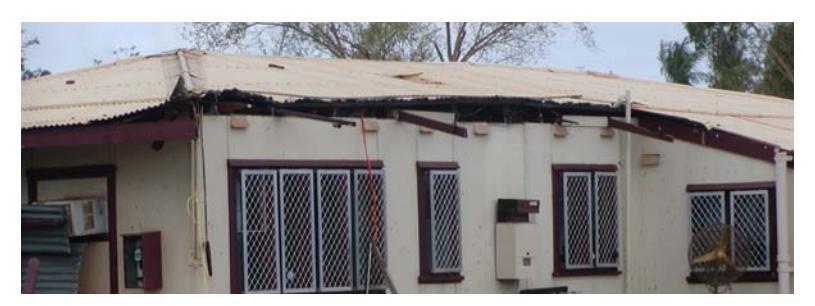
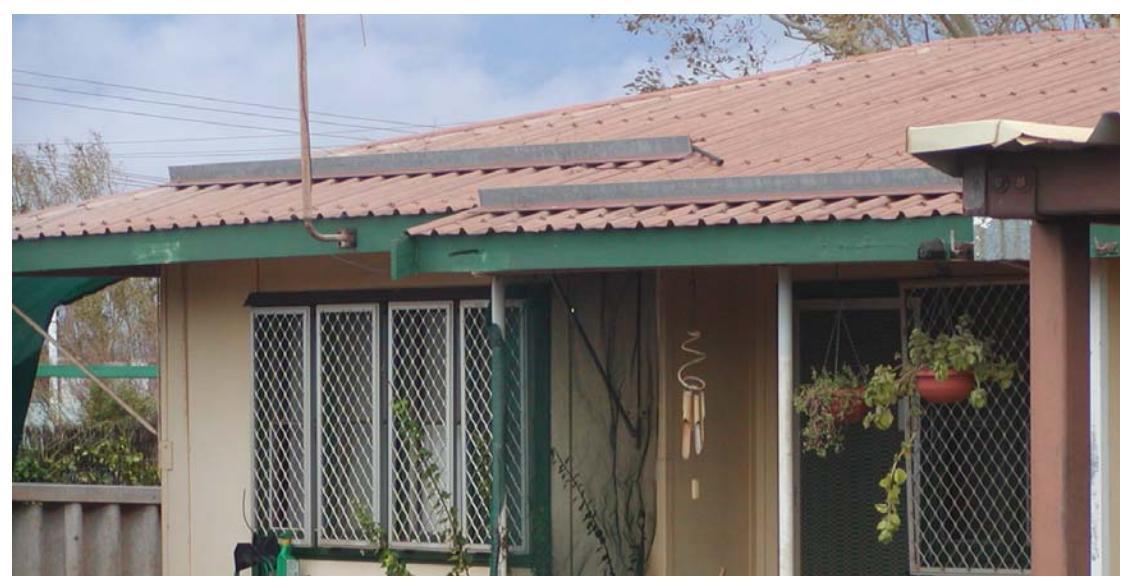
Figure 4.5(b) shows the over-batten installed on a house. On the left of the photo, the over-batten is above an external wall frame, and on the right of the photo, it is above a verandah beam with steel posts that function as the tie-down rods.

(a) roof failure arrested by over-battens

(b) large angle over-battens Figure 4.5: Over-batten on steel roof sheeting

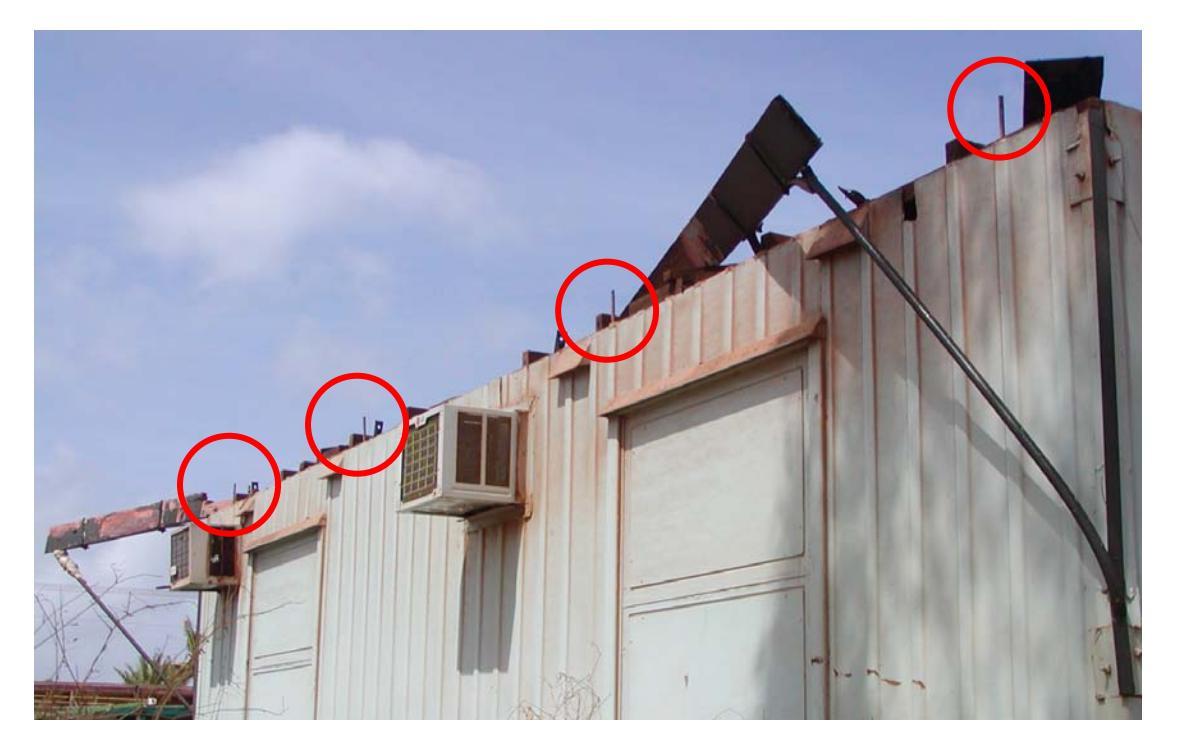
Seven roofs of the twenty three houses with some structural damage had been built using over-battens, but the tie-down rods had been oxy-cut in the past. These houses had each been re-roofed at some stage, but the over-battens had not been replaced, and no other tie-down system had been installed in any of these houses. Figure 4.7 shows a roof failure with the cut tie-down rods highlighted. In this case, the rafters had detached from the walls but the hip rafters which were independently anchored had remained.

Figure 4.7: Removal of Over-batten on re-roofing led to roof failure

Many of the batten-to-rafter failures and the rafter-to-wall failures listed in Table 4.1 were due to the removal of the over-battens. It is imperative that where a tie-down system is significantly changed, a replacement load path is installed.

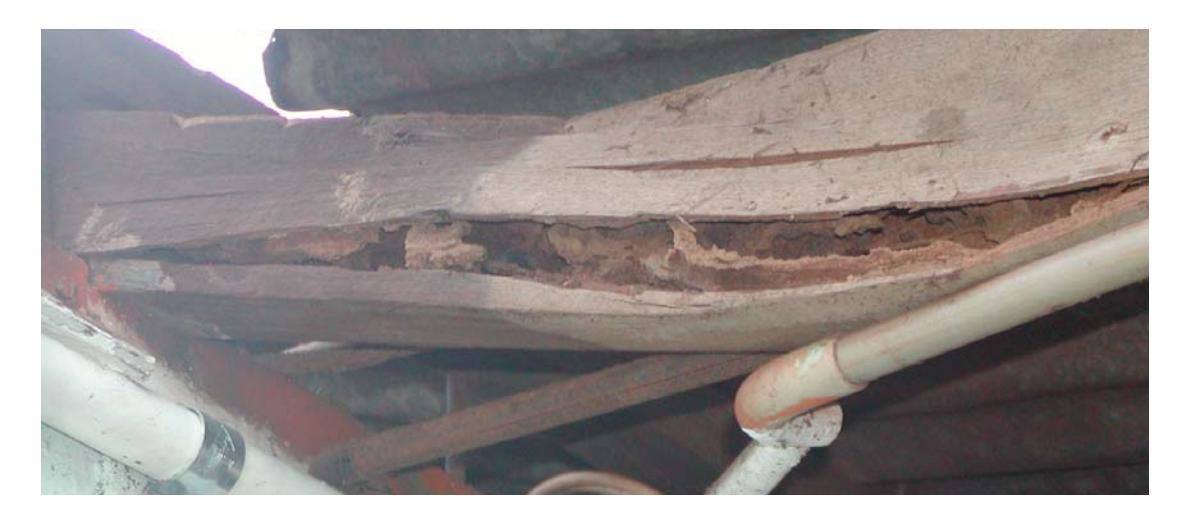
Figure 4.8 shows some rafters that had been seriously compromised by termite activity. This led to partial roof loss, and caused safety issues for workers installing tarpaulins during the response phase.

Figure 4.8: Termite-damaged rafters led to partial roof loss

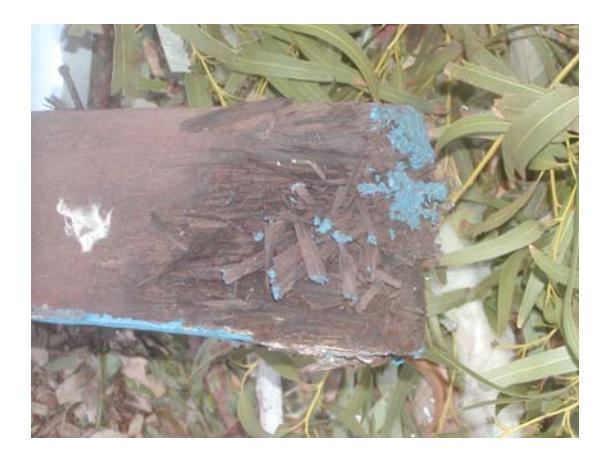
Figures 4.9 and 4.10 show some rot and corrosion in timber framed structures. There were also many instances of corroded roofing, though in most of these, the corrosion was not the prime cause of the failure.

Figure 4.9: Rot-damaged rafters led to partial roof loss

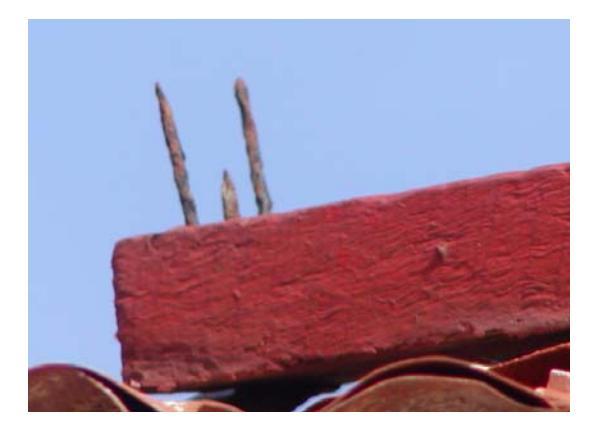
Figure 4.10: Corroded fasteners contributed to partial roof loss

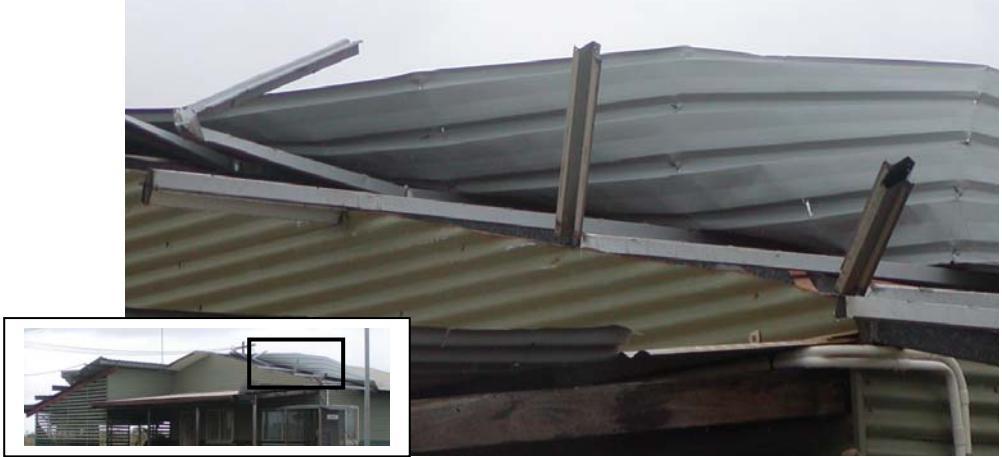
One type of standard house uses a 600 mm cantilever on the end of a deep top hat batten. This is more than the design recommendations suggest for this region. Figure 4.11 shows the failure of this cantilever.

Figure 4.11: Failure of cantilevered top-hat battens

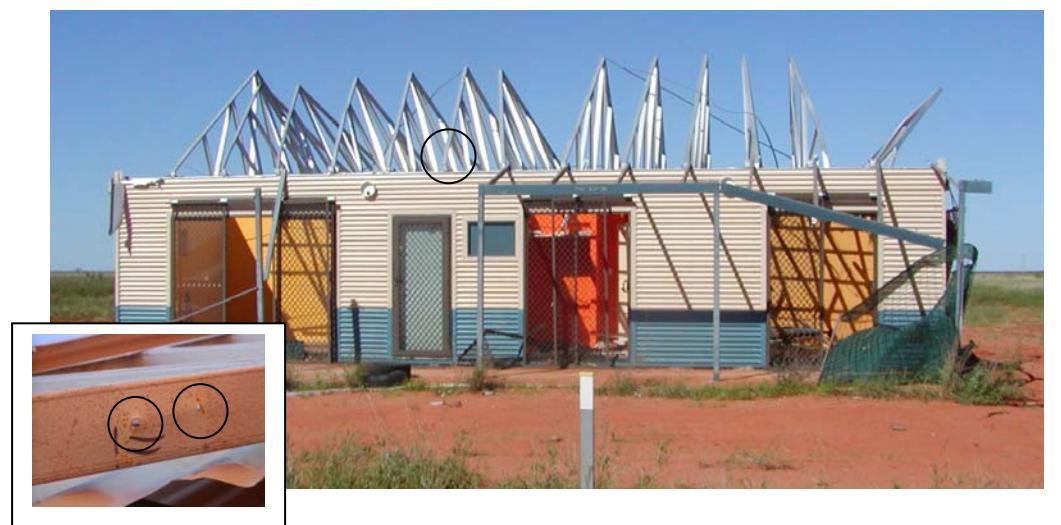
An aboriginal community that experienced the eye wall wind speeds (estimated at less than 75 m/s) had two identical houses that lost all of the roof battens. These battens had pulled their fasteners out of the light gauge truss elements as shown in the inset in Figure 4.12.

Figure 4.12: batten loss from steel roof trusses (inset shows detail of truss top chord)

The batten fasteners had worked their way out of the trusses which appeared to have a steel thickness of around 1 mm. The truss steel had locally deformed at the anchorage (highlighted by the circles in the inset). A number of the trusses showed signs of buckling at the batten anchorage also highlighted by a circle in the main photo. As the wind speed did not exceed the design speed for this house, the performance of the connection was of concern. Further investigation of anchorage of light steel battens into light steel trusses is required.

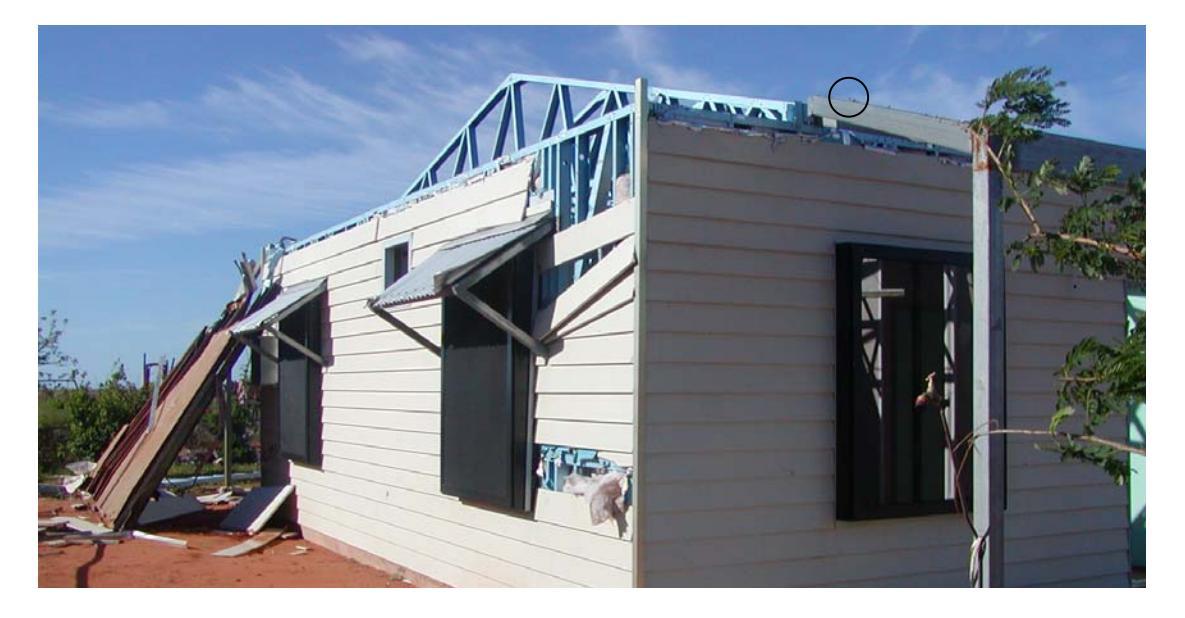
illustrated in Figure 4.12, debris damage initiated failure of batten to verandah rafter connection, causing progressive failure of the remaining batten to rafter anchorages. A circle in Figure 4.13 shows that the batten screws remained in the RHS verandah rafters, and the screws pulled through the 0.75 mm thick battens. In the trussed portion of the roof, the screws pulled out of the trusses as shown in Figure 4.12.

Figure 4.13: batten loss from steel framed roof

The batten spacing on the verandah was 450 mm which performed well at this wind speed on an identical house next door. However, once one anchorage had been lost, the load on adjacent anchorages increased beyond their capacity. This system is sensitive to damage caused by debris or irregularities in anchorage installation.

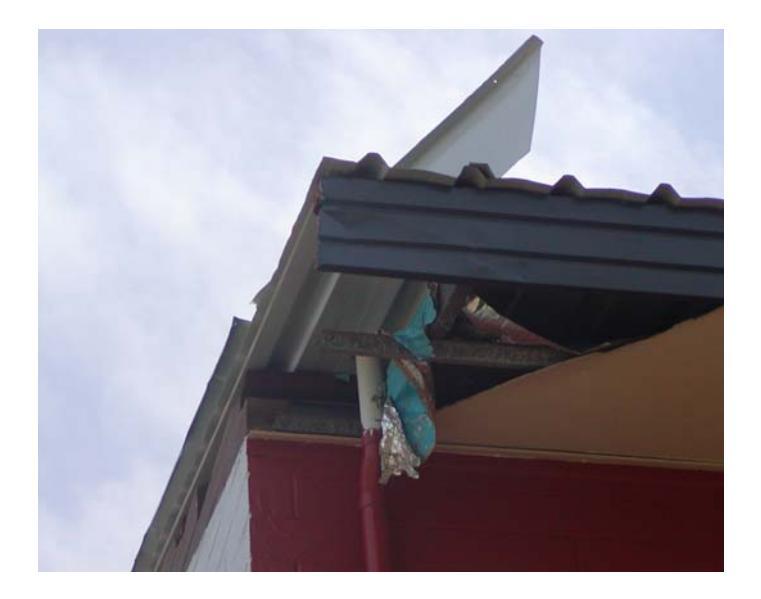
In one case, a trim became detached from a barge board and dragged two sheets from the roof when they might otherwise have stayed attached. This type of failure is shown in Figure 4.14. (The soffit damage evident was a secondary failure.) Similar damage to trim was also observed in schools.

Figure 4.14: Failure of trim

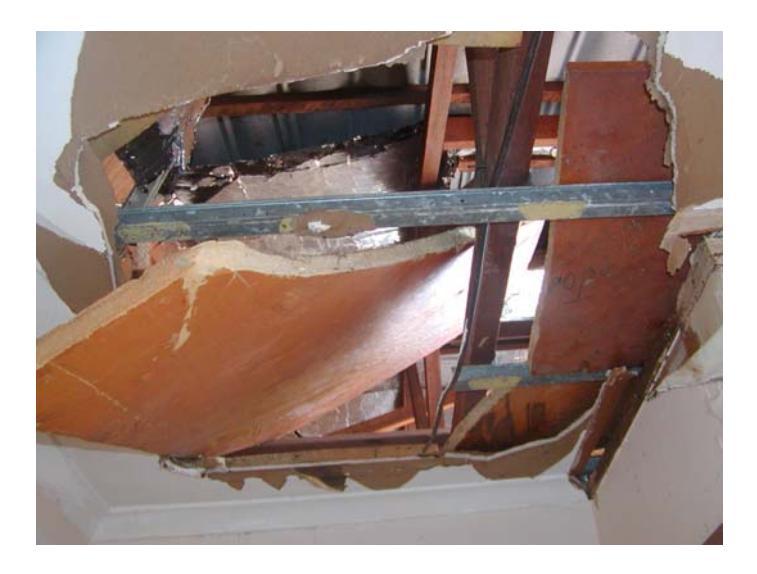
Figure 4.15: Water damage to plasterboard ceilings

Plaster ceilings suffered water damage, even if the roofing was only very slightly damaged. Also, damage to gable panels allowed water entry to the roof space and caused damage to ceilings as shown in Figure 4.15.

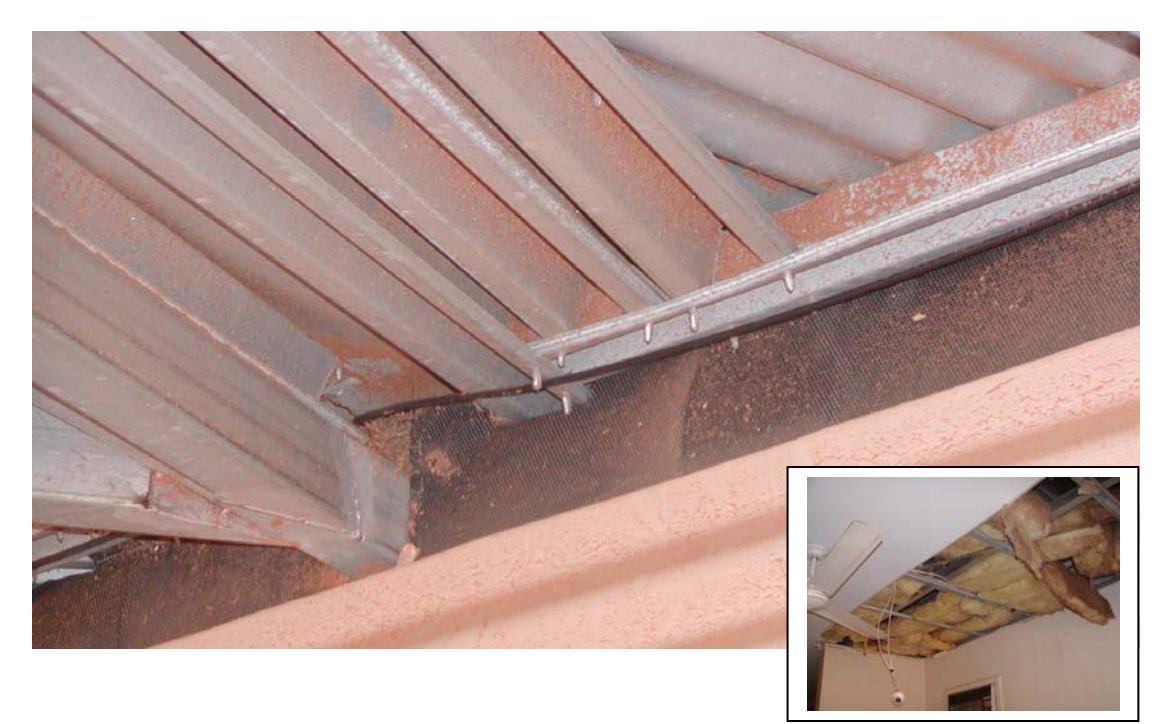
In a number of houses, fine mesh was installed in place of bird boards between the trusses to provide ventilation into the roof space, as shown in Figure 4.16. Unfortunately, wind borne rain was driven through the mesh, ponded on the plasterboard ceilings, and lead to collapse of the ceiling.

Figure 4.16: Mesh ventilation to roof space Inset: Water damage to plasterboard ceiling

Figure 4.16 shows soil that has been blown onto the underside of the roof and onto the wall cladding on the windward wall. The soil and water were blown through the mesh shown between the top of the cladding and the underside of the battens. Where such ventilation is used, resilient lining materials must be installed. Alternatively, where plasterboard or other water sensitive lining materials are installed, roof space ventilation openings are not recommended.

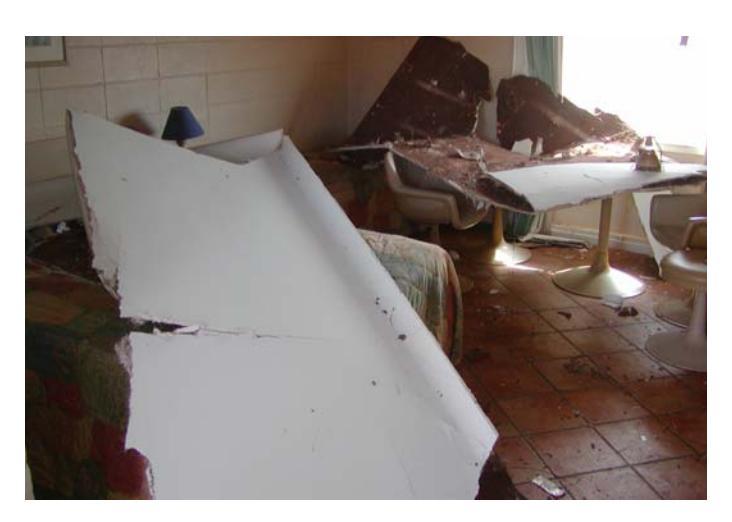
Pressurisation of the roof space through gable ventilators caused downward pressure on ceilings and a number of dry ceiling collapses were due to this effect. An example of this type of damage was seen in motel rooms, illustrated in Figure 4.17. In each case in which this was observed, there was no opening that could develop dominant internal suction in the affected rooms, though any leakage through doors and windows would have been from suction surfaces. The affected rooms were not adjacent to the windward wall, but were some distance from it. Any water blown in through the vent landed on ceilings closer to the vent.

Figure 4.17: Collapse of dry plasterboard ceiling due to roof space pressure

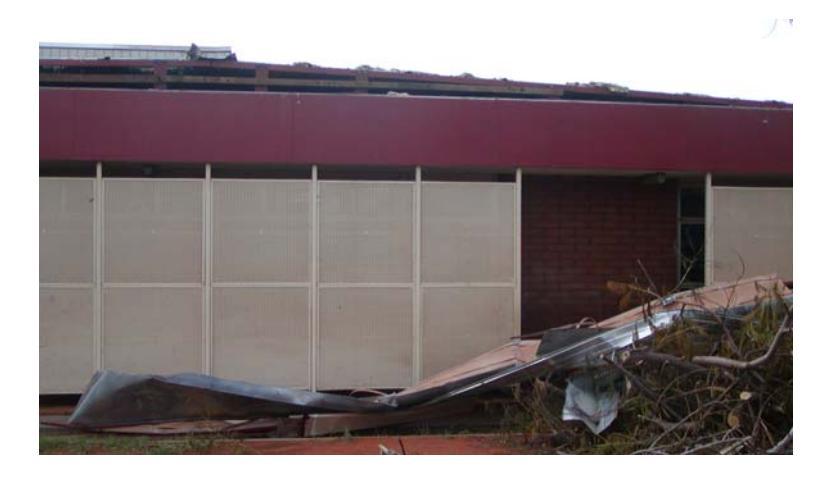
A number of school buildings and the Civic Centre had some damage to the roof that appeared to originate at flashings on the windward edge of the roof. In each case, the flashing seemed very large (around 600 mm wide). Flashings are not normally regarded as structural elements, but in this case, the flashing takes loads comparable to loads on roof sheeting that is regarded as a structural element. The flashings are located in a local pressure zone, which can double the loads on specific fasteners.

Figure 4.18: Damage to wide flashings roofing and trim on windward edge of roof

As this type of detail appears to be quite common in public buildings of this age, it may be advantageous to have the structural adequacy of the wide flashings verified by structural engineers. (Wide flashings and trim can be treated in the same way as roofing.) If needed extra fasteners should be fitted to this detail wherever it occurs in the cyclone regions (C or D) [5].

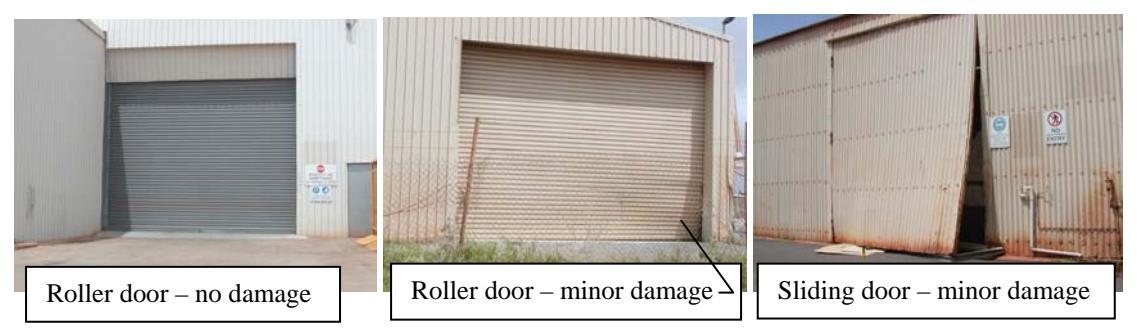
Light industrial buildings are concentrated in the port area and in Wedgefield. There was little structural damage to observe. Few roller doors are used on these structures – most buildings use heavy sliding doors in place of roller doors. One undamaged commercial roller door that faced the West was seen, and another with some track damage was noted. Sliding doors seemed to perform well, though some trim damage at the top was seen on two and one had been dragged from its track at the bottom – see Figure 4.19 (a).

(a) Industrial doors
