SAFETY ALERT

AUSTRALIAN STEEL INSTITUTE
SAFETY GROUP

Number:	SA0016
Subject:	Failed lifting lug on crane C Hook
Date:	September 2006

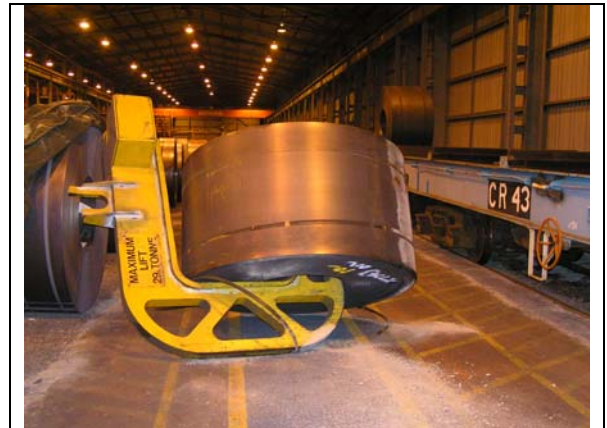
- An operator was offloading a coil from a rail wagon using a remote control. The coil was lifted and began to move toward the storage area when the Bobbin (lifting lug) on the C Hook failed. The coil and C Hook fell onto the edge of the rail wagon (from a height of ~ 1m) and then onto the ground. The crane driver was observing the 5m rule. However, the crane driver sustained slight strain injuries to his back and foot in moving to avoid the coil and C Hook.

- The second C Hook was immediately taken out of service and sent away for a weld repair to remove the cracks. The failed C Hook has been redesigned and is in the process of having the new design fabricated. Once this has been complete the second C Hook will be taken out of service and have the design implemented.
- All other lifting equipment (Lifting Beams) is being inspected by NDT.
- An inspection program involving regular NDT is being scheduled.
- A review of inspection procedures for all equipment is underway.
