SAFETY ALERT

AUSTRALIAN STEEL INSTITUTE
SAFETY GROUP

Number:	SA0017
Subject:	Wrist fracture due to incorrectly engaged hook
Date:	September 2006

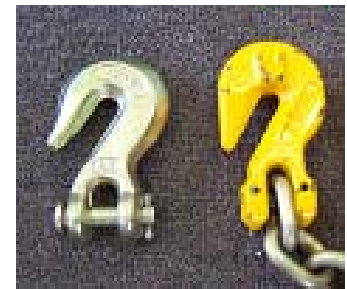
Example Grab hooks

- When chaining loads it is important to visually inspect and test the system first by applying light pressure before applying maximum force.
- Claw hooks have a greater tendency to come loose than traditional grab hooks.

- All hook connections should be visually inspected prior to load binding and then the system should be tested by applying light pressure before applying full force to the load binder.
- Communicate incident and conduct refresher training to raise awareness.
- Consider using plain or winged grab hooks in place of claw hooks.
