SAFETY ALERT

AUSTRALIAN STEEL INSTITUTE
SAFETY GROUP

Number:	SA0023
Subject:	Appropriate Load Restraint
Date:	March 2007

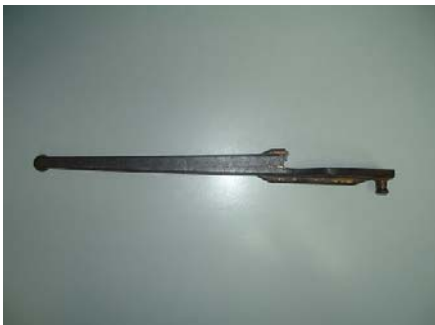
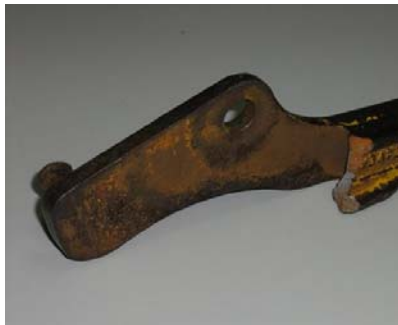
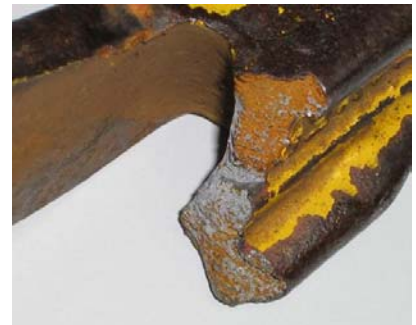
A vehicle transporting 16t load of steel was required to conduct an emergency brake (vehicle only traveling at approximately 10kph). Dogs and chains were employed as secondary control measures for the load. Under the braking strain, one of the dogs snapped. Closer inspection revealed that the dog had a hairline fracture prior to its failure. Investigation into the incident showed that the dog was under rated for the load being transported.

- Ensure that an appropriate inspection program is in place and that all loaders & drivers are trained in this program.

- Have a life span on each of the 'dogs' and keep central register.
- Ensure that the correct load capacity for the device is marked and the dog is colour coded accordingly.
- That the dogs are used in accordance with the manufacturer's specifications – users are to be aware of this.
- Not to use 'cheater bars' while tightening load restrained.
