SAFETY ALERT

AUSTRALIAN STEEL INSTITUTE
SAFETY GROUP

Number:	SA0026
Subject:	Tipped side-loader exiting warehouse
Date:	May 2007

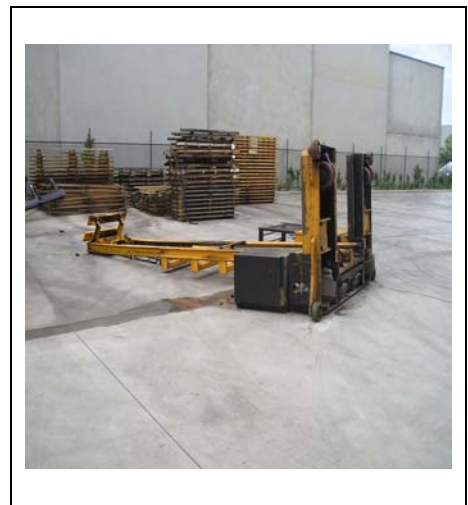
- Employee was exiting warehouse with tines in fully raised position. The side-loader tipped on its back when turned sharply
- The slope of the driveway is at a decline of approx 8 degrees to that of the level warehouse floor. There was no load being carried
- The employee stayed within the cage and was shaken but unhurt. He was able to climb out. The mast was bent and the fork tines thrown across the driveway

- Raised forklift tines elevated the centre of gravity. Tines must be in the down position when driving
- Side-loaders are less stable than forklifts on sloping surfaces and should be restricted in their use in such areas
- Surveillance film showed operator did not slow when turning after exiting warehouse. Operator unaware of hazardous situation created

- All operators to be skills assessed on all types of side-loader/forklifts
- Confine the use of side-loaders to level floor warehouse areas. Forklifts to be used outside
- Follow up with forklift refresher training by WorkCover qualified trainers
