SAFETY ALERT

AUSTRALIAN STEEL INSTITUTE
SAFETY GROUP

Number:	SA0030
Subject:	Jammed Drill - Sprained Wrist
Date :	February 2008

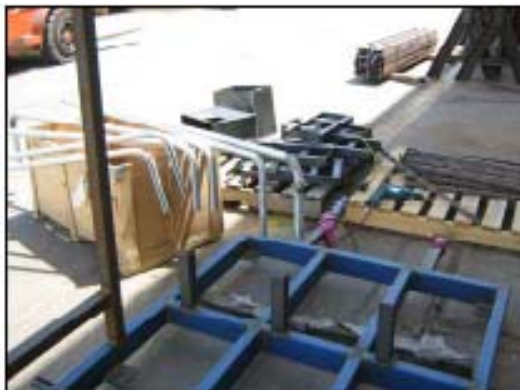
An employee was required to drill holes in a number of steel pipes with a hand-held electric drill. There were no clamps or a vice provided to the worker to secure the work to be drilled. As such he supported the pieces on a wooden crate and pallet, creating a poor work posture. During the drilling of one item, the drill bit jammed (possibly due to the work moving). There was no clutch on the chuck of the drill. The torque twisted the drill in the worker's hands causing a strain injury to his wrist.

Above: work supported on wooden crate and pallets not facilitating an appropriate posture.

- **Always secure work to be drilled to ensure that it cannot twist or move.**
- **Work should be secured in a vice mounted at an appropriate height to facilitate a strong grip / control on the drill.**
- **Ensure to purchase / use hand-held drills with a clutch that will prevent the drill body spinning out of the operator's grip when jammed.**

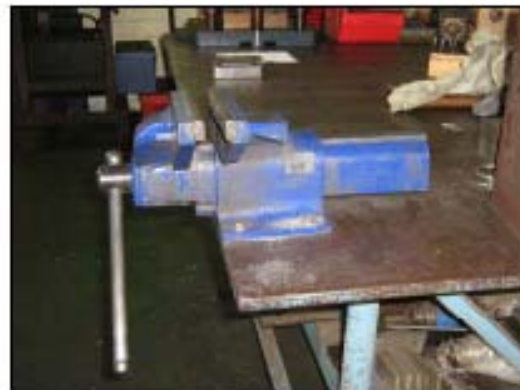
Above: Work should be secured in a vice, mounted on a bench at an appropriate work height.
