SAFETY ALERT

AUSTRALIAN STEEL INSTITUTE
SAFETY GROUP

Number:	SA0036
Subject:	Personnel Awareness in Plate Storage Areas
Date	August 2009

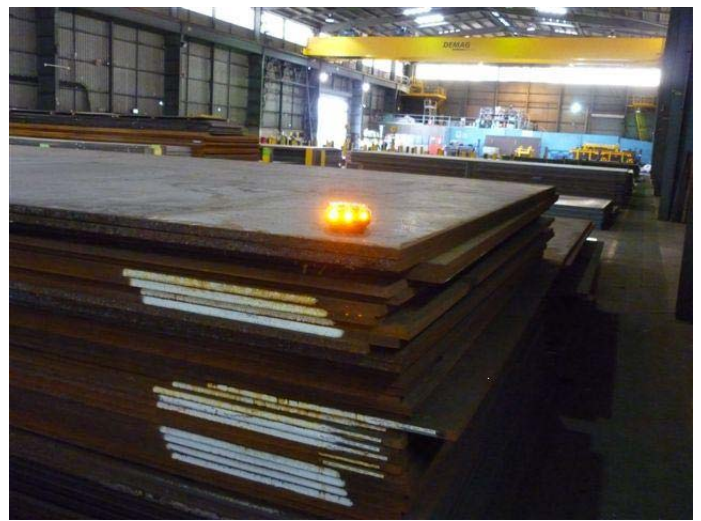
- In November 2008, an employee working in a plate storage area reported an incident where an overhead crane had approached unnoticed. The employee was crouching down behind a stack of plates, counting inventory, when the unloaded crane approached within three metres. Subsequent discussions between the employee and the crane operator revealed that neither person knew of the other's presence.
- Contributing Factors
 - Employee had entered the warehouse wearing a high visibility vest and been acknowledged by the crane operators. The crane operator was not aware of the employee location ten minutes later.
 - Procedure / protocol for personnel entry to plate facilities / warehouse were not developed.
 - Employee was working amongst tall stacks (~1500mm high)
 - Lighting conditions were good, but may worsen during hours of darkness.

Plate Stack with Light Beacon on end. (Orange)

- Personnel to follow developed protocols for warehouse entry.
- Enhance personnel visibility, through use of a "Personnel Location Beacon" (Flashing light – battery operated) when working in Plate handling areas. Toolbox talks to discuss the purpose and use of the light beacons.
- Crane operators to plan travel path considering visibility when working in proximity to high stacks of materials such as plate and lighting conditions.
