# CORROSION IN THE 'UNDERWORLD'

## INTRODUCTION

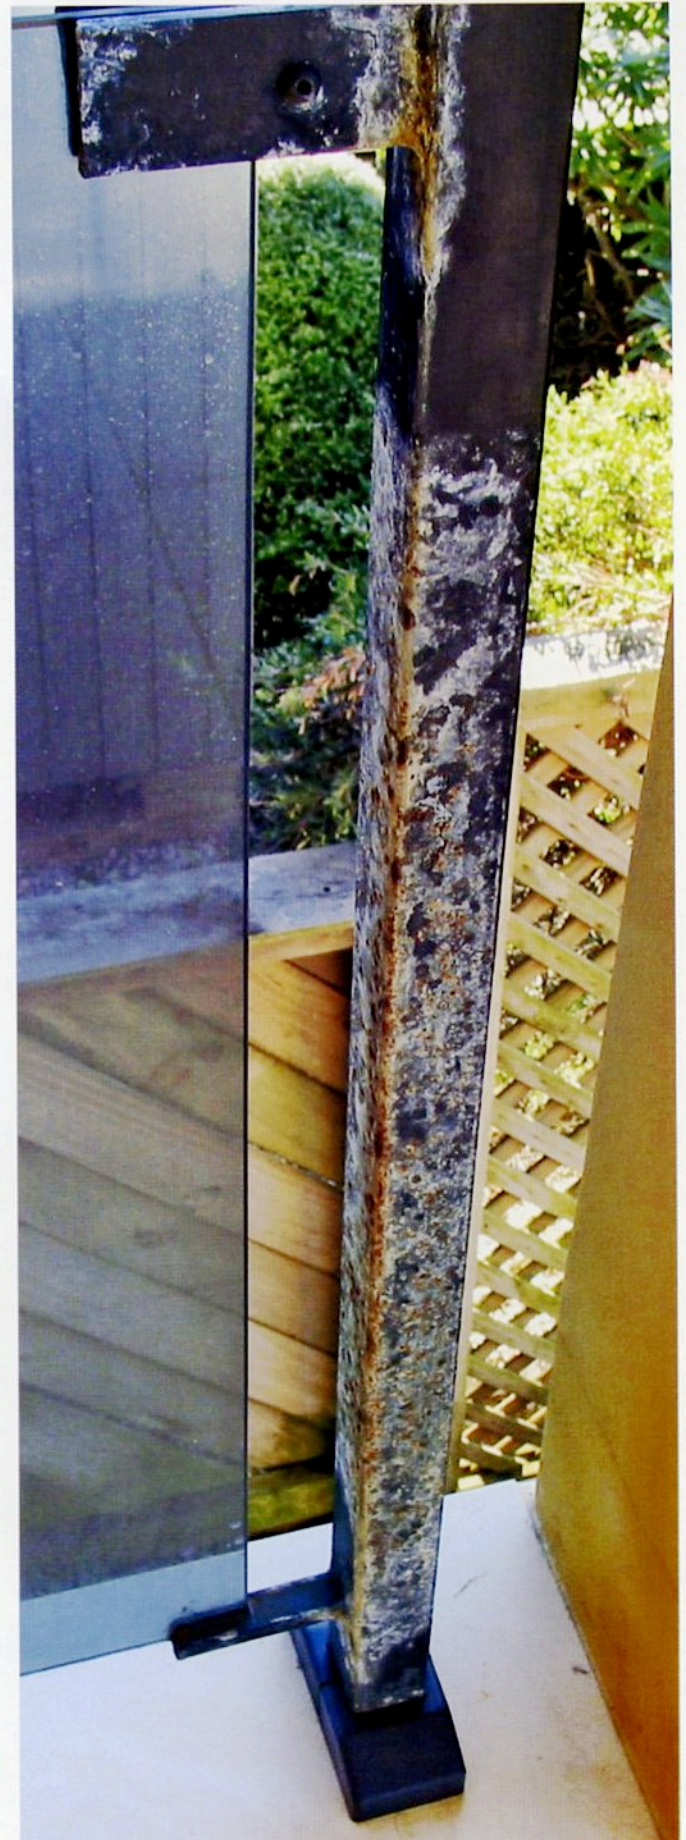
*Total powder coating failure on this bayside verandah stanchion within 2 years on sheltered area of the verandah.*

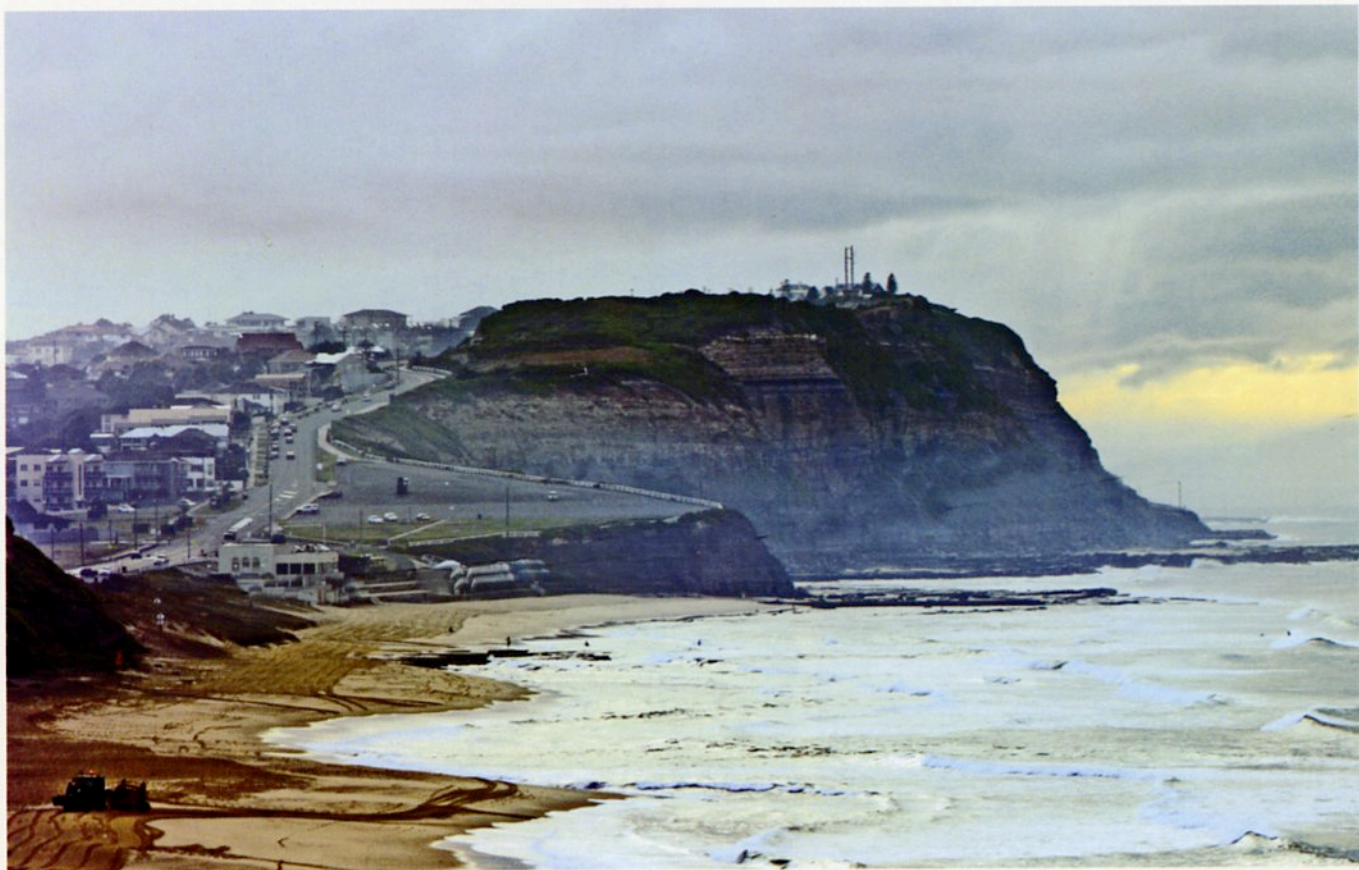
Airborne salt is a major driver of corrosion and accumulates in sheltered areas. The height above sea level can have a big influence on salt deposition as this photo of salt mist illustrates.

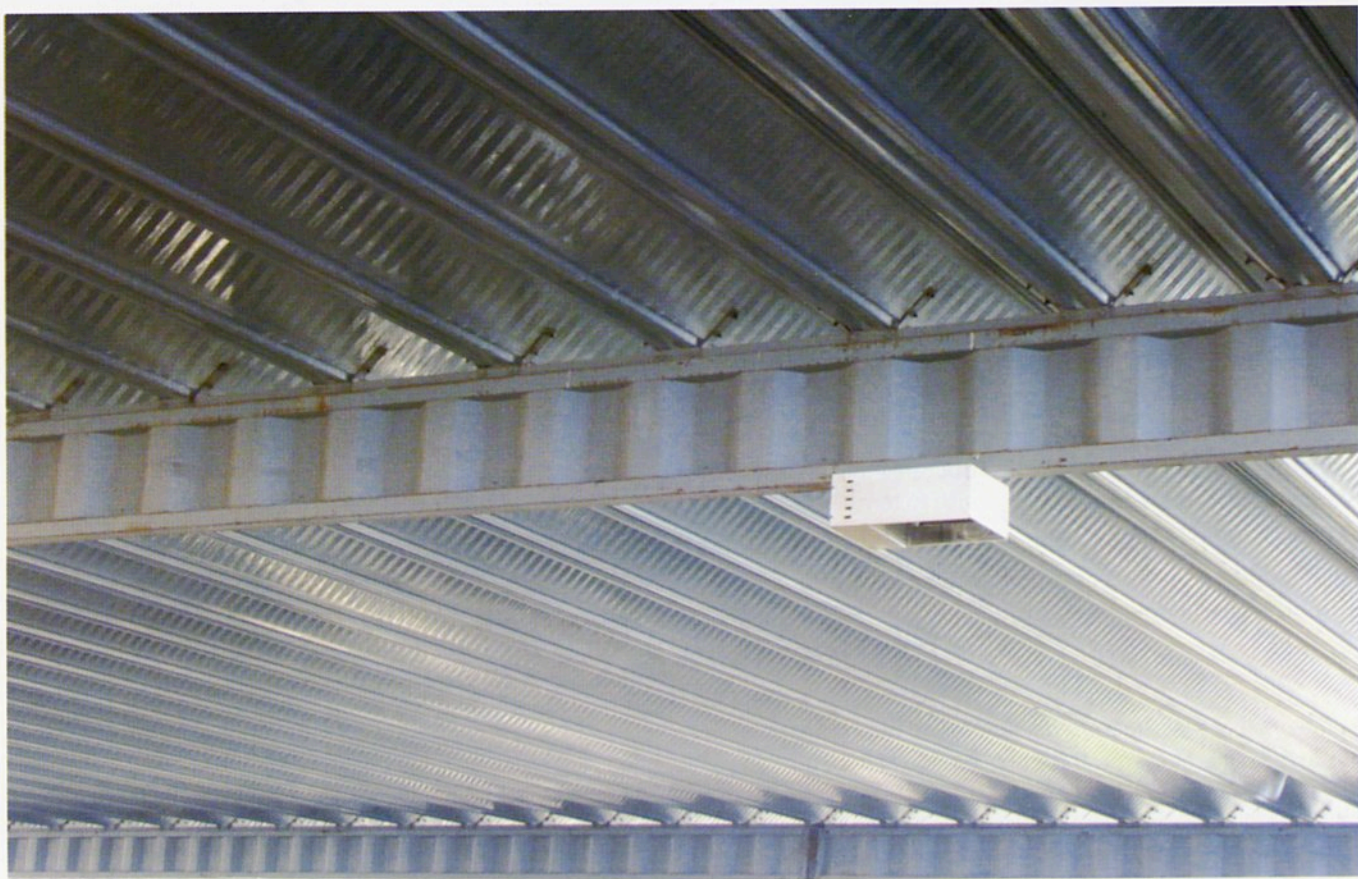
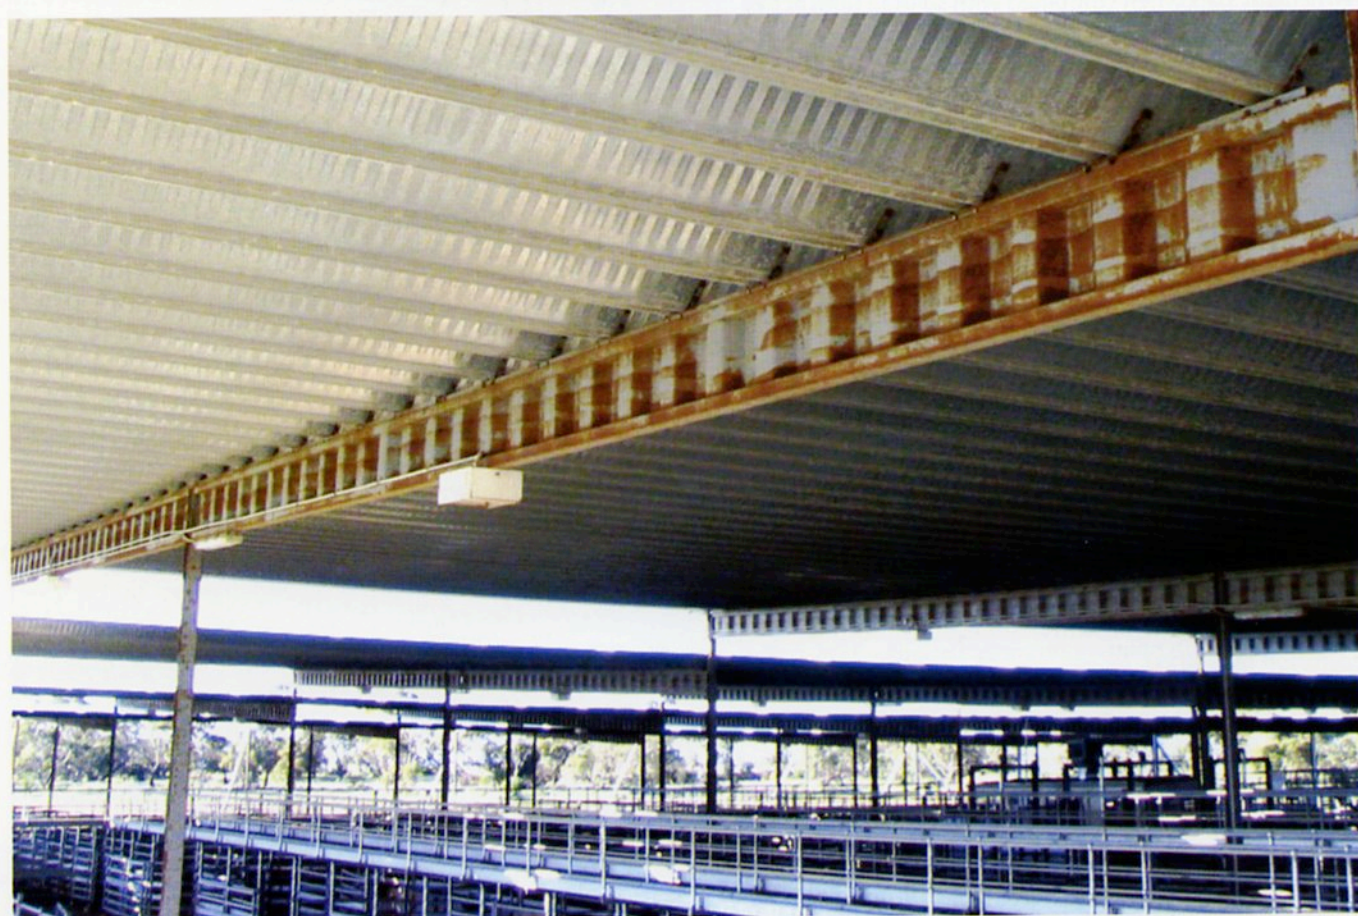
*This large open roof structure located north of Adelaide SA shows the effects of chloride induced corrosion stress after 2 years on the windward (bottom) and leeward (top) sides of the main roof beams.*

In coastal application, orientation has a dramatic influence on corrosion stress. The seaward-facing side of structures will 'cop it' while the leeward side of the same structure may have a very low level of corrosion stress on its sheltered surfaces.

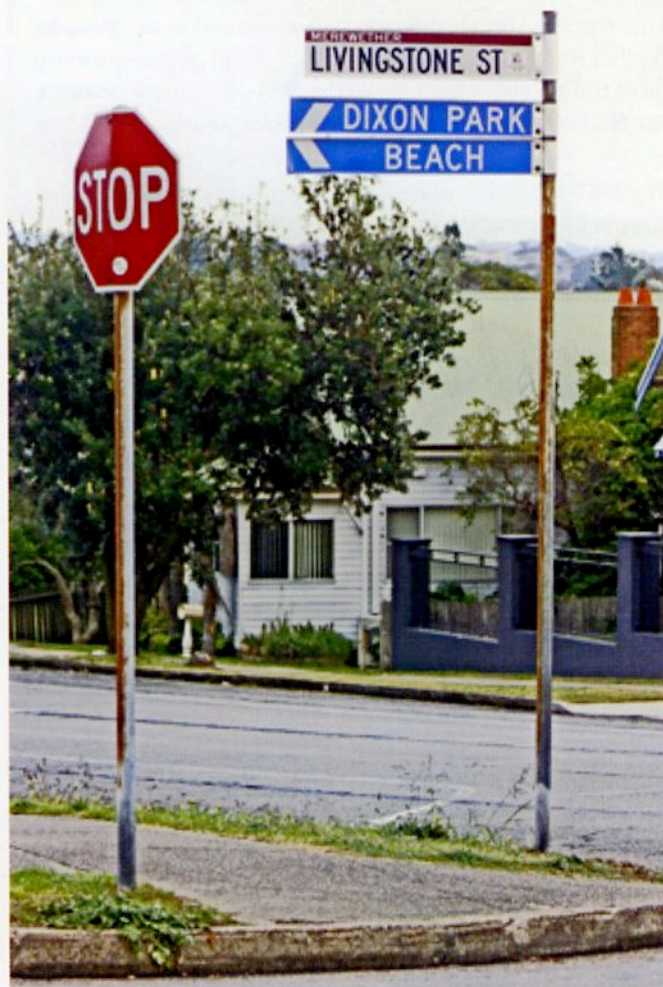
*Orientation is critical in sheltered areas. These galvanized signposts show the clearly defined corrosion stress on the rusty (southerly) side of the posts facing the ocean 400 m distant.*

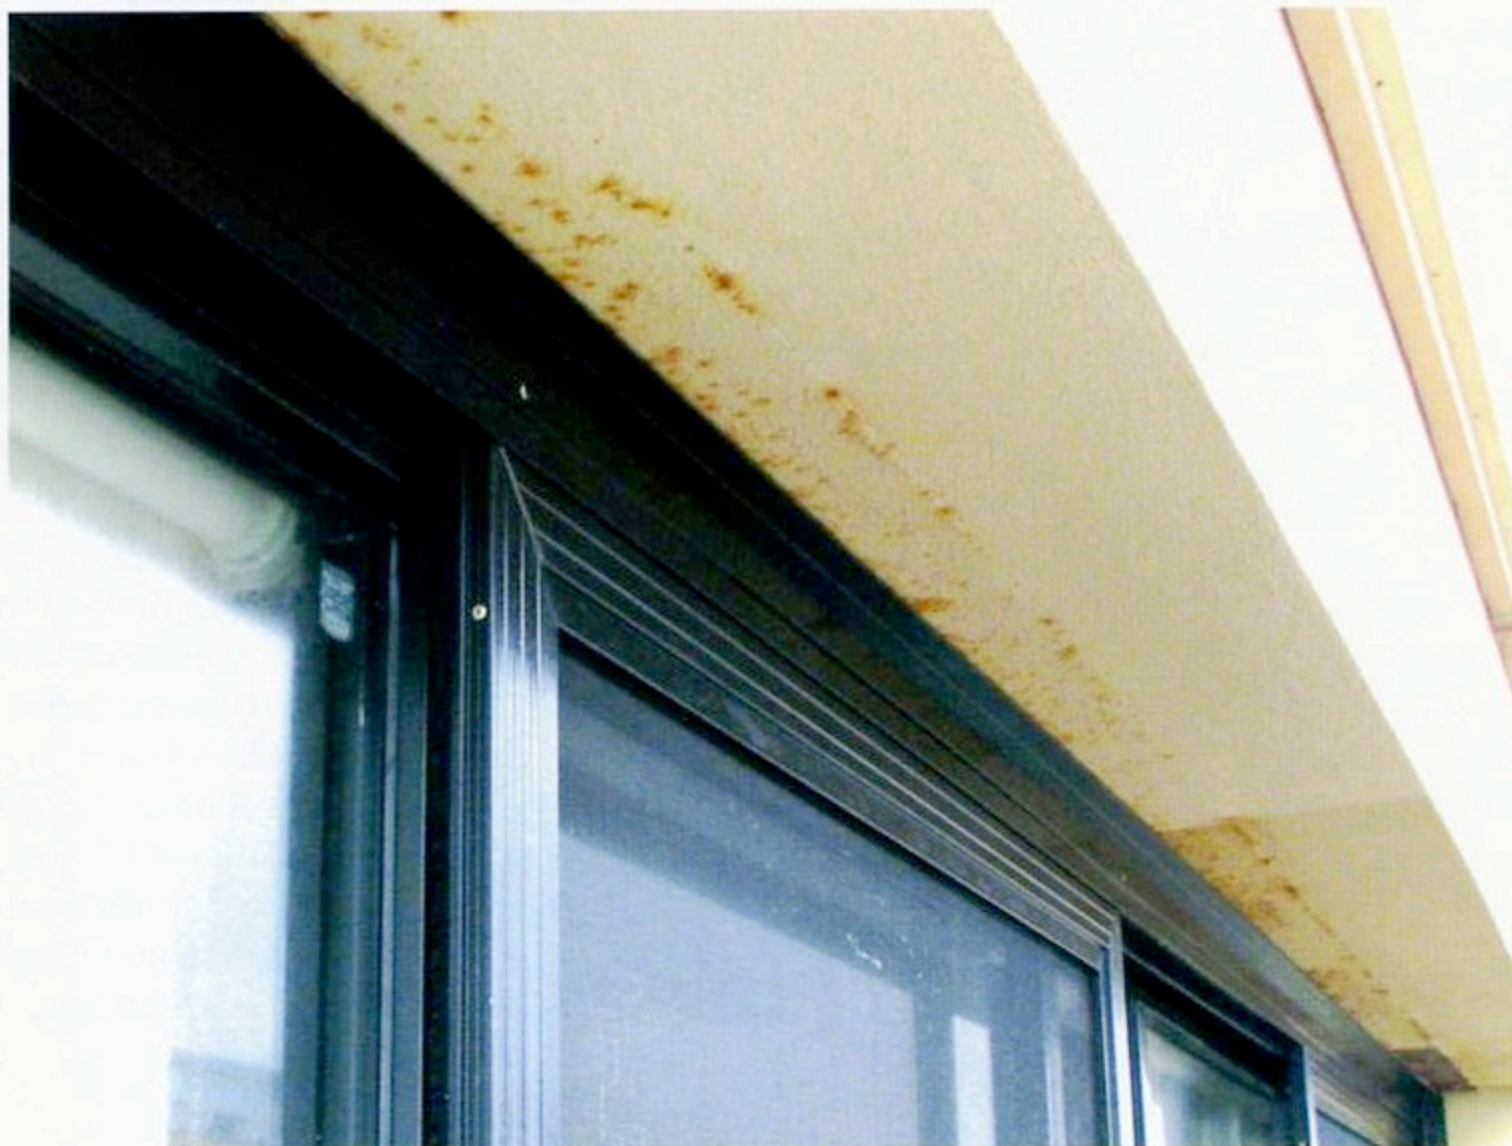
*Lintels are always in sheltered locations on building facades and need to be adequately protected, unlike this 3-year old installation - Page 14*

AS 2699.3 recognises the need for a higher level of corrosion prevention for lintels, which are invariably used in sheltered locations on the exterior of structures.

The Standard requires that for R0, R1 and R2 exposure classifications, galvanized coatings on steel lintels complying with AS/NZS 4680 or AS/NZS 4791 be used that have a minimum coating mass of 300 g/m<sup>2</sup>.
