RECYCLING OLD STEELWORK

CORROSION MANAGEMENT

May 2003

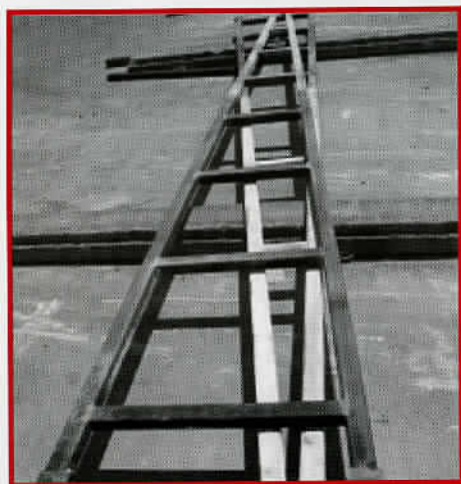
These fabricated "A" frames are ready for re-galvanizing. They have been abrasive blasted. The surface rust that forms after blasting is easily removed in the galvanizing pre-treatment.

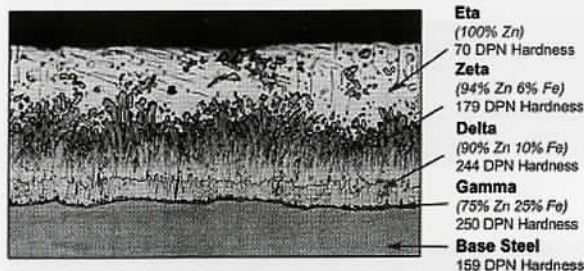
The above micrograph (over page) of a galvanized coating shows a section through a coating about

100 microns in thickness. Much of the coatings is made up of a crystalline layer of zinc-iron alloys, formed when the steel reacts with the zinc at galvanizing temperature. This reaction will not take place if the steel is dirty or rusty, and the coating will not form.

With recycled steel that has been abrasive blast cleaned, the roughness of the surface causes the steel to react more vigorously with the zinc, resulting in a heavier coating. Galvanized

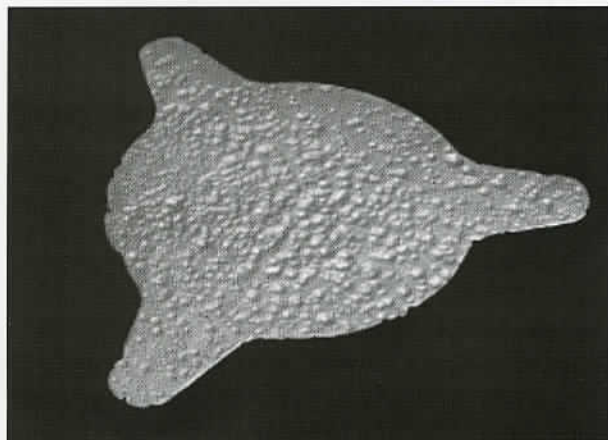
This steel cover plate has been fabricated from old 12 mm plate and hot dip galvanized. The texture of the pitting from the original badly rusted steel is easily visible. The hot dip galvanized coating is about 50% thicker than would be the case on a similar item made of new steel plate.

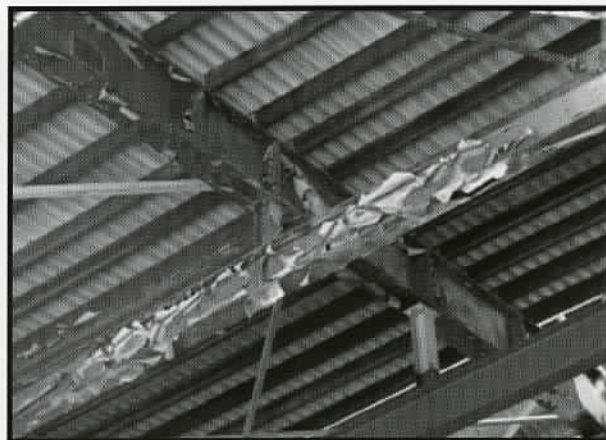
These crane monorail beams are being refurbished in the pre-treatment area of a galvanizing plant, where the original epoxy coating has failed completely. The beam at the rear has been removed, abrasive blasted, hot dip galvanized and coated with an acid-resistant chlorinated rubber paint coating.
