## DURABILITY PERFORMANCE OF COATED METAL ROOF AND WALL CLADDING

*By D J Bartlett - Victorian Manager, CTI Consultants Pty Ltd*

# CORROSION MANAGEMENT

November 2001

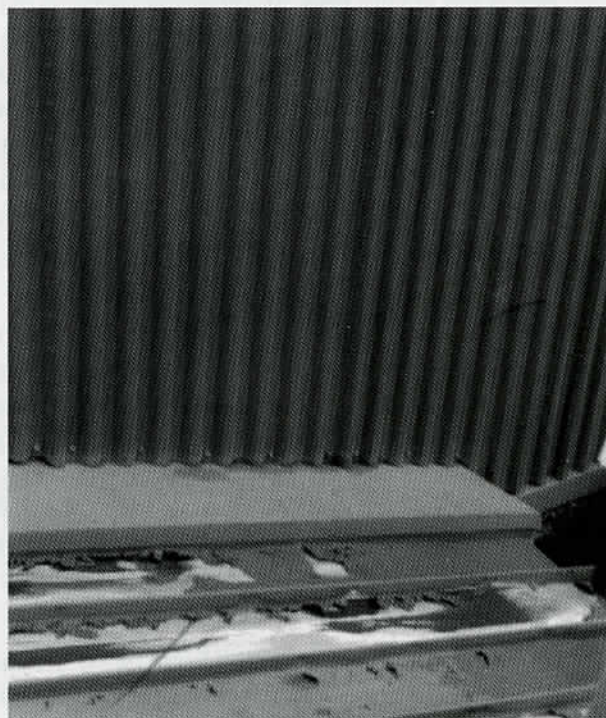
*Severe breakdown of PVC coating on horizontal surface, in contrast with sound condition of vertical sheets with cooler vertical orientation.*

Some 15 years ago a spate of dramatic failures of the material occurred in Australia, such that the coating disintegrated and rapid rusting of the base metal occurred within about 4 years. The problem only occurred with darker colored product, and on horizontal and near horizontal roofs where the underside was thermally insulated.

The failure was shown to be due to the high surface temperature reached with this combination of factors; the thermal decomposition of the PVC generated hydrochloric acid which attacked the metal substrate. Here was an example of a material, highly appropriate for one purpose, which failed catastrophically when some of the conditions were changed.

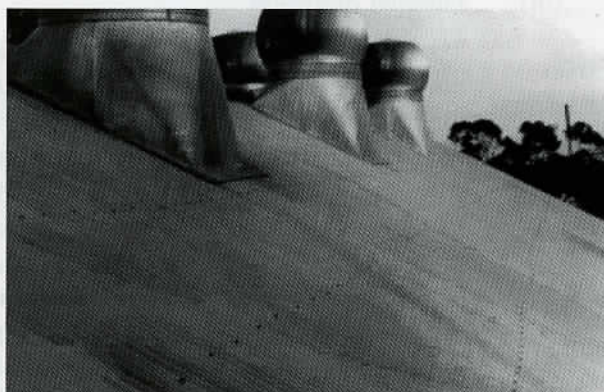
*Stainless steel roof on explosives factory; precoated steel roof proved vulnerable in the acidic service conditions.*

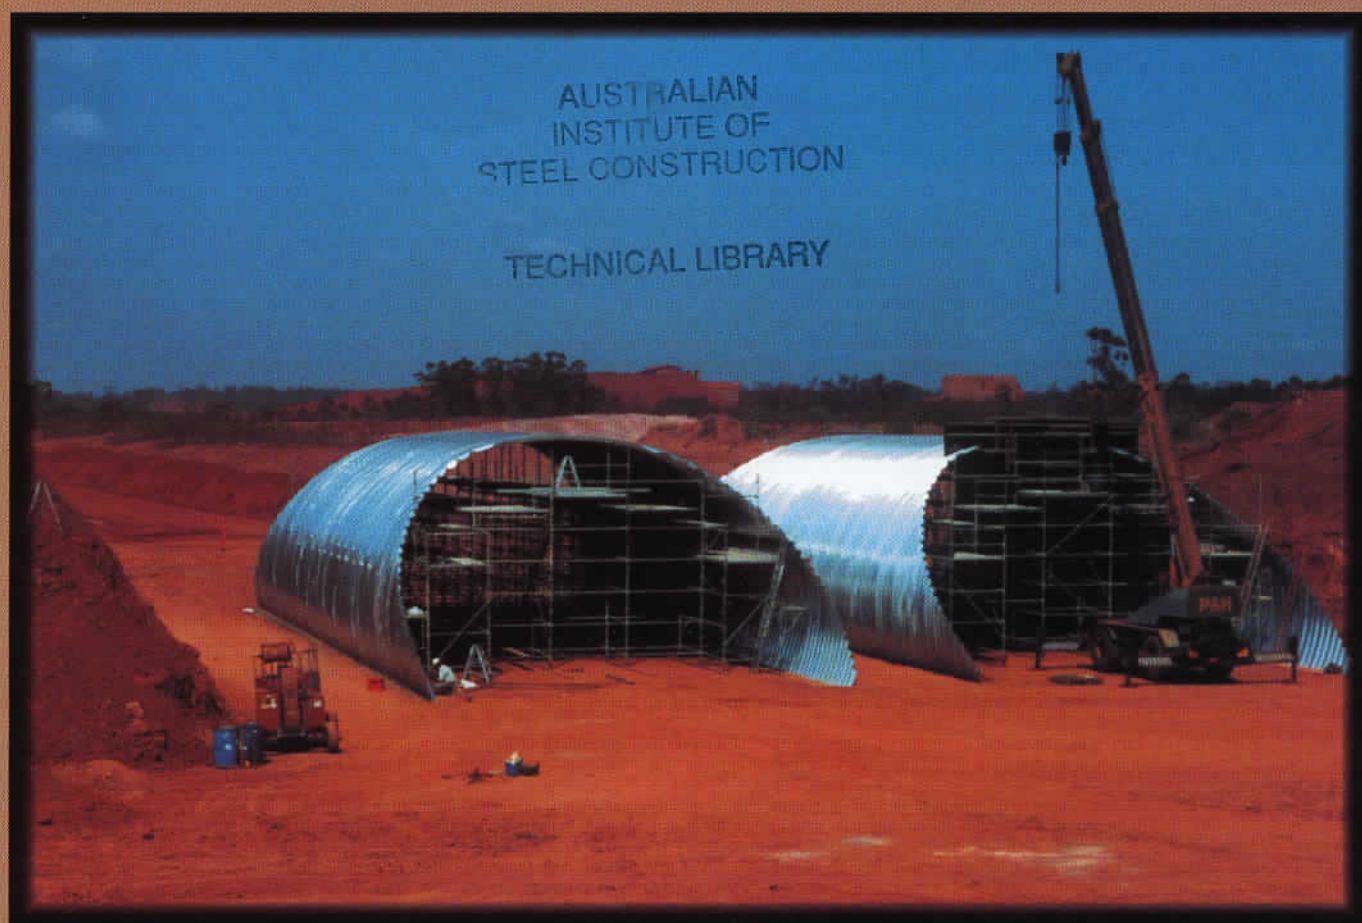
The first major SUPER\*COR installation in Australia at the Nabalco Bauxite Mine, Nhulunbuy in the Northern Territory, manufactured by Ingal Civil Products. Read more about this innovative bridging system on page 21.
