Potts Hill Pressure Tunnel Bridge

Process Engineering Technologies (PET) was engaged to design, fabricate and install a replacement truss bridge that not only looked similar to the existing Potts Hill bridge, but was compliant with today's design codes and standards. To help retain the bridge's original, heritage-listed appearance, the original painted bridge gate and intruder bars were salvaged and blasted, and corroded sections were repaired, prior to hot dipped galvanizing.

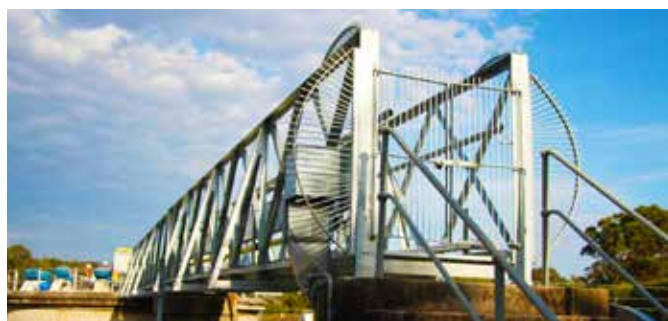
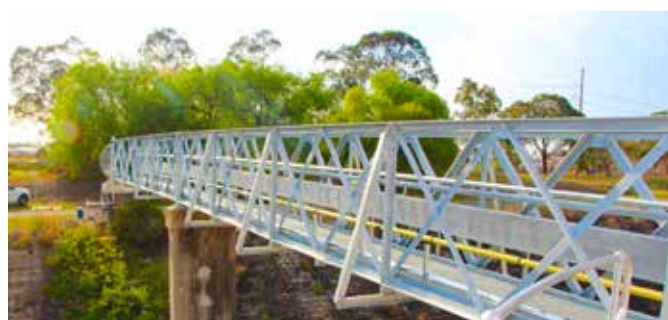
To ensure that the 12.3m long truss frames could be galvanized using a single dip process, the stabilising members on the exterior of the truss frame (a feature designed to maintain the historical appearance of the bridge) were

removed during the galvanizing process. This required the installation of temporary cross bracing inside the frames during transportation and lifting. The stabilising members were then bolted onto the outside of the truss prior to installation, and the temporary cross bracing was removed.
