38 - LIQUID METAL ASSISTED CRACKING OF GALVANIZED STRUCTURAL STEEL SECTIONS

01 - SPECIFIERS MANUAL – THIRD EDITION

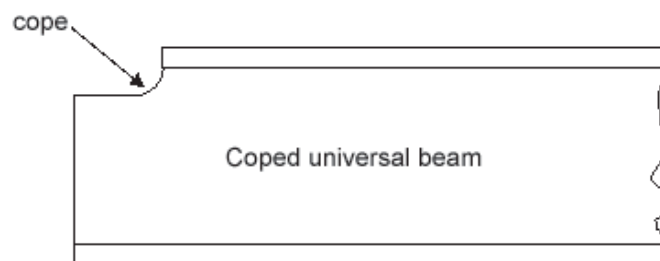
The illustration below shows a cope detail on a universal beam. Copes are oxy cut, usually in two operations. The first cut removed the top flange and a section of the web. The second operation cuts the cope radius and removes the remaining section of the web.
