Damage investigation of buildings at Minjilang, Cape Don and Smith Point in NT following Cyclone Ingrid

Report: TR50 September, 2005

TECHNICAL REPORT NO. 50

By David Henderson and Cam Leitch

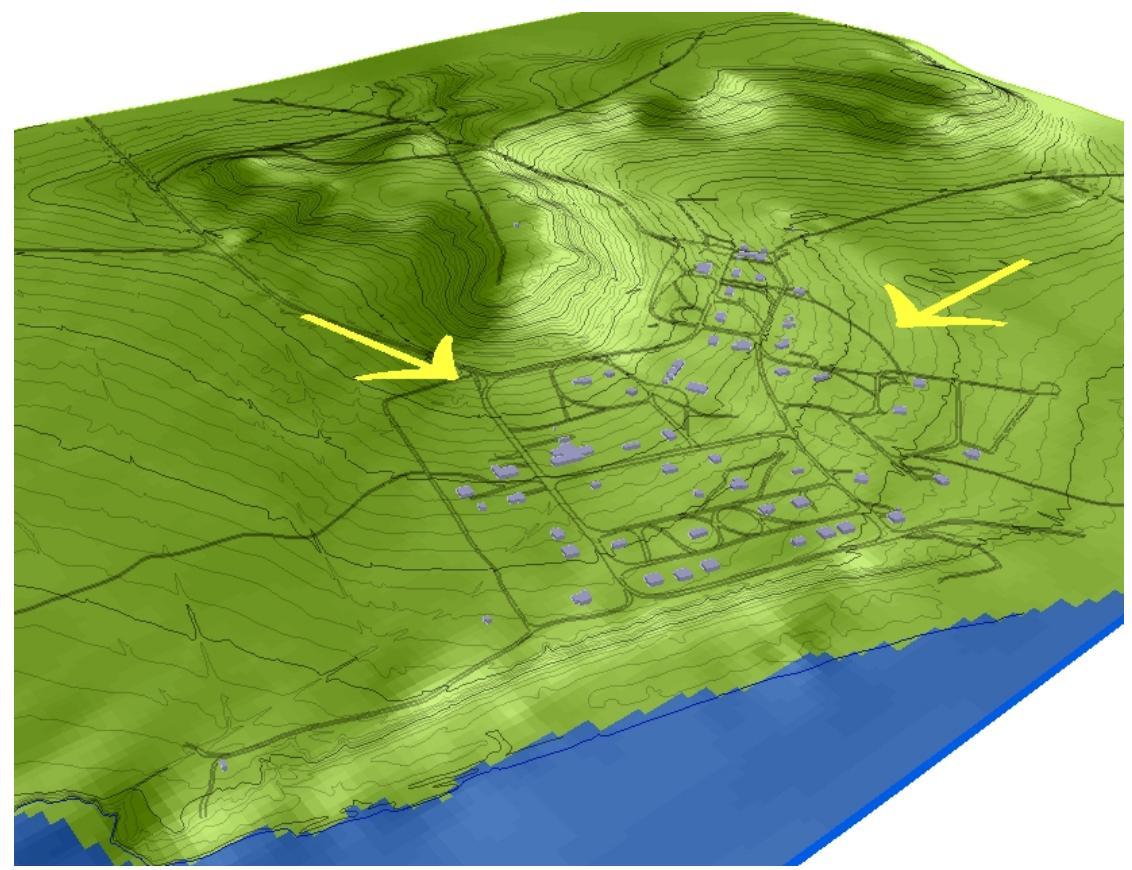
As shown in Figure 7 the 54 m high hill lying to the West provided some shielding from the Westerly winds for the older houses and workshop building in the North of the town. For the Northerly winds, roughly a third of the houses were provided with some form of shielding from neighbouring houses.

Figure 7: WSW and N wind directions impacting on Minjilang

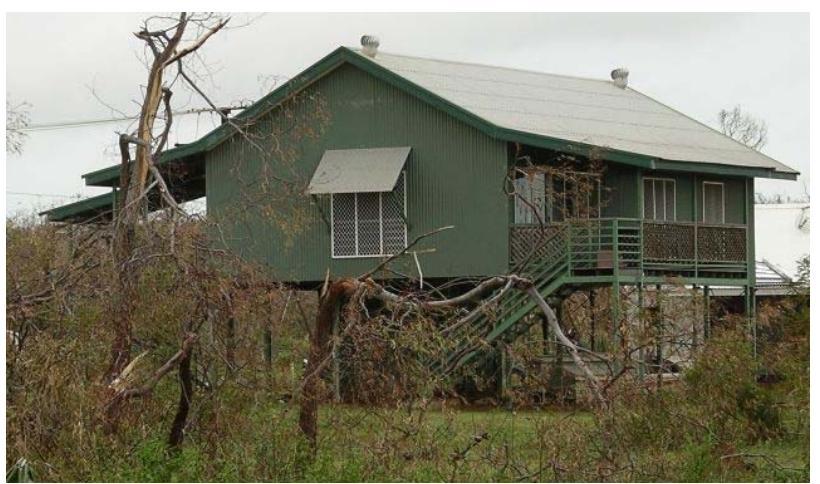
Typically housing that was constructed in the past 10 to 15 years survived with minimal structural damage from wind loads observed (Figure 9 and Figure 10). Impact from wind driven debris, fallen trees, flashing loss (Figure 11) and soffit loss was noted.

Figure 9: Recent construction

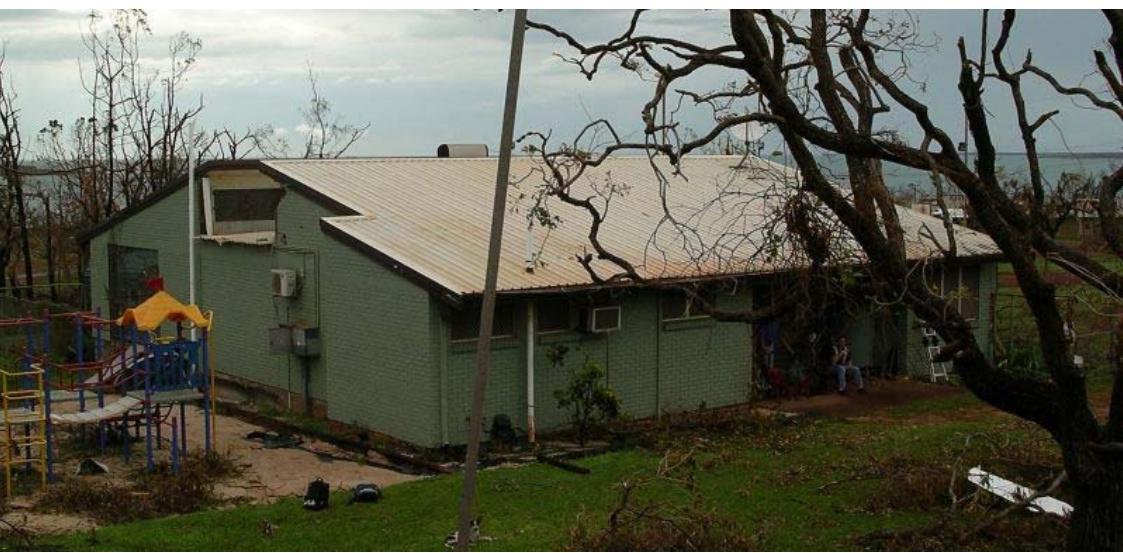
The brick single storey early childhood centre (Figure 22) acted as a shelter for some of the residents including teaching staff. Although structurally withstanding the severe wind forces, we were advised that the water ingress added to the trauma of the situation. Minor structural damage was observed;

- loss of some flashings,
- damage to the brick skin adjacent to a gable truss end where a satellite dish was attached, and

- damage to polycarbonate cladding which was adding some wind and water protection along the central glass louvred skylight.

Figure 22: Early childhood building

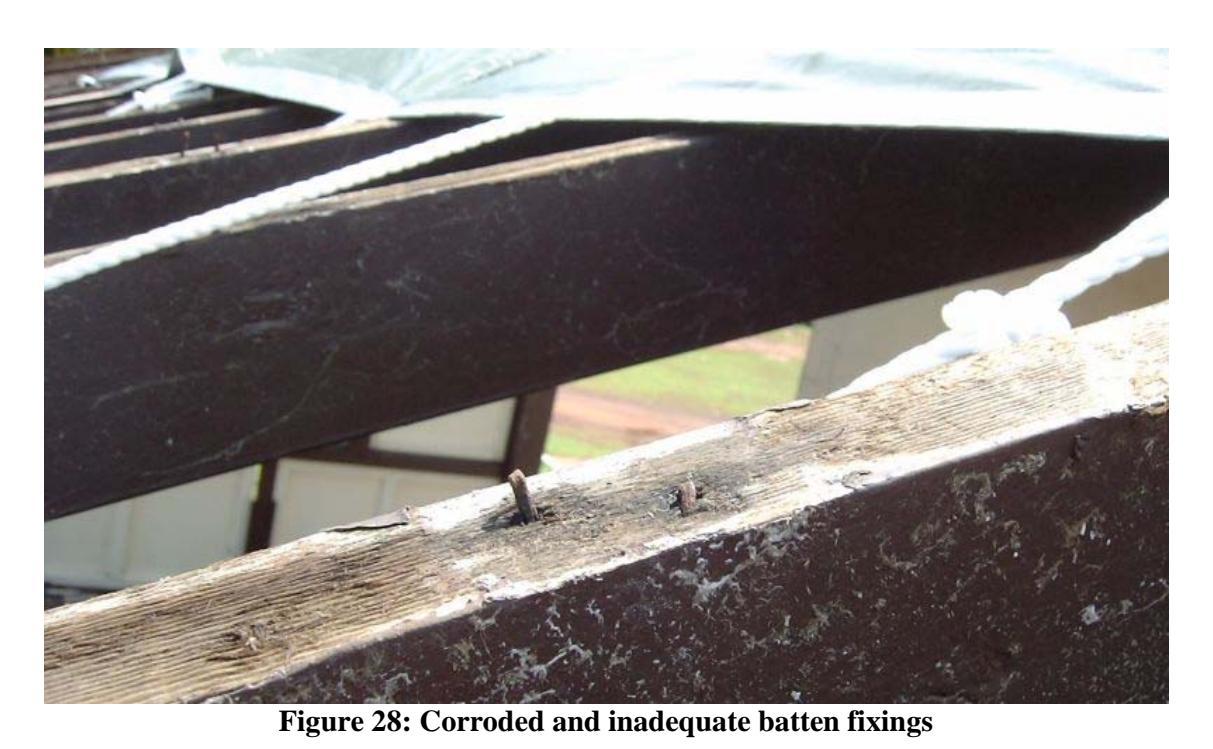
The guest lodge suffered major loss of roof cladding (Figure 27). Some of the screws fixing the corrugated asbestos cement cladding had corroded. Severe corrosion was also noted in the batten fixings and rafter connections (Figure 28). It was advised that the cleanup and removal of the asbestos cladding was going to be a major undertaking (Figure 29).

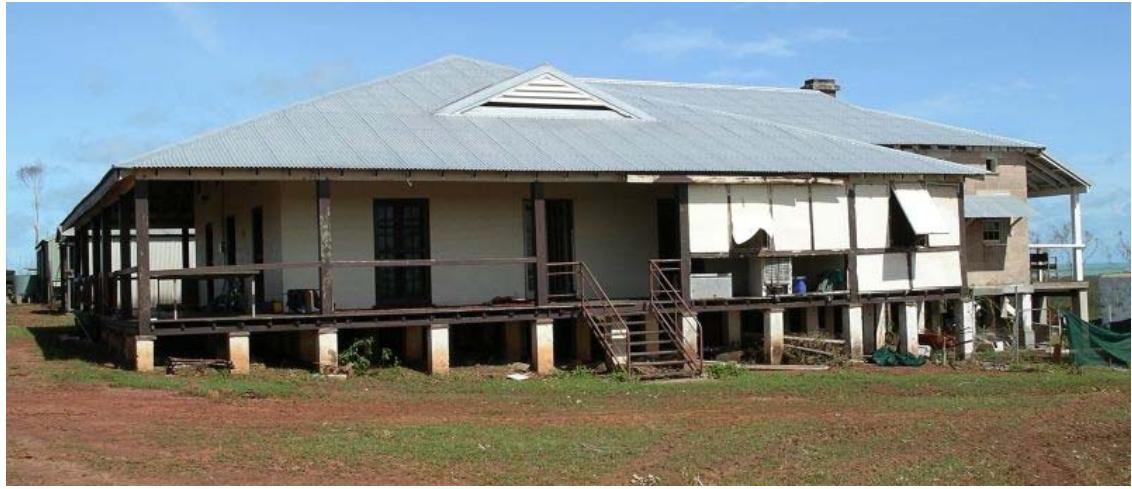
In comparison, the retrofitted staff lodge suffered no loss of roof cladding (Figure 30). Corrugated metal roof cladding was screw fixed with cyclone assemblies to timber battens at nominally 600 mm centres. The battens were strapped to nominally every second rafter (Figure 31). The rafters were spaced at nominally 450 mm centres. The loss of fascia, guttering and damage to some awning cladding was observed.

Figure 30: New roof on staff lodge

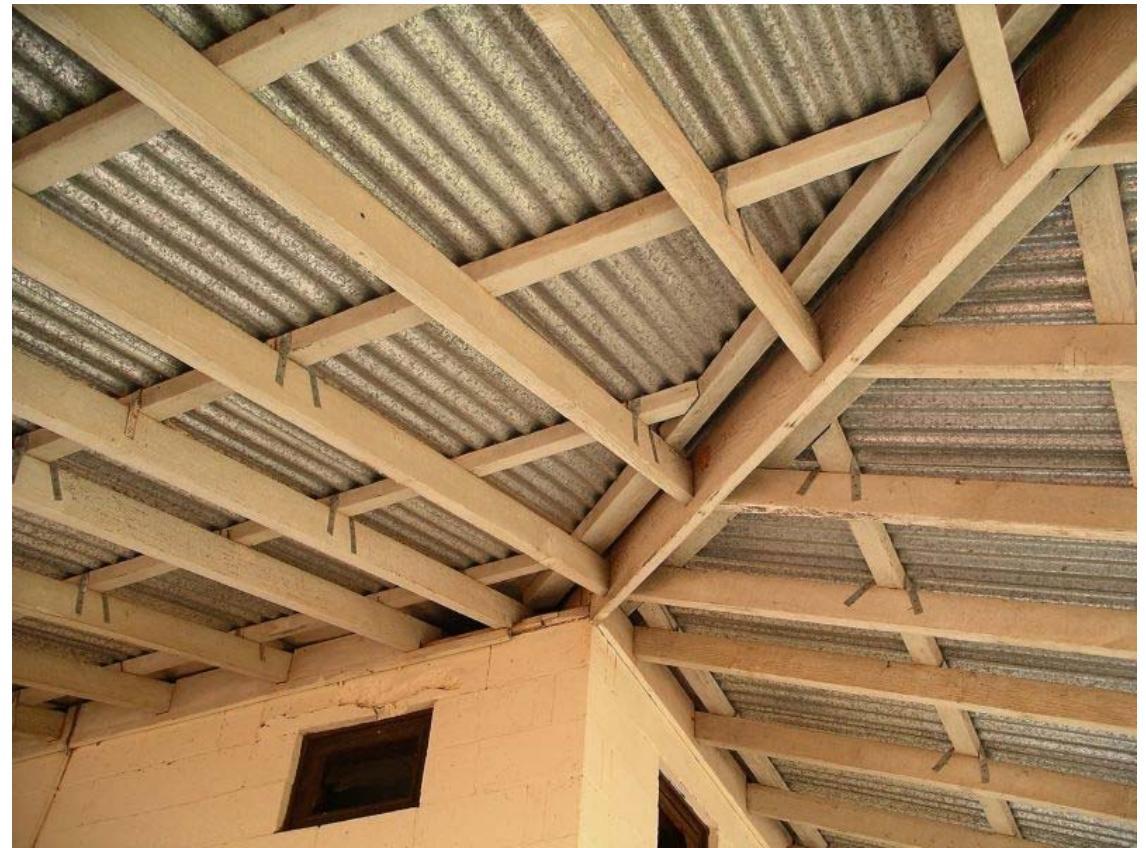
Figure 31: New batten straps on staff lodge
