Tropical Cyclone George Damage to buildings in the Port Hedland area

Report: TR52 April, 2007

TECHNICAL REPORT NO. 52

Authors: G. Boughton, and D. Falck (TimberED Services, Perth)

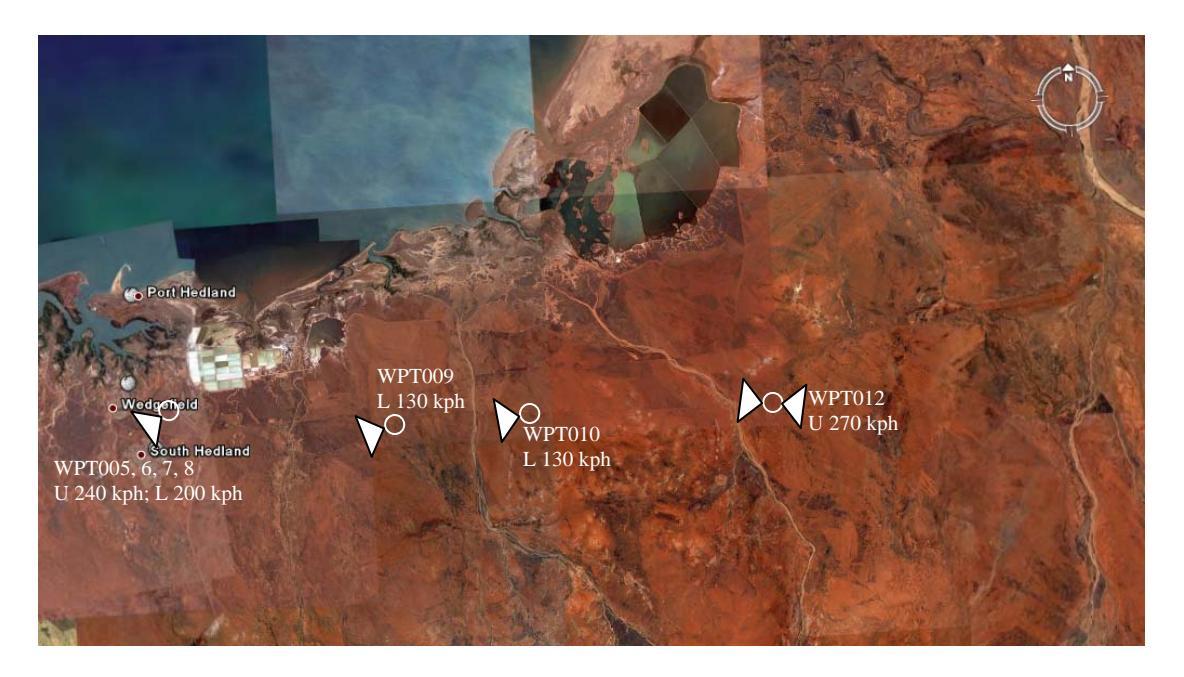
A number of road signs were examined during the study, and from these several were selected as providing the most reliable wind speed information. Figure 2.4 shows a map indicating locations of road signs selected for analysis, corresponding lower (L) or upper (U) wind speeds at 10 m height in terrain category 2, in kph, and the approach direction. The approach direction is shown as a triangle. The legs of the triangle show the wind direction for which the pressure coefficient used is valid. It represents a range which for most signs was from South to West – the range of directions as the eye wall passed Greater Port Hedland.

The wind speed calculated for South Hedland was in the range 200 to 240 kph. As the lower bound sign had just established plastic hinges, it was assumed that the peak gust was close to the lower bound speed -200 kph or 55 m/s.

The wind speed calculated for the eye wall region – near Tabba Tabba Cr was in the range 130 kph to 270 kph (36 to 75 m/s). It is suggested that the likely speed was near to the top of that range from relating vegetation damage between Tabba Tabba Ck and the Strelley R to the damage in Greater Port Hedland.

Figure 2.4: Location of road signs used for wind speed assessment (Background from Google Earth)

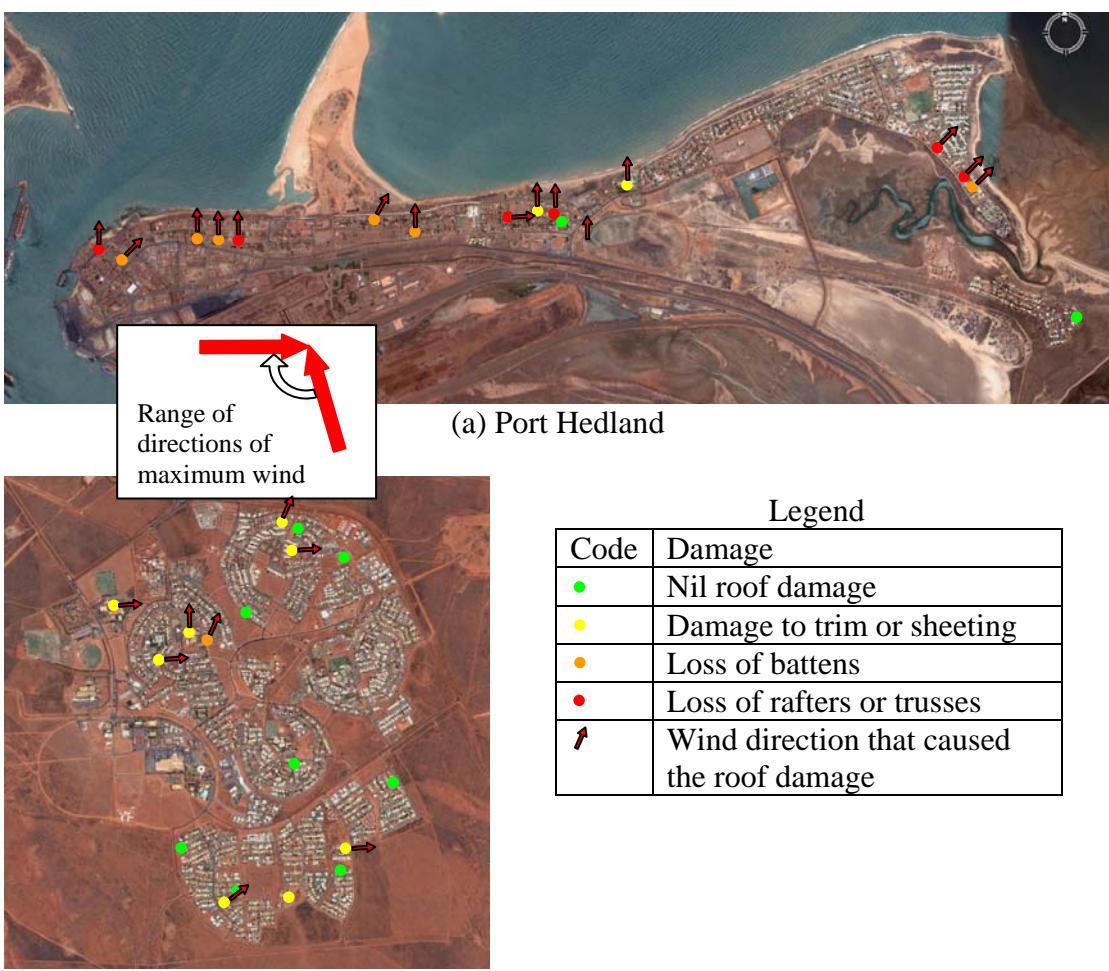
Figure 4.1 shows the extent of roof damage of the buildings inspected in Port Hedland and South Hedland. There seems to be little concentration of damage, and the worst damage appears to be in Port Hedland where buildings are generally older.

(b) South Hedland Figure 4.1: Roof damage on buildings inspected

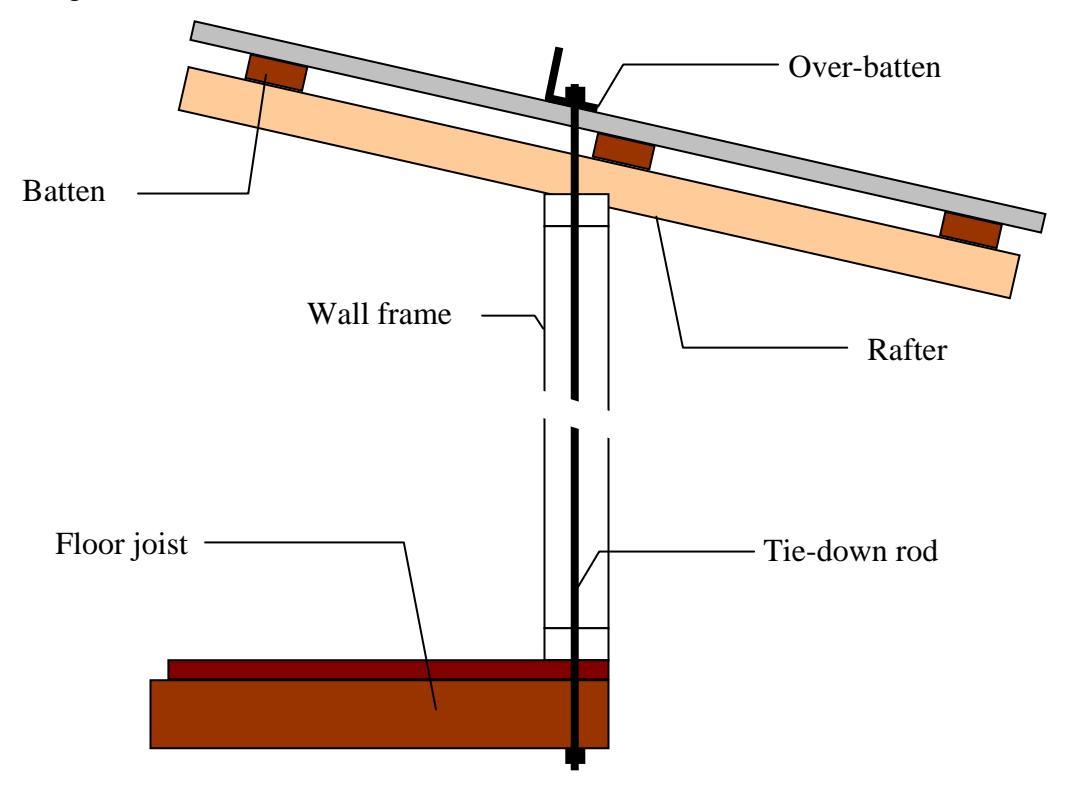
galvanised equal angle that sits on top of the roofing. It is connected to the floor structure by heavy bolts that pass by the battens and rafters, through the top wall plate and within the wall frame, through the bottom plates to the underside of the floor joists. Figure 4.4 shows a section that illustrates the system. The over-batten secures the battens and the rafters at the line of the external wall.

Figure 4.4: Over-batten in original configuration

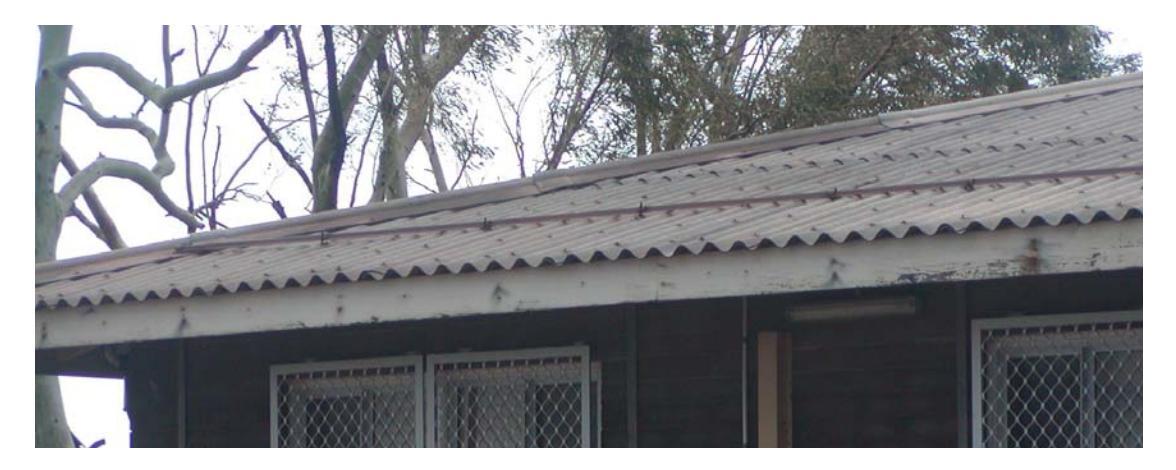
Figure 4.6 shows the same system used over a fibre-cement roofing system. Here the over-batten is smaller, and the anchorages are closer together.

Figure 4.6: Over-batten on fibre-cement sheeting

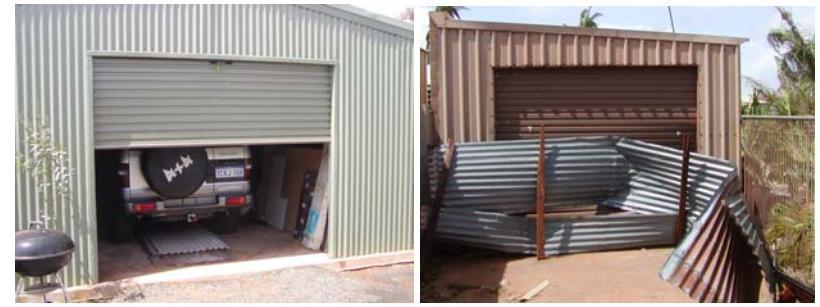
Roller doors were rarely used in house garages with carports the favoured shelter. Two exceptions were seen, and both of these doors were undamaged and operational. They are shown in Figure 4.19(b). Neither had been fitted with any special anchorages.

(b) Undamaged Domestic roller doors Figure 4.19: Roller and sliding doors
