Shoalwater and Roleystone WA tornadoes  
Wind damage to buildings

Report: TR54  
August, 2008

**TECHNICAL REPORT NO. 54**

Authors: G. Boughton (TimberED Services, Perth)  
D. Falck (TimberED Services, Perth)

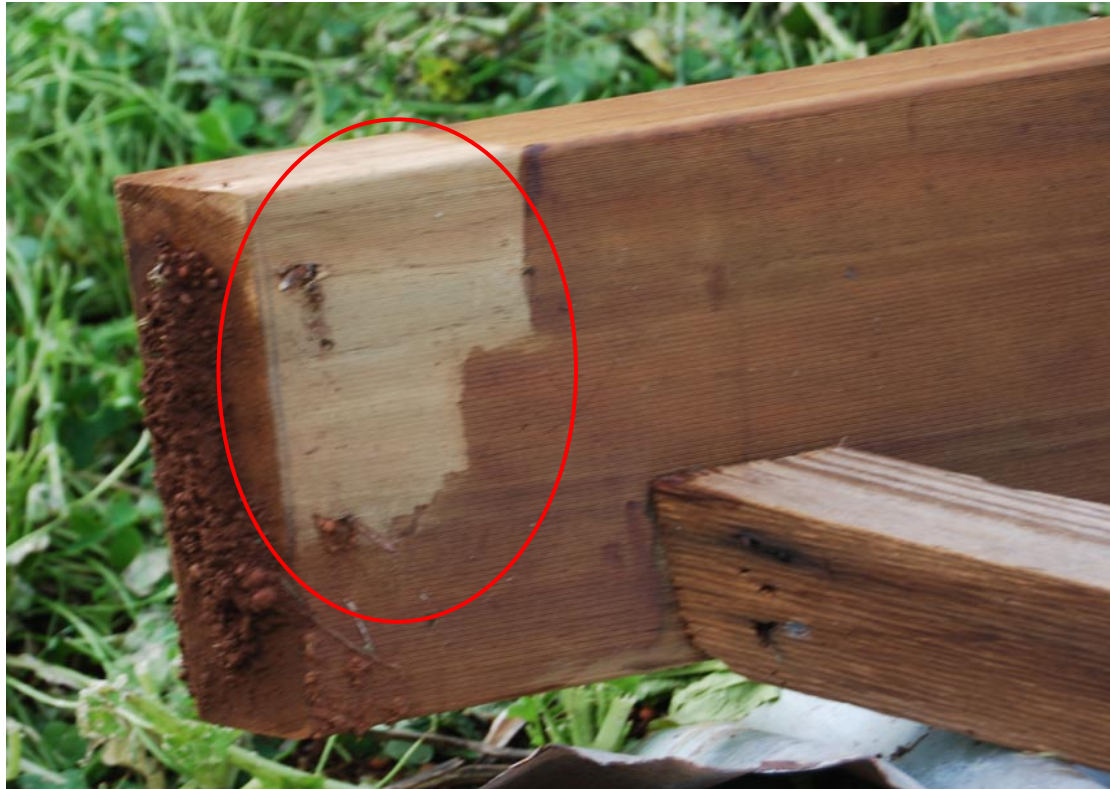
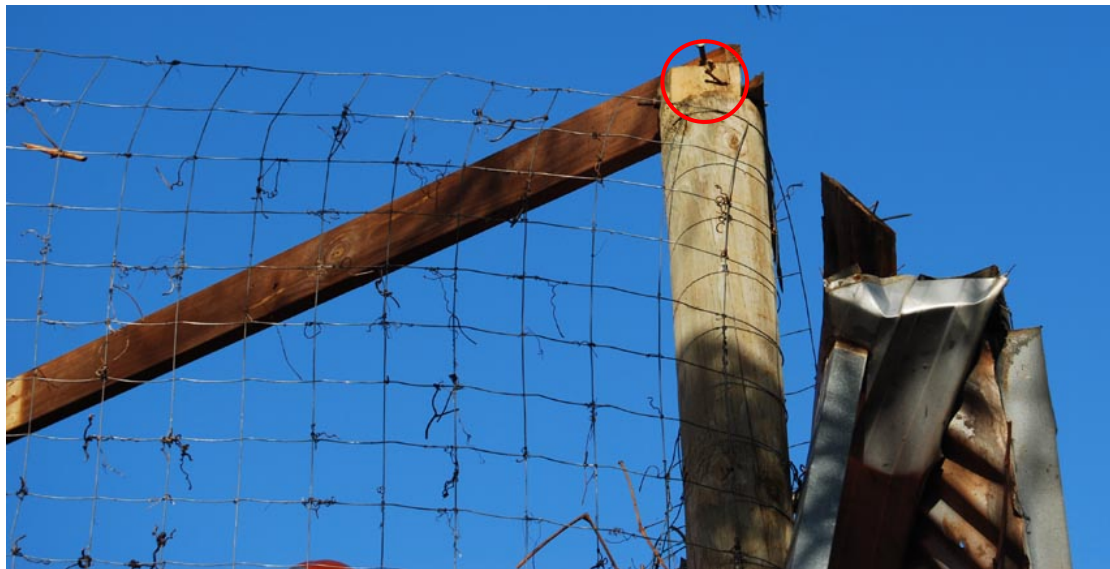
**Figure 5.2 Verandah beam to post connection**

Figure 5.2 shows a verandah beam to post connection that failed under wind load leading to loss of both the verandah and main roofs. This connection was made with two nails, but two M16 bolts are specified in AS1684.2 [5].

(a) Verandah beam

(b) Verandah post

The information required to correctly select and apply this detail is outlined in AS1684.2 [5]:

- The wind classification of the house is found from AS4055 [2].
- Table 9.13 in AS1684.2 [5] can be used to select a force from the roof type, wind classification, roof load width, and spacing between beam to post connections.
- Table 9.20 in AS1684.2 [5] can be used to select appropriate connections to resist wind uplift forces.
