PERFORMANCE OF HOT DIP GALVANIZING IN COASTAL ENVIRONMENTS: A REVIEW

A. Sheehan¹

¹Galvanizers Association of Australia, Melbourne

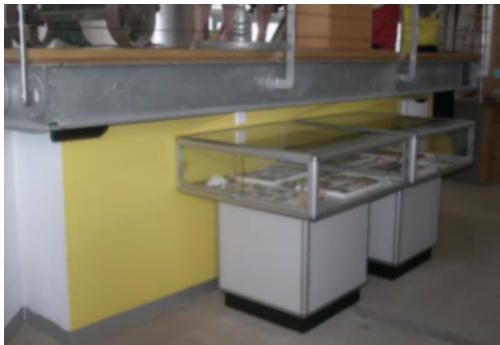
Figure 10 Galvanized beam supporting inside decking of the Maritime Discovery Centre

The average coating thickness of the structural steel from the first study was stated as 2 to 3 times (160-220 μm) the required level of AS/NZS 4680[1]. During this visit, the galvanizing thickness was measured in various locations around the Discovery Centre, both inside and out. Average coating thicknesses ranged from 111 μm to 206 μm on various galvanized items (See the Appendix for details). The spread of coating thickness measurements on the various steel items can be seen in Figure 12. The coating thicknesses of the galvanizing were still well above the required minimums in AS/NZS 4680 for the different steel thicknesses present in the structure.

Based on this data, the existing coating thickness will protect the steel from corrosion for approximately a further 15 to 30 years prior to the need for maintenance, affording an estimated total of 30 to 50 years of protection for the main structure.

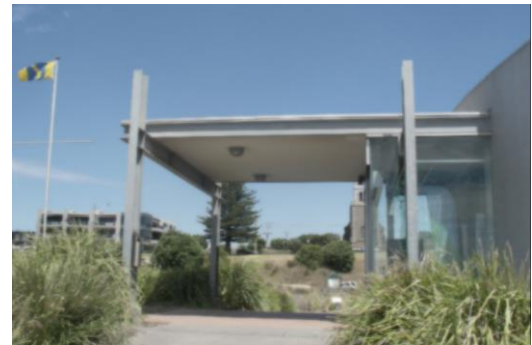
Figure 11 Hot dip galvanized beams hold up the entrance to the Centre

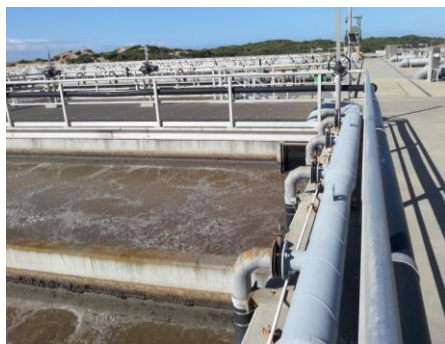
Figure 13 Black Rock Water Reclamation Plant primary settling tank

At the time of the previous case study most of the steelwork had been installed for around 10 to 15 years and was stated to be performing above expectations in a H_2S and chloride environment [1], but no thickness measurements were published. On the return visit to the reclamation plant, numerous coating thickness measurements were taken around the plant. Items measured included the pipes carrying air beside the tanks (Figure 14) and a section underground (Figure 16), stairs (some duplex, some bare galvanizing) (Figure 17), machine cages and other, more recently installed, structural members. The spread of coating thickness measurements on the various hot dip galvanized items are shown in Figure 18. The average coating thicknesses ranged from $70\mu m$ to $185\mu m$ with many over $150\mu m$. For a table of the average coating thicknesses on the items see the Appendix.

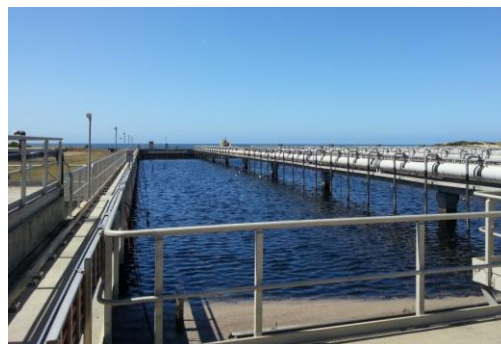
Figure 14 Black Rock aeration tank with the ocean below the horizon

In addition to the remaining large coating thicknesses measured on the galvanized steel, in most areas there were little to no signs of corrosion. This can be attributed in part to good material selection and design. The pipes delivering air into the aeration tanks use both hot dip galvanizing and stainless steel for the exposed and immersed sections respectively. In order to prevent bimetallic corrosion, a neoprene sleeve is used to electrically isolate the two metals and provide a connection between them (Figure 15). In the locations closer to the relatively raw sewage and H₂S sources, such as the filtration area and the primary settling tanks (Figure 13), there was more evidence of corrosion, with some lightly rusted areas. On the whole, after nearly 20 years or more in service, the hot dip galvanized coatings have performed fittingly and will continue to perform their purpose in this environment for many years to come.

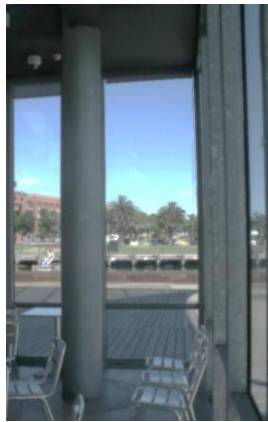
Figure 21 Corner of Pavilion showing hot dip galvanized column and mullions

The Carousel Pavilion had been open for 6 years when the last case study was performed and the steelwork was said to be in excellent condition, with all of the galvanizing being 2 to 3 times in excess of the levels required by AS/NZS 4680 [1]. A further 6 years, 12 years in total, and the hot dip galvanized coating, although weathered to a dull grey and accumulating dirt in some of the higher areas of the structure, is still performing with no signs of coating degradation. The average coating thicknesses measured were between $72\mu\text{m}$ and $233\mu\text{m}$ on steel items of varying thicknesses. (Refer to Appendix for details.) This indicates a life to first maintenance of 25 – 50 years for the structural elements of the Pavilion. The spread of coating thickness measurements on the various steel items can be seen in Figure 24.

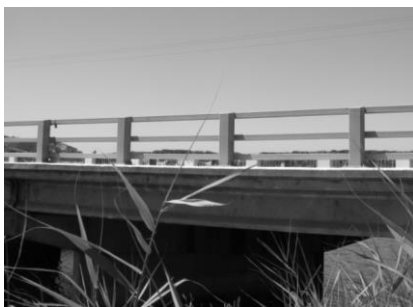
The average measured coating thickness on the bridge rails were mostly still well above the required minimum average coating thickness stated in AS/NZS 4680. The average coating thickness on the bare galvanized rails ranged from 83µm to 224µm, with base plate thicknesses from 126µm to 333µm and the thickness of duplex painted rails were between 184µm to 348µm. See the Appendix for details on average coating thicknesses. Figure 28 shows the spread of coating thickness measurements for the bare galvanizing items and Figure 29 shows the spread of measurements for the duplex coated items.

Figure 25 Painkalac Creek bridge rails

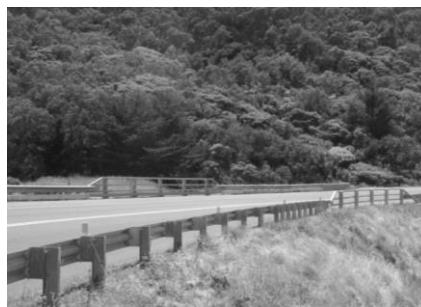
Figure 26 Reedy Creek bridge rails and road safety barriers

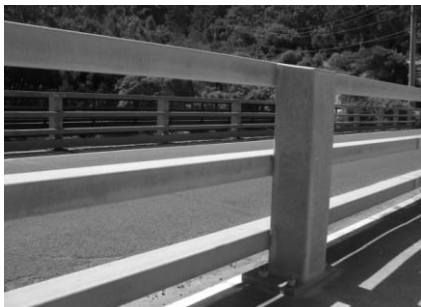
The rails examined were generally located approximately 100m to 1km from the breaking surf on the coastline and many were over estuarine waters. Due to their close proximity to the ocean, many of the rails were encrusted in salt deposits or had developed a rough patina (Figure 33). Some of the rails had been cut or welded after galvanizing and subsequently repaired with a zinc rich paint. Some of the repairs were performing with no rust visible, some looked to have been re-coated (Figure 27) and others showed visible signs of rust. Where the rails had been designed without the need for welding or cutting after galvanizing, such as when bolted connections were used (Figure 32), there were little to no signs of rusting.

Figure 30 Wye River bridge rails and post with bolted base plate

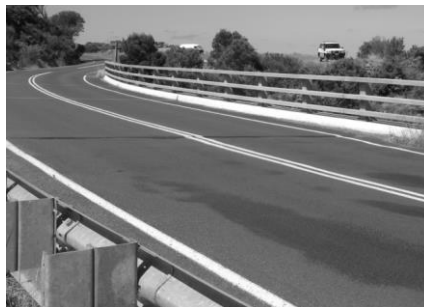
Figure 31 Kennett River bridge rails and safety barrier

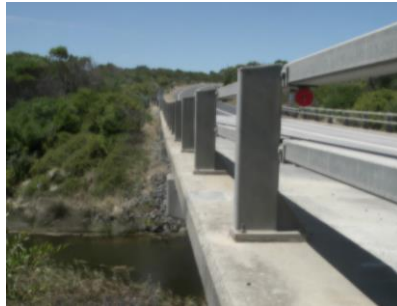
The local road authority has a general life expectancy for rails of 20 years with minimal maintenance [1]. Some of the rails inspected are 15 or more years old and most are still in a reasonable condition, indicating they will achieve their expected life and more than likely surpass it by many more years.

Figure 37 Sherbrooke River bridge rails, posts and base plates

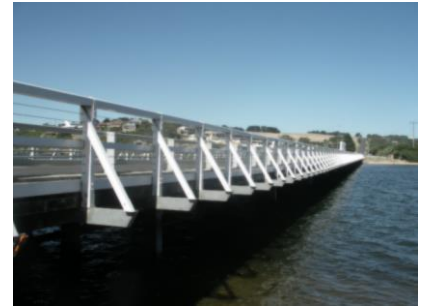
Figure 38 Hopkins River hot dip galvanized structural
