GALVANIZED COATING PROBLEMS & SOLUTIONS

INTRODUCTION

This article examines some of the common causes and effects of galvanized coating defects and variations, along with possible solutions.

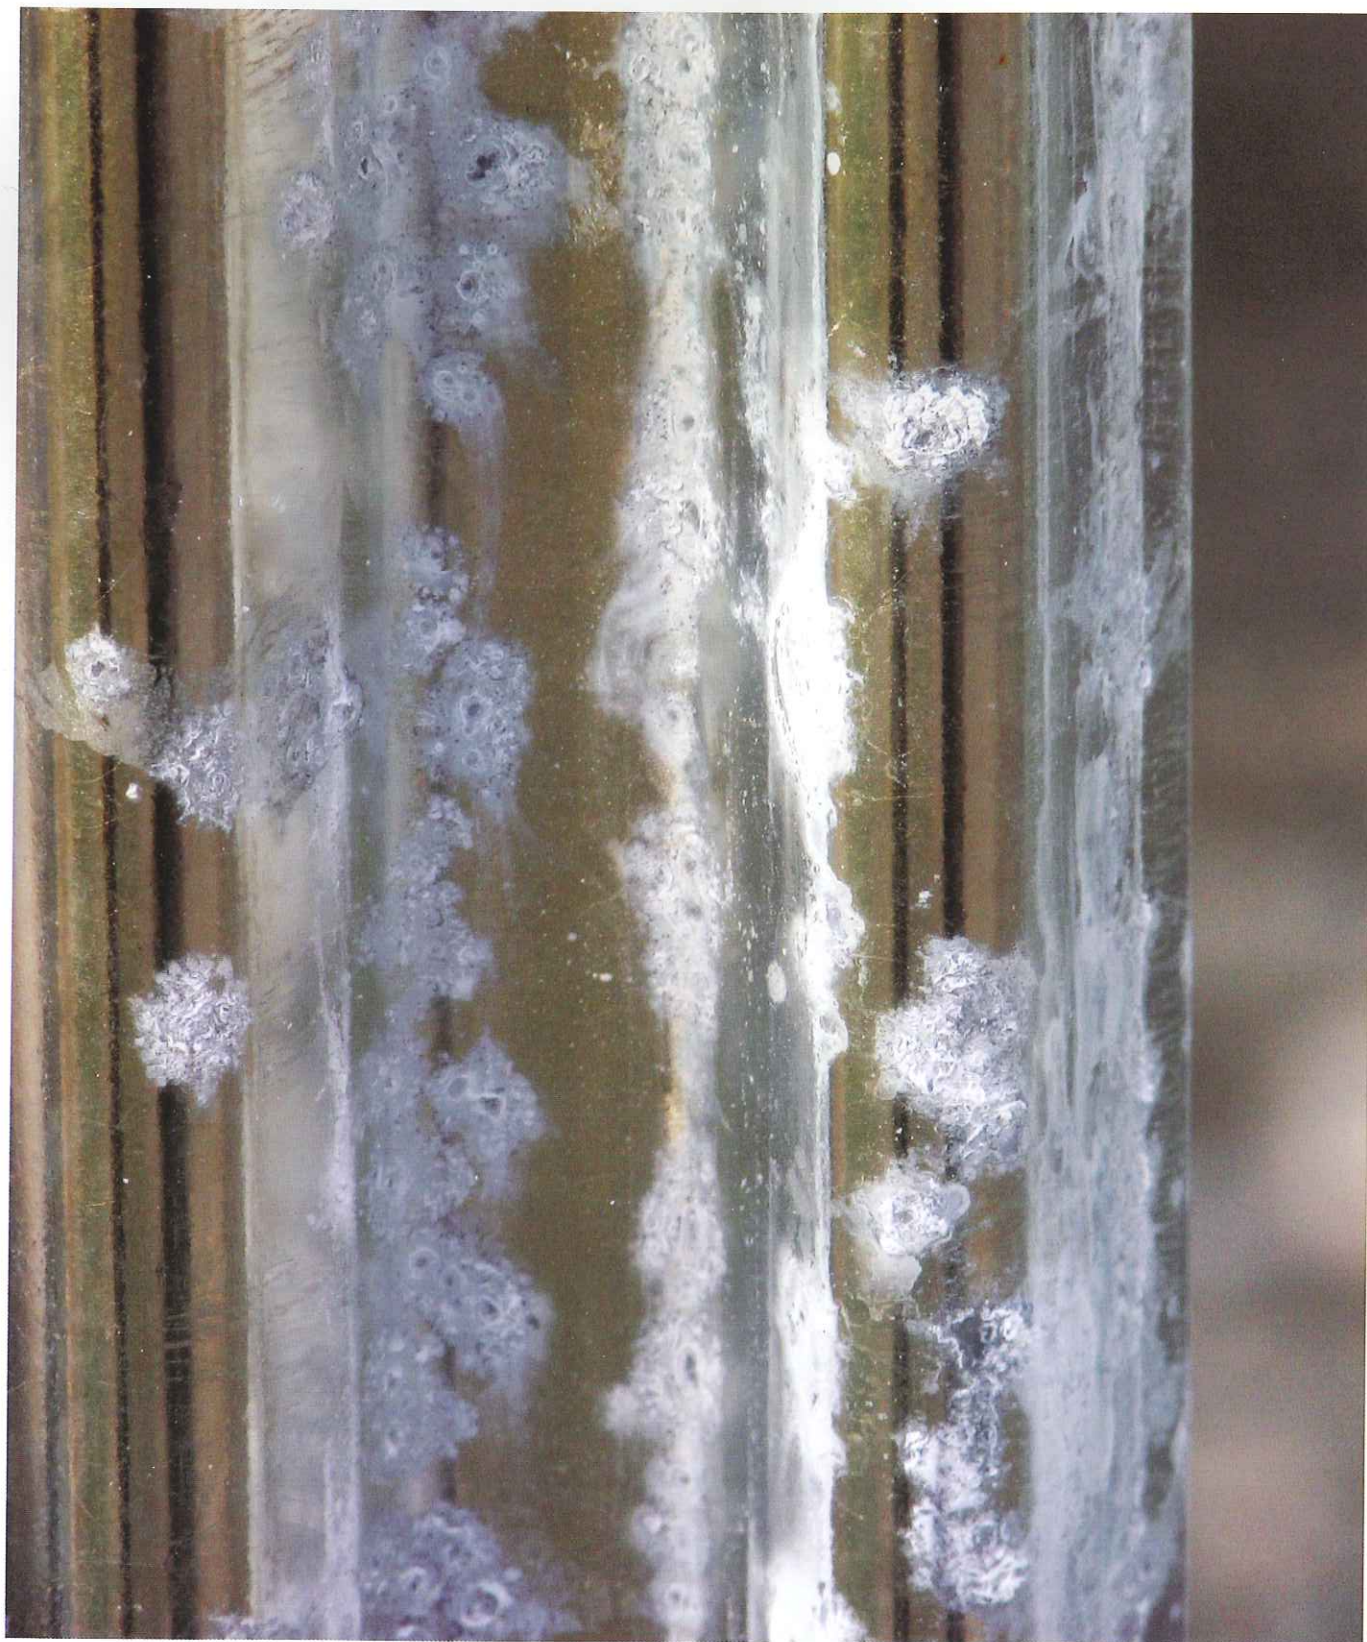
Light white rusting has occurred on these galvanized steel security fence palings through storage in wet conditions. While unsightly, there has been little coating loss and durability is unaffected.

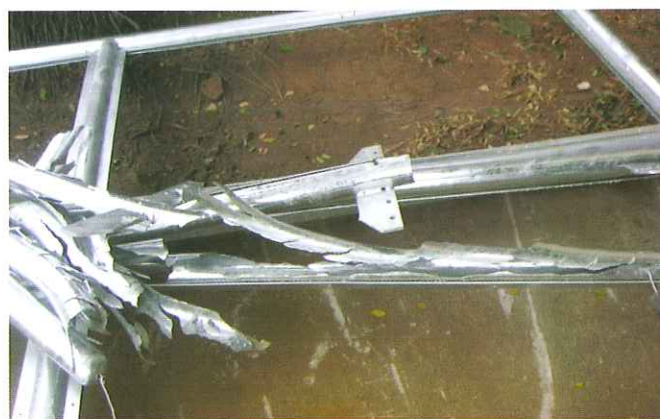
Extremely severe and nearly total delamination of the galvanized coating on these relatively small tube fabrications is a result of very reactive steel high in both silicon and phosphorous.

Once the thickness of a hot dip galvanized coating exceeds about 250 microns, the coating is likely to become more fragile and susceptible to mechanical damage, and in the worst case, subject to delamination from the steel's surface.

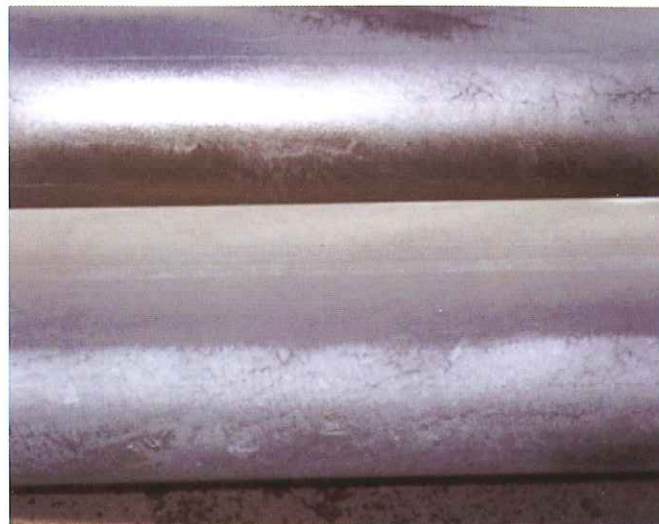
Variations in galvanized coating appearance such as this are caused by the steel being in a reactive range due to its silicon content, causing some or all the free zinc on the coating's surface to be converted to zinc-alloy. These coatings are thicker than standard galvanized coatings.

A factor called the silicon equivalent is used to determine steel reactivity to molten zinc. This factor is derived from the silicon content of the steel added to 2.5 times the phosphorous content. If the resulting number exceeds 0.25%, it is likely that the hot dip galvanized coating will be thick, fragile and possibly unsightly. High silicon/phosphorous levels can result in the galvanized coating being wholly or partly matt gray in appearance, rather than having a typically shiny appearance.

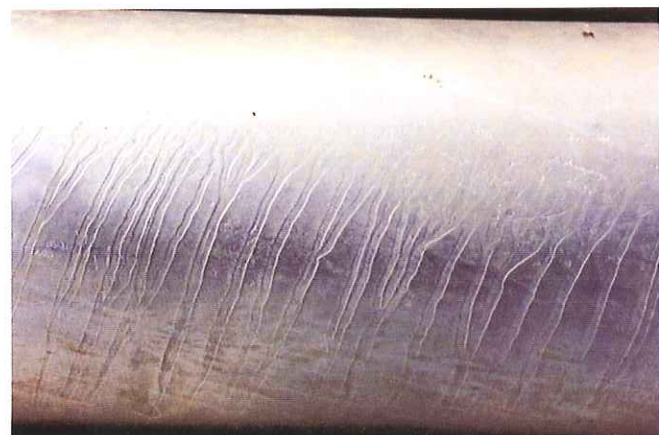
"Fishboning" of a galvanized coating on large pipes is a result of rust activation of the pipe surface during storage in wet conditions. While unsightly, durability is unaffected.

From time to time, particularly on large diameter pipes and other products manufactured from heavy hot rolled coil of plate, a phenomenon called 'fish-boning' may occur with the galvanized coating. This gives the coating a ribbed appearance with areas of different coating thickness running in roughly parallel lines down the surface of the section.

This is caused by the surface of the steel being activated by corrosion, which is caused by rainwater running over the surface of the steel section during prolonged outside storage prior to galvanizing. The pattern in the galvanized coating will closely match the pattern formed by areas of

heavier corrosion arising from the water draining off the steel surface. This occurs although all the rust and corrosion products are removed from the steel's surface during the acid pickling process. It is an aesthetic issue and has no effect on coating durability.

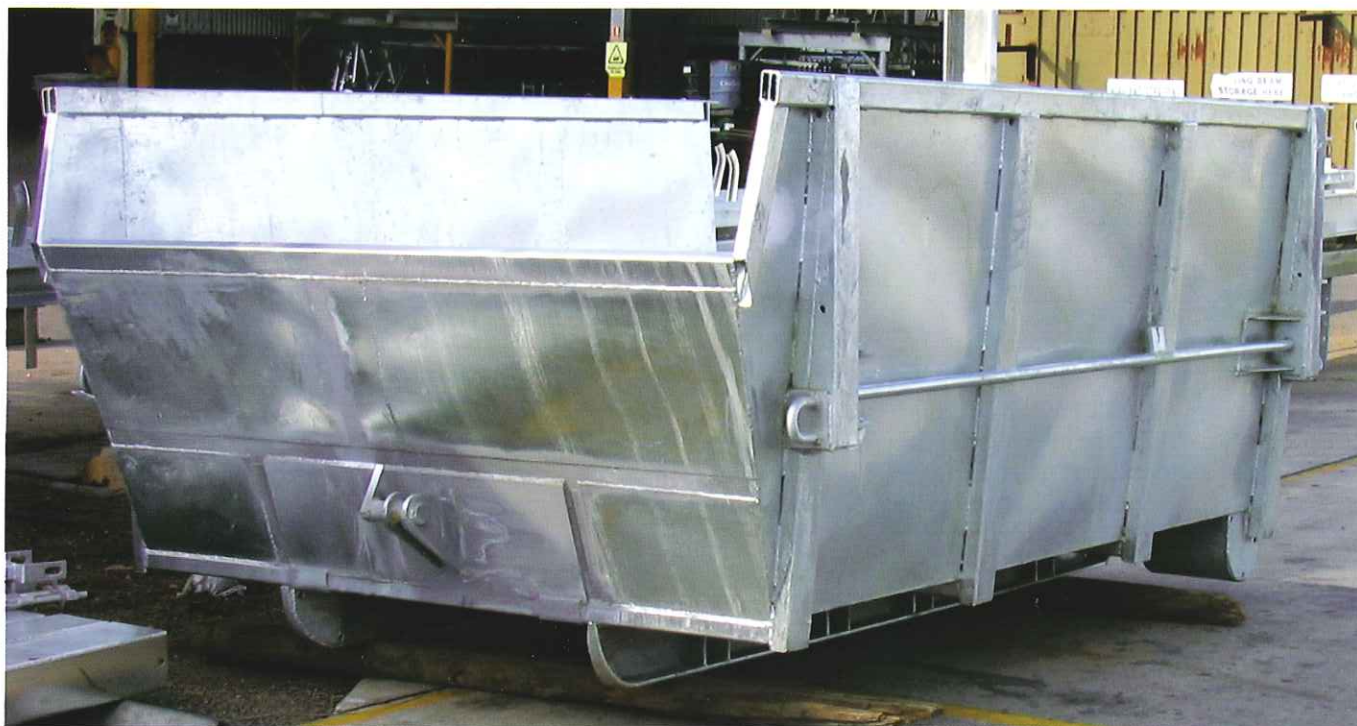
Some buckling of the plate used in the sides and bottom of this dumper bin has occurred, but is acceptable to the client because of the significant (up to 5x) service life of galvanized bins over painted items.

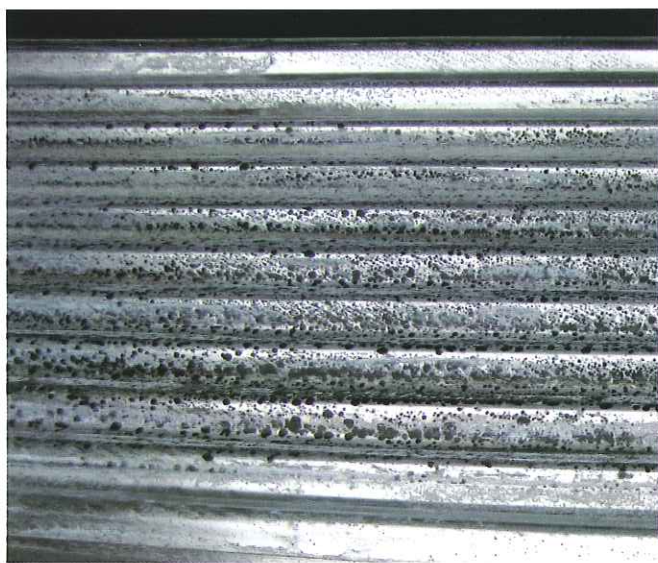
Severe white rusting of these corrugated hot dip galvanized sheets, intended for an architectural application, was caused through being stored in packs during very wet weather over the Christmas holiday shutdown period.

This is characterised by very heavy oxide deposits. Items may be stuck together. Areas under the oxidised area may be almost black or show signs of red rust. A coating thickness

check will determine the extent to which the galvanized coating has been damaged. Remedial treatment to reinstate the coating should be undertaken as follows:

- Wire brush or buff the affected area to remove all oxidation products and rust if any
- Apply one or two coats of approved epoxy zinc-rich paint to achieve required dry film thickness of 100 microns minimum

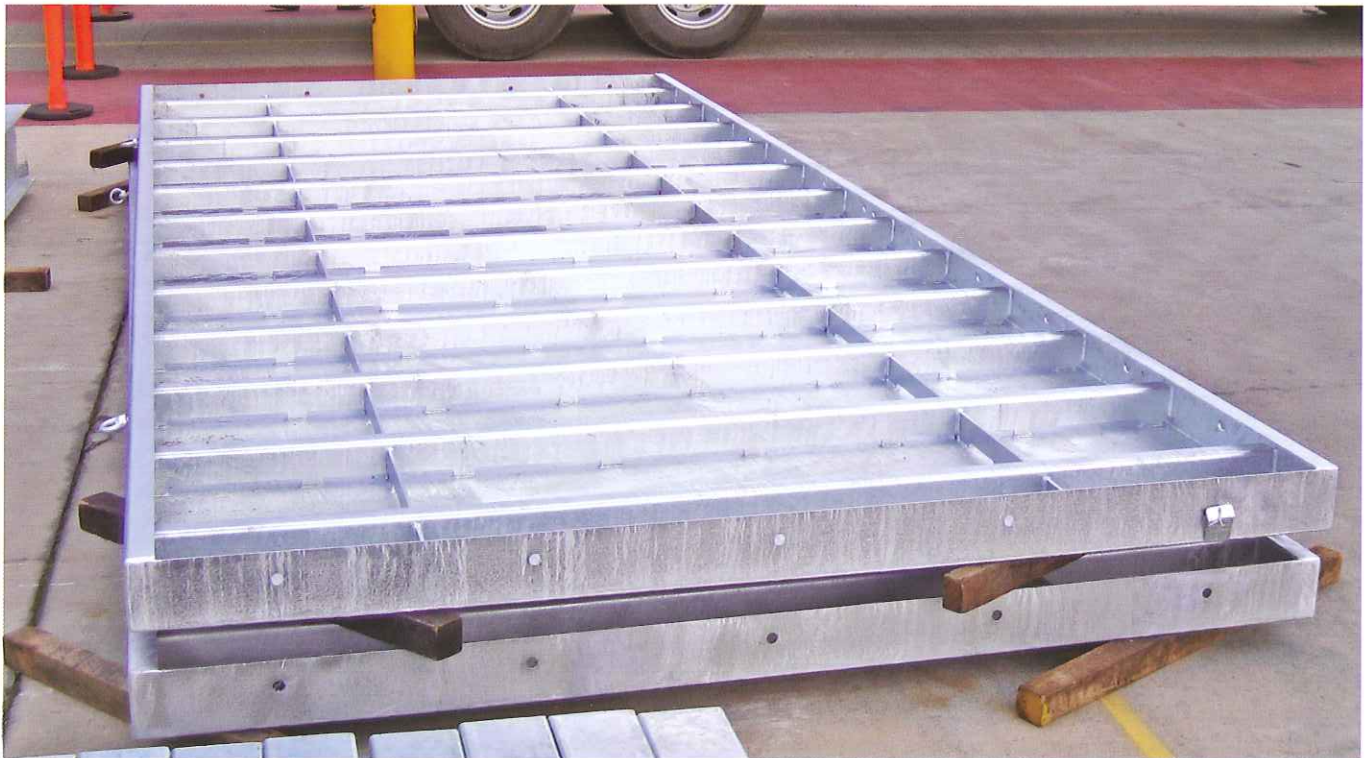
Careful handling has allowed these large panel frames to be satisfactorily hot dip galvanized with no distortion problems. Fast Immersion, slow cooling and proper stacking contribute to a good result.

In most cases, distortion can be avoided or minimised by appropriate design and modifications to the galvanizing process to eliminate or reduce the distortion stresses. These techniques can include rapid immersion and withdrawal from the molten zinc to minimise the temperature differential across the fabrication, and the elimination of the chromate quenching process by air cooling the fabrication, to again minimise thermal stress across the fabrication.
