# NASH NEWS

JUNE 2009

# BRICK TIE TESTING FOR EARTHQUAKES

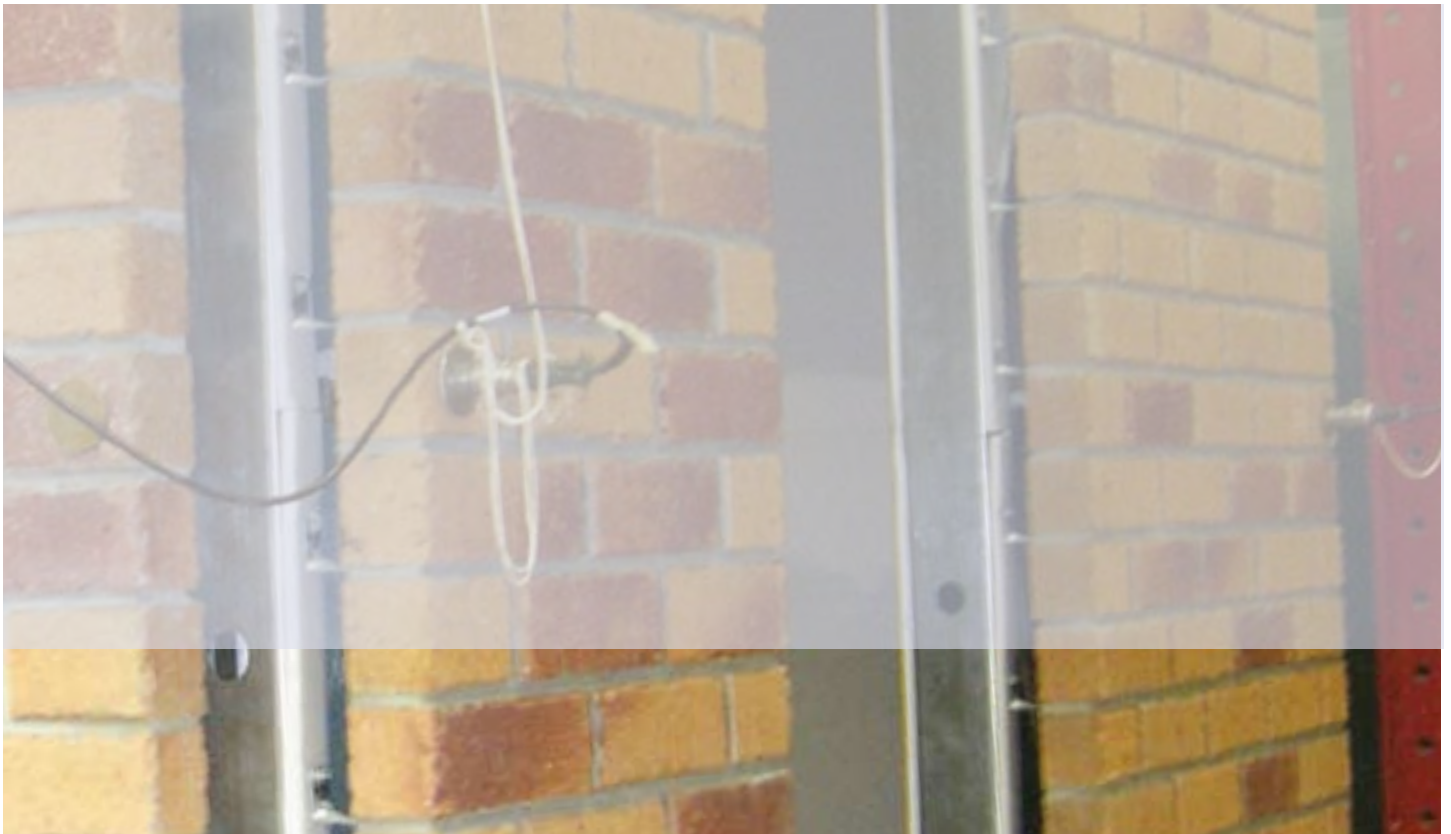
The Test House measured approximately 2.6m x 2.8m in plan and was 2.4m in height. It comprised a steel frame with brick veneer exterior cladding and plasterboard interior lining. All building components were typical, full size and sourced from either New Zealand or identical suppliers in Australia. Specifically, the steel frame was made of 0.75mm thick G550 lipped C sections, the bricks were standard 70 Series and the brick ties were Type B Eagle ties. The brick ties were screwed to the flanges of the studs with the presence of 40mmx10mm thick standard thermal break.

The Test House was designed to encompass a range of typical geometric features in the veneer walls in different directions. It had two brick veneer walls without openings in one direction and in the orthogonal direction it had one wall with a window opening and the other wall with a door opening. Given the bi-directional capabilities of the shaking table, the Test House was subjected to earthquake excitations in the north-south and east-west directions.

A roof slab weighing 1500kg was placed on the top of the Test House and supported by the frame to simulate the equivalent mass from a house roof. With this roof mass combined with the designed frame wall bracing the Test House exhibited the same dynamic characteristics as those of a typical full scale single

storey brick veneer house. The Test House had a fundamental natural frequency prior to earthquake shaking of approximately 6Hz.
