SAFETY ALERT

Number: SA0005

Subject: Fall from Height – Ladder Incident

Date:(mth/yr) April 2005

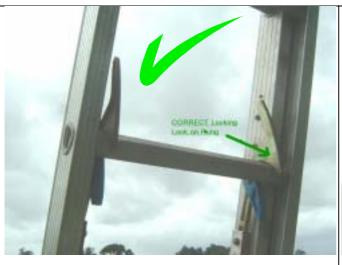
Contractor had climbed up the ladder without checking to see if the extension lock was safely
engaged, and had begun to step onto the roof with his right foot when the ladder extension
lock suddenly disengaged causing the extension to slide down several rungs toward the
ground with the worker still holding on to it. The worker lost his balance and fell 3.5m to the
bare ground.

- Need for contractors' daily toolbox meetings to reinforce good and safe work behaviours & practices.
- Need to conduct regular site safety audits by both contractors and employees.
- Need to raise understanding by all concerned on safety procedures related to working at height.

- Workers reinducted on working at height safety, including the proper use of ladders.
- More safety auditing of people working at heights.
