# SAFETY ALERT

AUSTRALIAN STEEL INSTITUTE  
SAFETY GROUP

<b>Number:</b>	SA0010
<b>Subject:</b>	Faulty Ladder Handrail
<b>Date :</b>	25/08/05

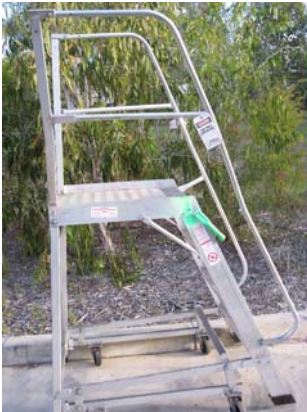
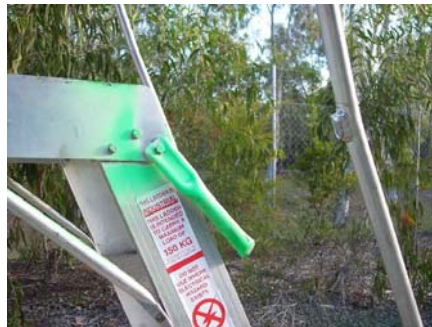
- During a routine inspection, an employee noticed a weakened area on a ladder handrail strut and upon closer checking, noticed that the joint had failed.

- Once the handrails become loose they are susceptible to becoming fatigue points.
- Handrails are an aid that people rely on to do tasks safely and need to be regularly checked.
- Damaged handrails could potentially lead to a person falling off the access ladder with severe consequences.

- Regular checking of ladder for fatigue points in particular the handrail.
- Regular tightening of handrail fixing points.
- Ensure all personnel that use access ladders are made aware of the potential for this failure to occur
