SAFETY ALERT

AUSTRALIAN STEEL INSTITUTE
SAFETY GROUP

Number:	SA0019
Subject:	Slip and fall from forklift
Date:	October 2006

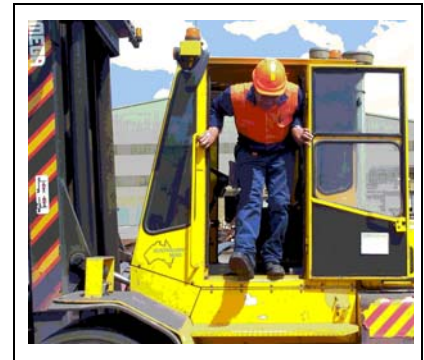
- Forklift operator parked 16t forklift and proceeded to exit while facing out from cabin.
- Forklift operator was unable to hold onto handrail as he was facing away from steps.
- When the forklift operator stepped onto the top step he lost his footing due to the slippery step and light grease on his shoes.
- The forklift operator fell 1.1metre to the ground, landing on his back and breaking his thumb in the process.

- Report slippery steps and if anti-slip tape is missing.
- Practice three paws – on stairs and also on ladders.

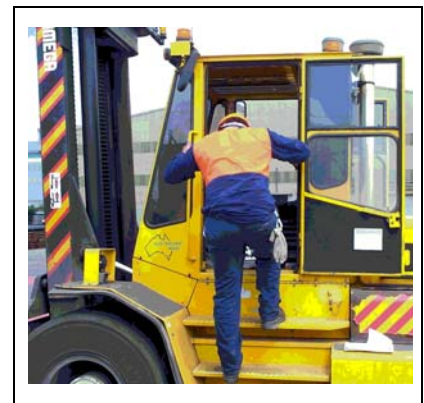
- Always use handrail provided when entering and exiting.
- Always face towards the steps when entering or exiting.
- Ensure minimum three paws contact, i.e. combination of hands and feet (see picture).
