Safety Alert

Worker Struck by Vehicle Mounted Crane

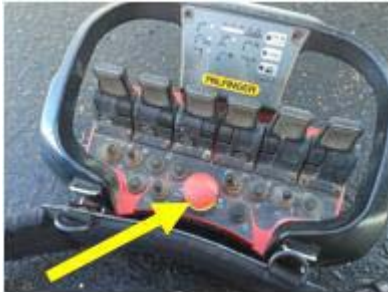
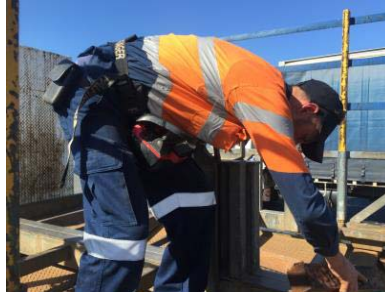
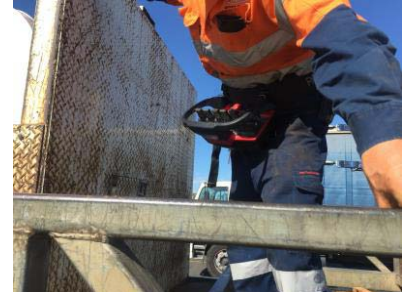
On the 30/10/2015 a worker delivering steel reinforcing products was struck by a vehicle mounted crane, the worker was using a remote control at the time of the incident and was on the vehicle tray balancing the load/lifting equipment prior to making the final lift.

As the worker leant over the load to move lifting equipment it is thought that the remote may have somehow made contact with either the workers body or a part of the load or vehicle which has then engaged the crane and caused it to move and subsequently strike the worker and crush him between the load and the crane causing mid torso injuries.

- **ALWAYS Isolate crane remotes prior to accessing a vehicle tray or deck.**
- Review **ALL/ANY SOPs** that relate to crane operations and ensure Isolation of the remote is included when the driver access's the vehicle tray or deck.
- **“TAKE 2”**- Assess the task. Is it safe? Can I do it safely?
Can I control the risk?
- **NEVER Work under a suspended load**
